Environmental Habitat Investigation on the Sediments Surrounding South Stulaigh Proposed Fish Farm Site, South Uist

September 2019

Stulaigh South Habitat and Maerl Assessment

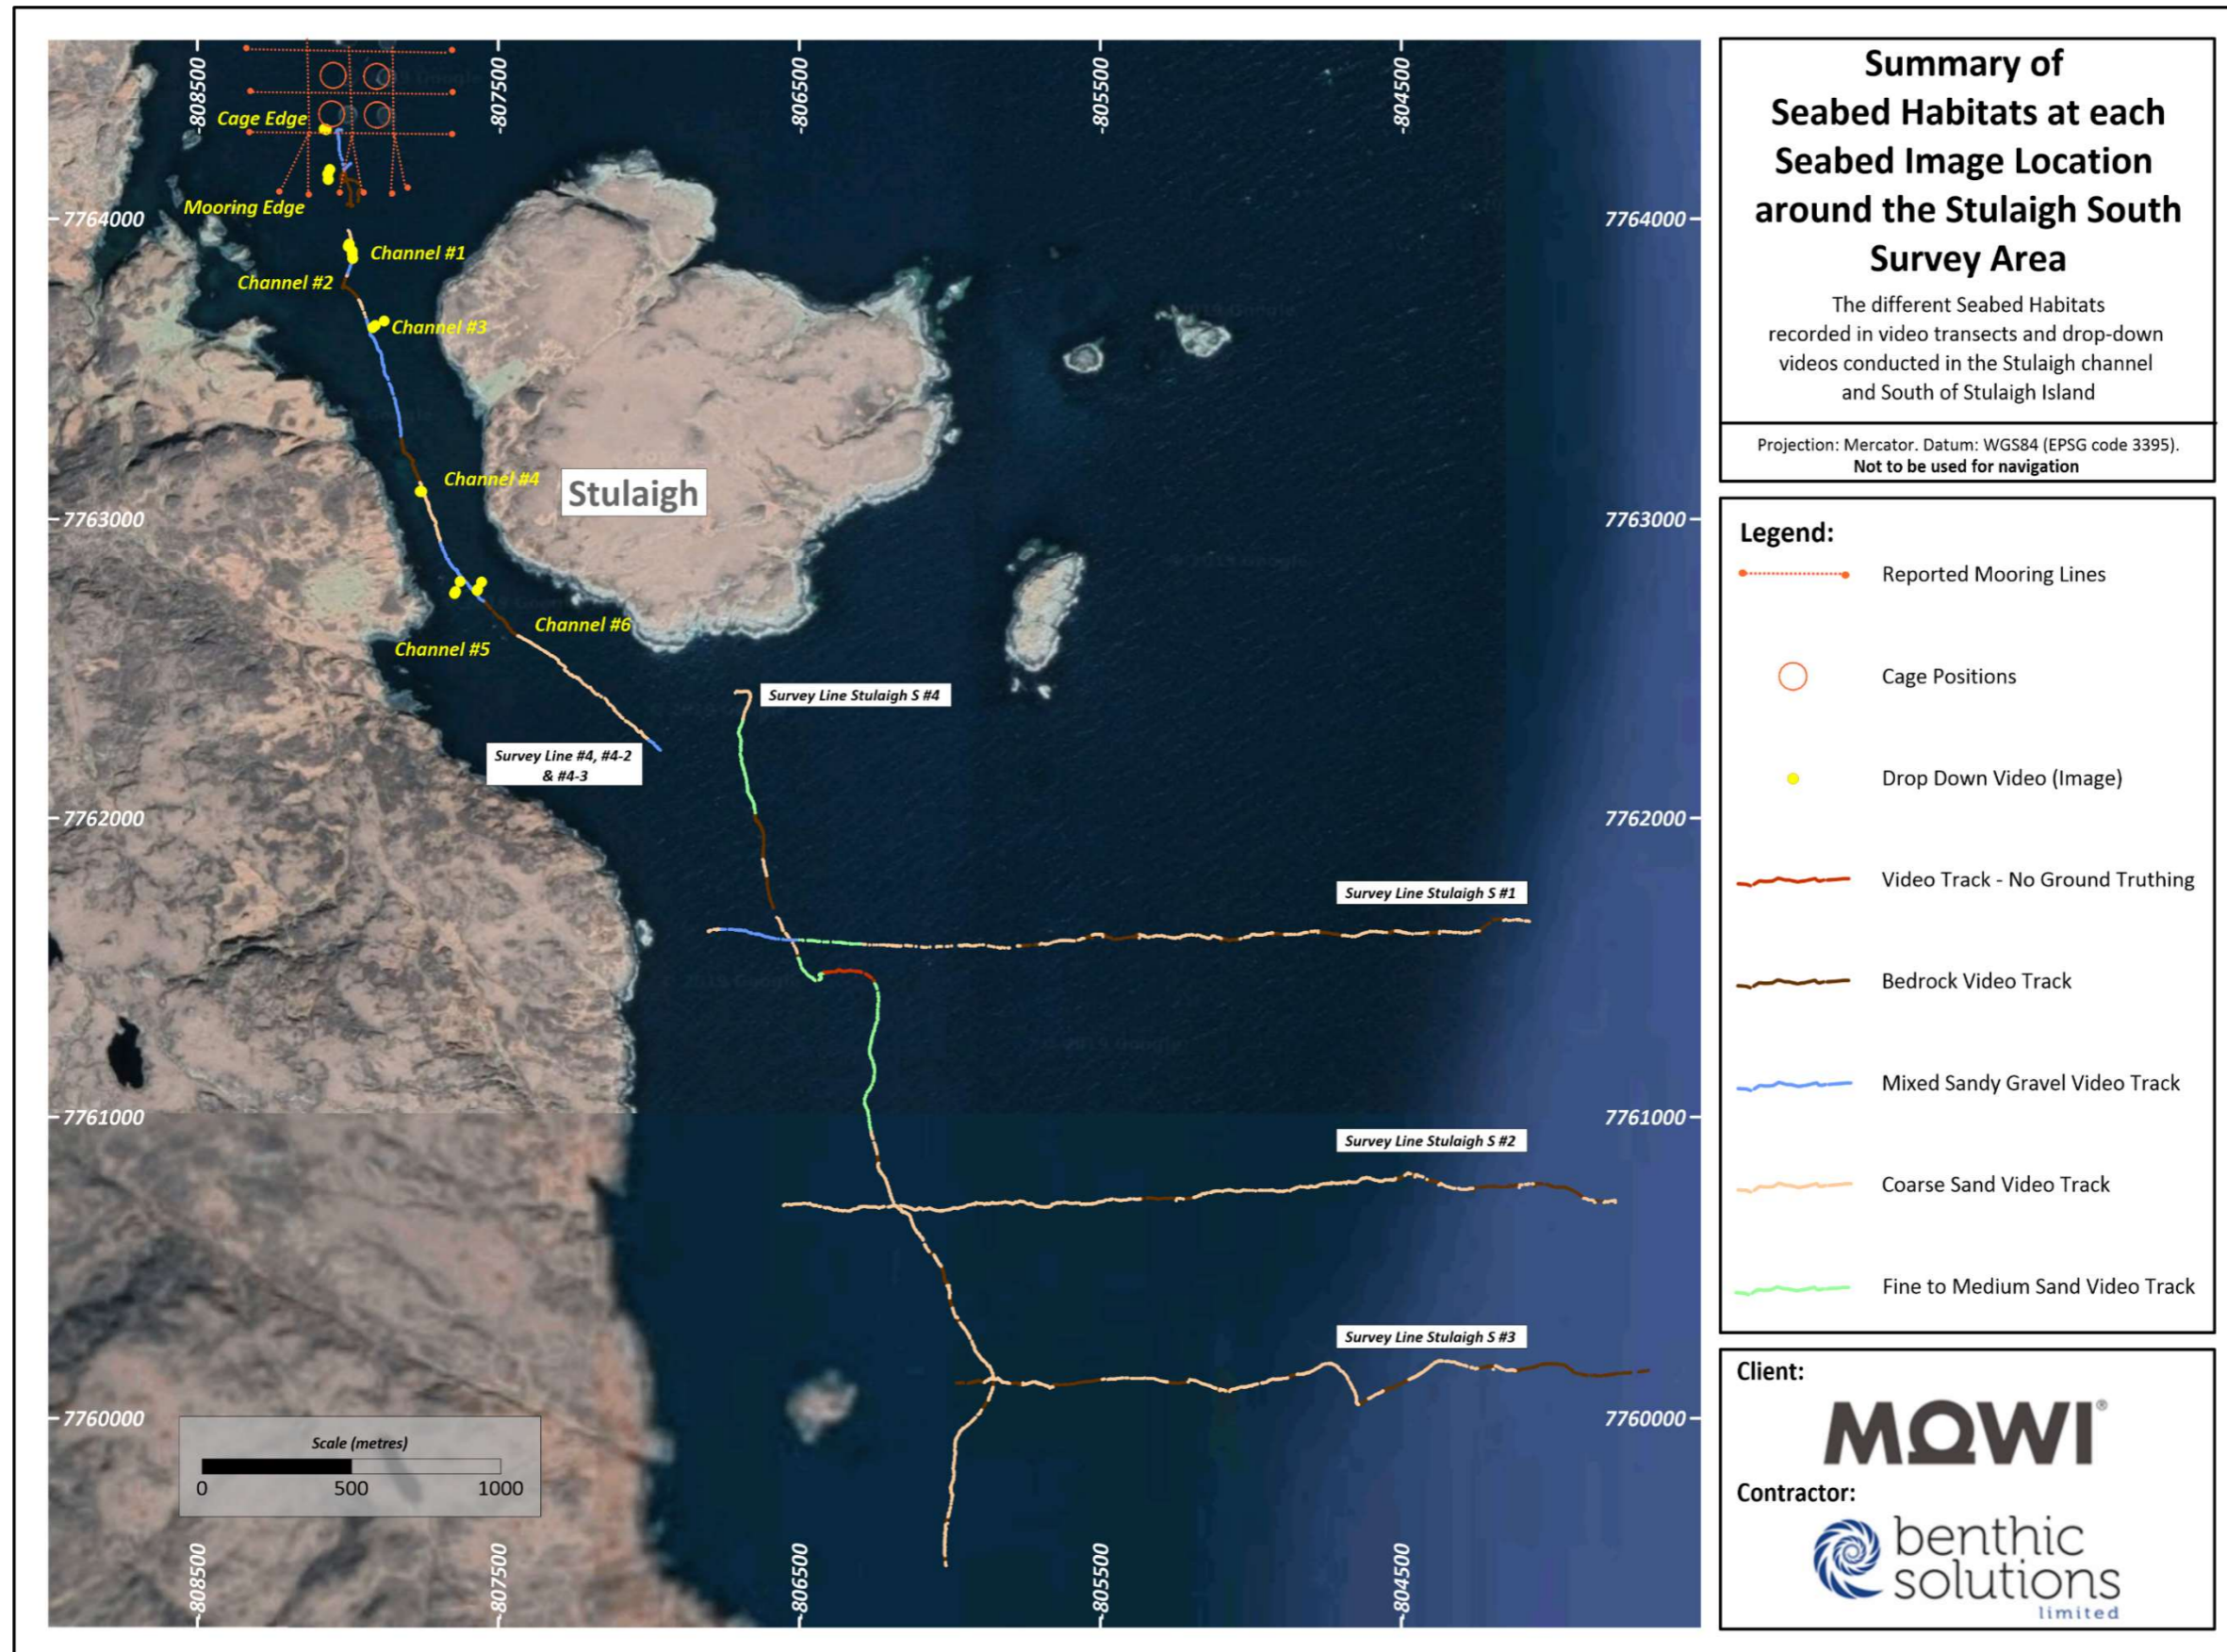
Figure 8.1 Summary of Habitats at each Seabed Image Location around the South Stulaigh Survey Area

Using the above categories, it was possible to delimit the survey lines into sections of different substrate types (Figure 8.1). At the southern edge of the North Stulaigh cages, the sediment was composed of silty sands overlying mixed shelly gravel becoming coarser to the south with boulders and exposed bedrock visible at the mooring edge (Figure 8.1). Further south, in the channel, the seabed was characterised by mixed sediments which consisted of areas of dead maerl rubble and living maerl aggregations. In addition, multiple sections of the channel (approximately 50m to 90m in length) contained areas of exposed bedrock colonised by *Laminaria* spp. The sediment immediately south of Stulaigh Island was composed of fine to medium sand with evidence of bioturbation, interspersed with coarse sand and exposed bedrock (Figure 8.1). Survey lines running east to west in the South Stulaigh survey area (Stulaigh S #1, #2, and #3) showed mainly coarse sands with occasional patches of exposed bedrock. (Figure 8.1).

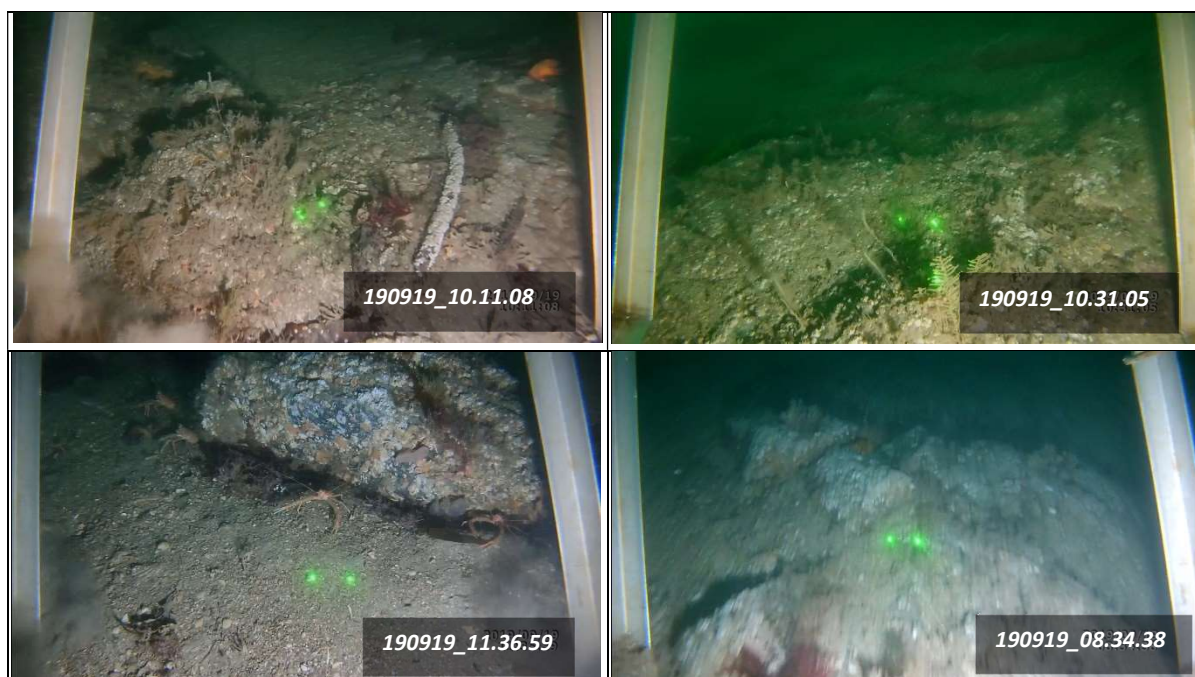
Figure 8.2 Example Images of Exposed Bedrock Habitat

Bedrock exposures were recorded within sections of the channel separating South Uist and Stulaigh Island (survey lines #4, #4-2, #4-3; Figure 8.1), and on all survey lines to the south of Stulaigh island (Figure 8.1). This substrate type was generally recorded as a continuous structure with numerous fractures and elevated up to several meters above the surrounding seabed. In small sections the bedrock exposure consisted of boulders that had been eroded from the main structure. Rocky faces were colonised by dense epifaunal assemblages suggesting a relatively diverse community. The combination of the habitat and faunal community is best described by the biotope of CR.MCR.EcCr – echinoderms and crustose communities. The biotope is dominated by echinoderms and algal crusts on wave-exposed and tide-swept circalittoral bedrock and boulders. Conspicuous epifauna included the crinoids *Antedon* spp., the solitary cup coral *Caryophyllia* (*Caryophyllia*) *smithii*, hydroid spp. (turf), Rhodophyta spp. (foliose and crustose forms), and the kelp *Laminaria* spp. In deeper areas, algal crusts were generally replaced with high densities of barnacles (*Cirripedia* spp.). Mobile fauna was common on the exposed bedrock and included the crustaceans *Munida rugosa* and *Liocarcinus depurator*, and the echinoderms *Henricia* sp., *Porania pulvillus*, *Asterias rubens* and *Marthasterias glacialis*.

Given the elevation and extent of the bedrock formations the areas delineated would likely classify as JNCC Annex I reefs, which are described as occurring “where bedrock or stable boulders and cobbles arise from the surrounding seabed creating a habitat that is colonised by many different marine animals and plants. Rocky reefs can be very variable in terms of both their structure and the communities they support. They provide a home to many species such as corals, sponges and sea squirts as well as giving shelter to fish and crustaceans such as lobsters and crabs” (JNCC,2016). From the recorded video data, the elevation of the bedrock observed in the Stulaigh South survey area does not appear to exceed 5m, although coverage of rock regularly exceeds 95% of the viewed area, and as such these patches would likely be mostly classified as medium reef habitat. It should be noted

however, that due to the gentle sloping nature of some bedrock exposure and the lack of geophysical data available, an accurate estimate of elevation above seabed was difficult to ascertain and as such the true elevation of these reefs cannot be confidently defined. As illustrated in Figure 8.2, the bedrock exposures observed during the current campaign were colonised by encrusting red calcareous algae, barnacles and kelp (*Laminaria* spp.), with associated communities of the sea urchin *Echinus esculentus* within the channel.

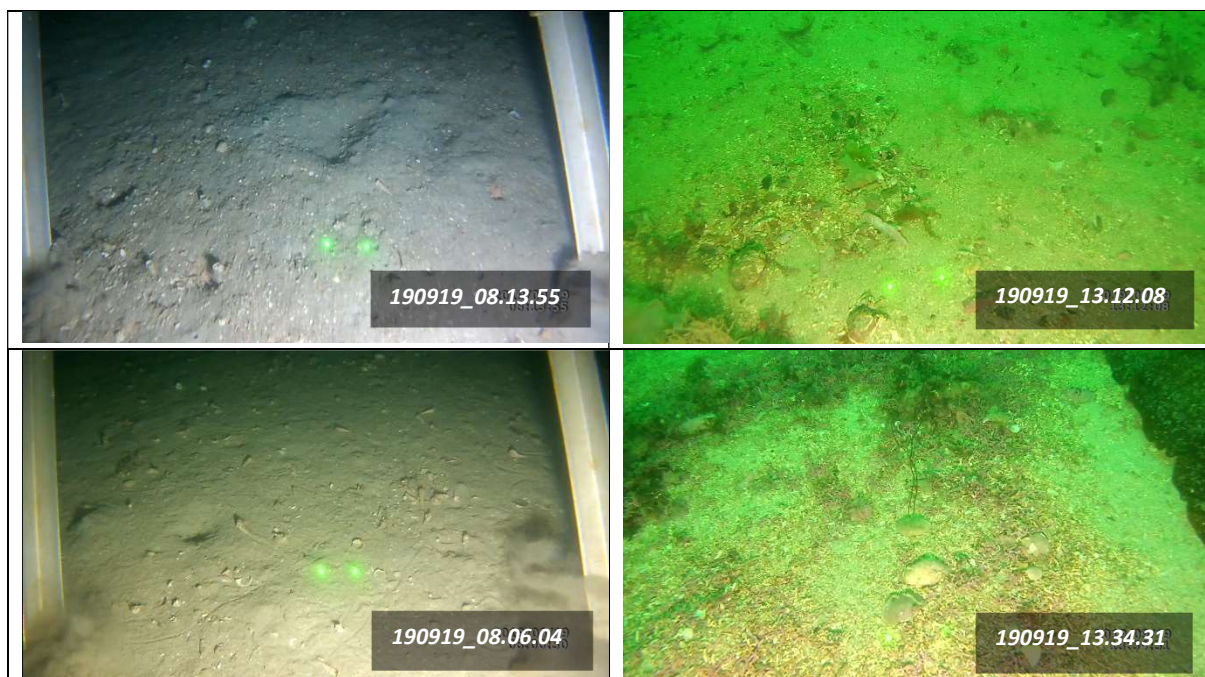
Figure 8.3 Example Images of Mixed Sediment Habitat Variation

Mixed sediments composed of muddy gravelly sand with pebbles and shells (predominantly *Turritella*) were recorded in the middle section of the channel and along the most westerly section of the survey line Stulaigh S #1 (Figure 8.1). Rocky substrate provided attachment points for *Laminaria* spp. holdfasts which subsequently supported bryozoan epiphytes such as *Membranipora membranacea* and the grazing echinoderm, *Echinus esculentus*. This broad substrate type also included areas of fine to medium sand surface sediments overlying coarse sediments, where conspicuous fauna included but was not limited to: *Luidia ciliaris*, *Munida rugosa*, *Antedon* spp., filamentous and foliose Rhodophyta spp., Ophiuroidea spp., *Pecten maximus*, and free swimming Gobiidae and Pleuronectiformes. This habitat-type generally conformed to the biotope ‘sublittoral mixed sediments’ (SS.SMx) with example images presented in Figure 8.3.

Dead and live maerl were also constituents of the mixed sediment habitat forming pockets of ‘maerl bed’ habitat (SS.SMP.Mrl) in the channel but were absent from lines south of Stulaigh Island (Appendix II). Larger aggregations of living maerl were typically limited to the channel separating South Uist and Stulaigh Island, approximately 1km south of the cage edge. The presence of aggregations of live maerl in this area likely relate to the sheltered nature of the channel when compared to the more exposed environment south of the island (Figure 8.1).

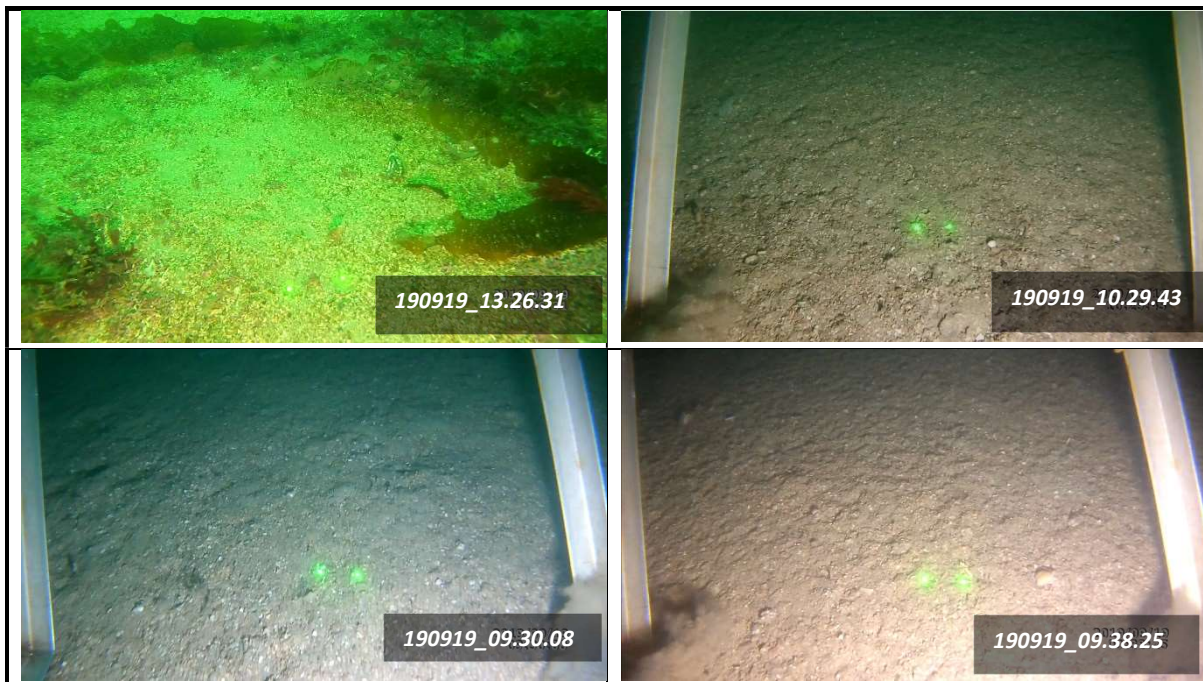
Figure 8.4 Example Images of Coarse Sand Habitat

This sediment type was well represented throughout the survey area and was composed of fragmented shell and/or dead maerl with occasional patches of live maerl in the southern channel close to station Channel #4 (approximately 1km from the mooring edge; Figure 8.1). Conspicuous fauna were similar to that observed in the mixed sediment substratum, including: the tube-dwelling anemone *Cerianthus lloydii*, the king scallop *Pecten maximus*, accumulation of *Laminaria saccharina* detritus, foliose Rhodophyta sp., sea stars *Henricia* sp. and *Luidia ciliaris*, and the crustaceans *Cancer pagurus* and *Munida rugosa*. The substrate type and associated fauna is illustrated in Figure 8.4 and is best described by the biotope 'circalittoral coarse sediment' (SS.SCS.CCS). The biotope may be characterised by robust infaunal polychaetes such as *Mediomastus fragilis* and *Lumbrineris* spp.; however, no grab sampling was undertaken to enable a more detailed biotope description. Sporadic patches of maerl were present only within the channel and were again assigned to the biotope SS.SMP.Mrl.

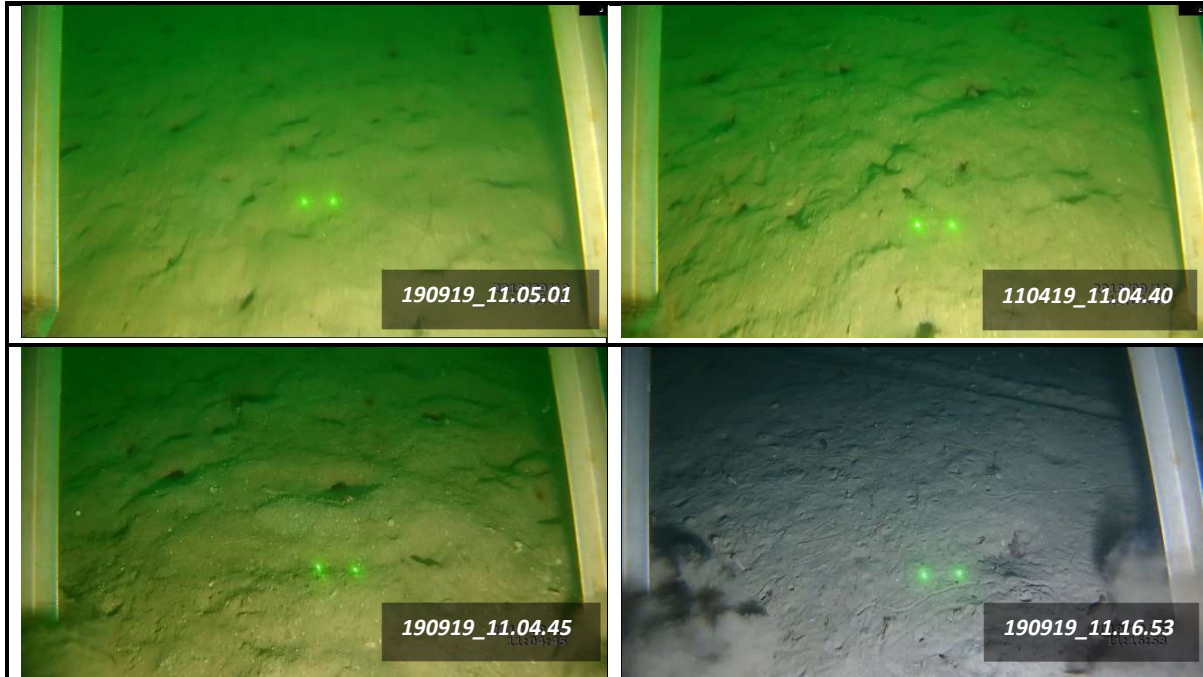
Figure 8.5 Example Images of a Fine to Medium Sand Habitat

This sediment type was found exclusively in the northwest corner of the Stulaigh south survey area, on lines Stulaigh S #4 and Stulaigh S #1, although it was also noted during the North Stulaigh survey (Figure 8.1). It consisted of fine to medium sand with minor proportions of shell fragments and was characterised by bioturbation and “lebensspuren” (Figure 8.5). The faunal community was generally impoverished, with relatively few conspicuous fauna recorded including: *Turritella communis*, *Munida rugosa*, Ophiuroidea spp., *Luidia ciliaris*, *Porania pulvillus*, and *Pecten maximus*. Maerl was absent from the fine to medium sand habitat.

The silty sand habitat recorded is well described by the biotope SS.SMu.CSaMu - circalittoral sandy mud. The observed presence of burrowing macrofauna and the bioturbated nature of the seabed may indicate the sediment type incorporates elements of the biotope of SS.SMu.CFiMu.SpnMeg – seapens and burrowing megafauna in circalittoral fine mud. The seapens and burrowing megafauna in circalittoral fine mud biotope may be further classified as the UKBAP ‘mud habitats in deep water’ priority habitat (UKBAP, 2008) and the OSPAR Commission ‘seapens and burrowing megafauna communities’ threatened and/or declining habitat (OSPAR, 2010), which are defined as follows:

The environmental conditions described by both the UKBAP and OSPAR habitats are commensurate with that recorded immediately south of Stulaigh Island, where silty sands and burrows were prevalent. The general absence of seapens (none recorded for the Southern survey area and a single individual recorded in channel line #4) from the habitat may not negate the classification, as while burrowing megafauna is an essential element of the habitat, seapens may, and by extension may not, be present (JNCC, 2014). According to JNCC (2014) guidance, burrowing species or burrows should be present at a SACFOR density of at least ‘frequent’ for a habitat to be classified as ‘Seapen and burrowing megafauna communities’ (

Five screengrabs containing the highest densities of burrows were assessed for burrow coverage per square meter using the SACFOR scale, all of which were recorded on transect Stulaigh S #4. The lowest density of burrows observed in these images was 18 burrows/m² and the maximum 48 burrows/m², with an average of 30 burrows/m² across the five images.

The burrow openings measured approximately 1-3cm in diameter however as no fauna was observed directly inhabiting the burrows, the size of the organism responsible for them is unknown. Although not directly observed in the still images used for assessment, numerous squat lobsters (*Munida* sp.) were recorded on the video, which would fall under the 3-15cm size category, and the horizontal nature of the burrows is characteristic of those created by burrowing crustaceans. As such, the 3-15cm size class has been used for calculation of the SACFOR abundance for the screengrabs.

When this size value was applied, the an average SACFOR density recorded was ‘Abundant’, with the calculated densities for all individual screengrabs falling into this category. As a result, it can be considered that the ‘seapen and burrowing megafauna communities’ habitat may be present within the Stulaigh South survey area as the burrow densities exceeded the minimum requirement of ‘Frequent’ on the SACFOR scale. It is important to note that although the fine to medium sand habitat was observed extensively on line Stulaigh S #4, and in a small section of Stulaigh S #1, high densities of burrows were only observed in a short section approximately 300m in length directly south of Stulaigh Island.

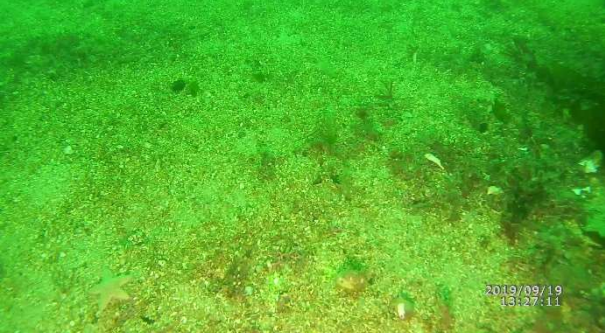
<p><5% (Channel #4)</p>

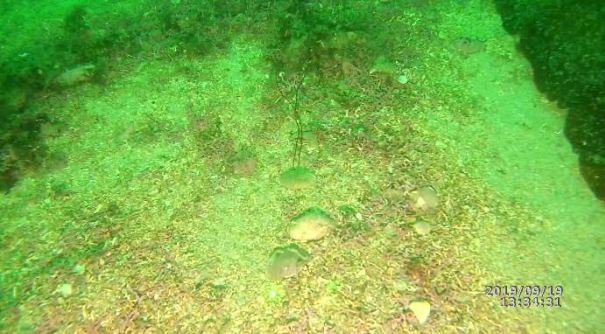
<p><20% (Channel #5)</p>

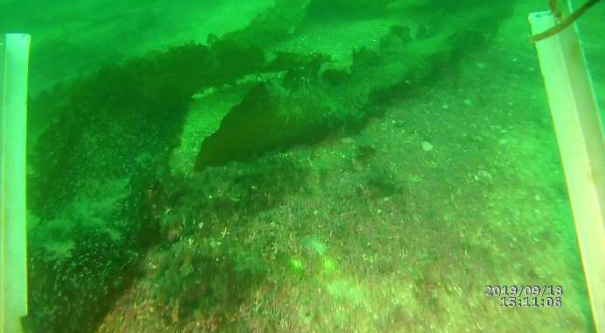
<p><50% (Line #4-3)</p>

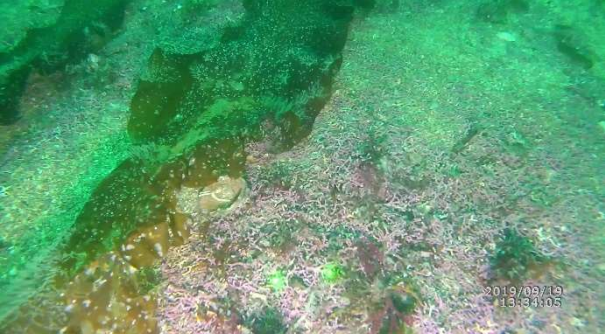
<p>>50% (Channel #5)</p>

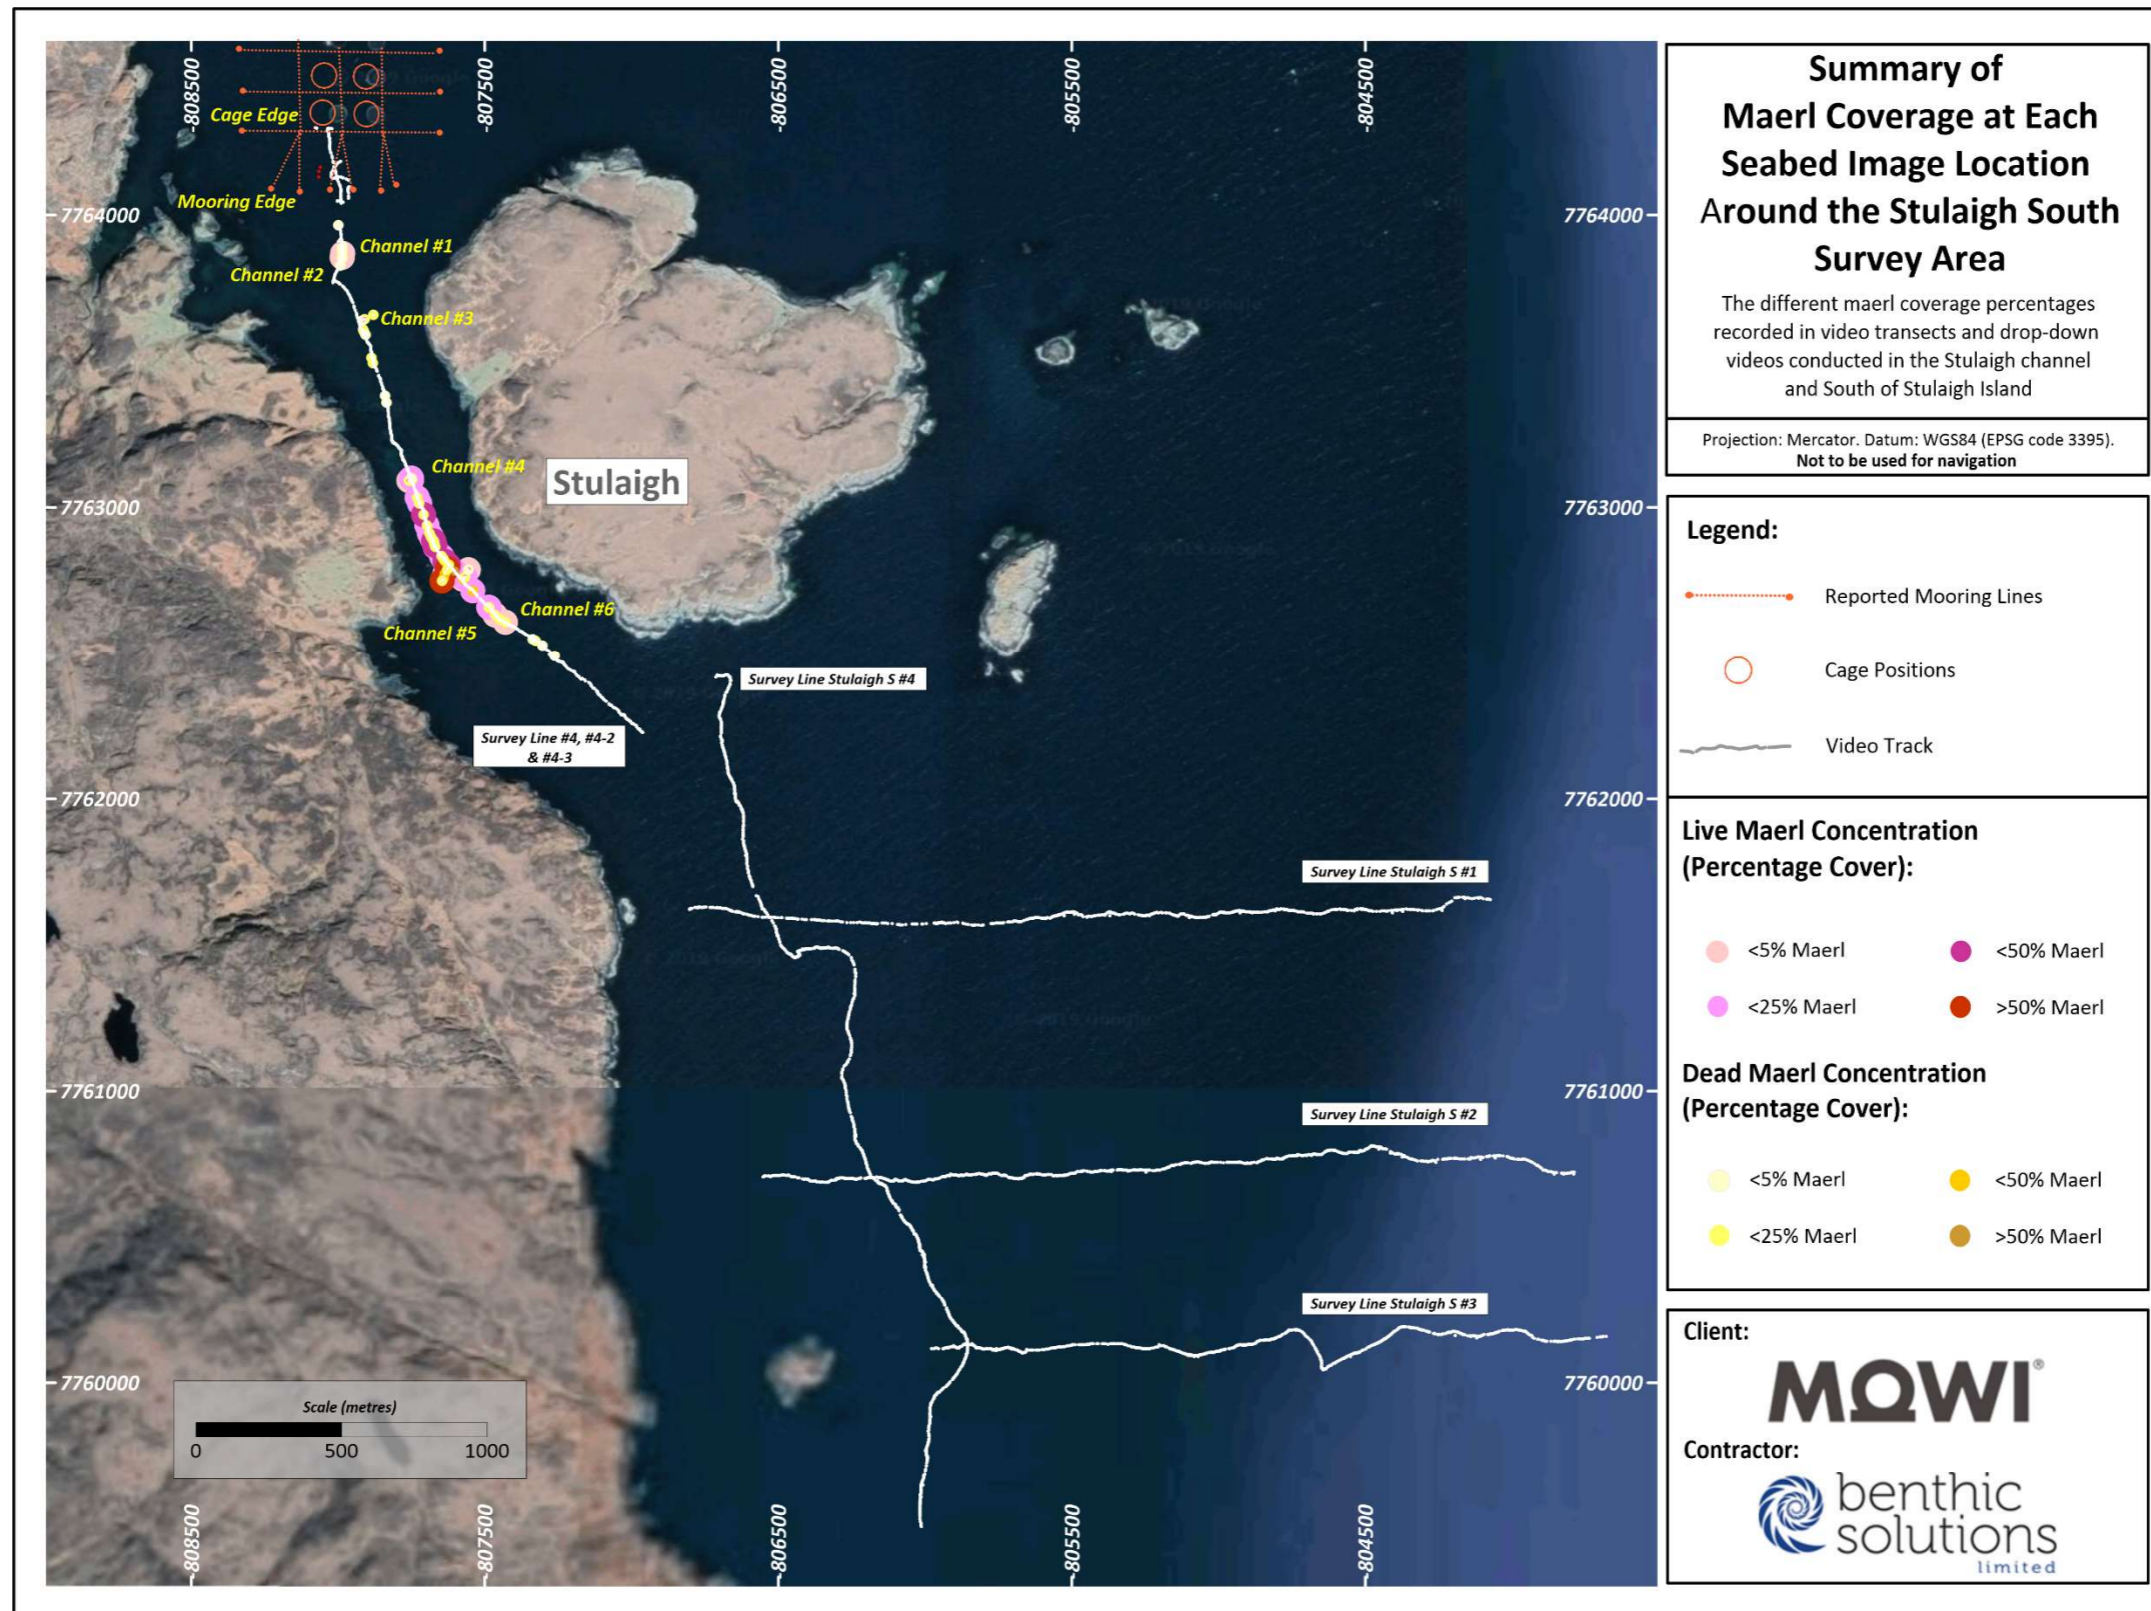
Figure 9.1 Maerl Coverage at each Seabed Image Location around the Stulaigh Fish Farm

No evidence of maerl was observed in any of the video data acquired on the Stulaigh S lines (Stulaigh S #1 to #4), with the only recorded maerl occurring in the channel between Stulaigh Island and South Uist (Figure 9.1). The distribution of maerl thalli appears to be related to the sediment type with denser aggregations occurring in mixed and coarse sandy sediment when compared to areas of fine-medium sand and exposed bedrock. The absence of maerl in similar sediments within the Stulaigh South survey lines also suggests that a sheltering effect from Stulaigh Island is a contributing factor to the presence of maerl within the channel.

The camera transect through the channel south of the Stulaigh fish farm (survey line #4, #4-2, #4-3) recorded the presence of living and dead maerl thalli (Figure 9.1). The 61 screenshots along this transect showed a high variability in maerl coverage, alternating between no maerl and >50% coverage. This variability may be explained by the presence of numerous sediment changes along the transect with the seabed transitioning between mixed sediment and areas of rocky reef (Figure 8.1). Small patches of dead maerl rubble (<5% to <20%) were observed approximately 330m south of the cage edge. In contrast, the greatest coverage was found at the southern extent of the channel where two screenshots at station Channel #5 recorded over 50% live maerl coverage (Figure 9.1; Appendix II). The maerl coverage by extended thalli form at Channel #5 existed as multiple layers with dead maerl visible as part of the underlying structure. The maerl aggregation in this part of the channel covered a length of at least 200m and given the percentage cover, the structure would be considered a maerl bed under current SNH guidelines (SNH, 2019). Maerl beds are predominantly associated with sheltered areas of granular sediments, which may explain the aggregations observed within the channel between the two islands (Figure 9.1).
