P2024037 Merkland Burn river habitat walkover survey report

Merkland Burn Hydropower Ltd.

November 2024

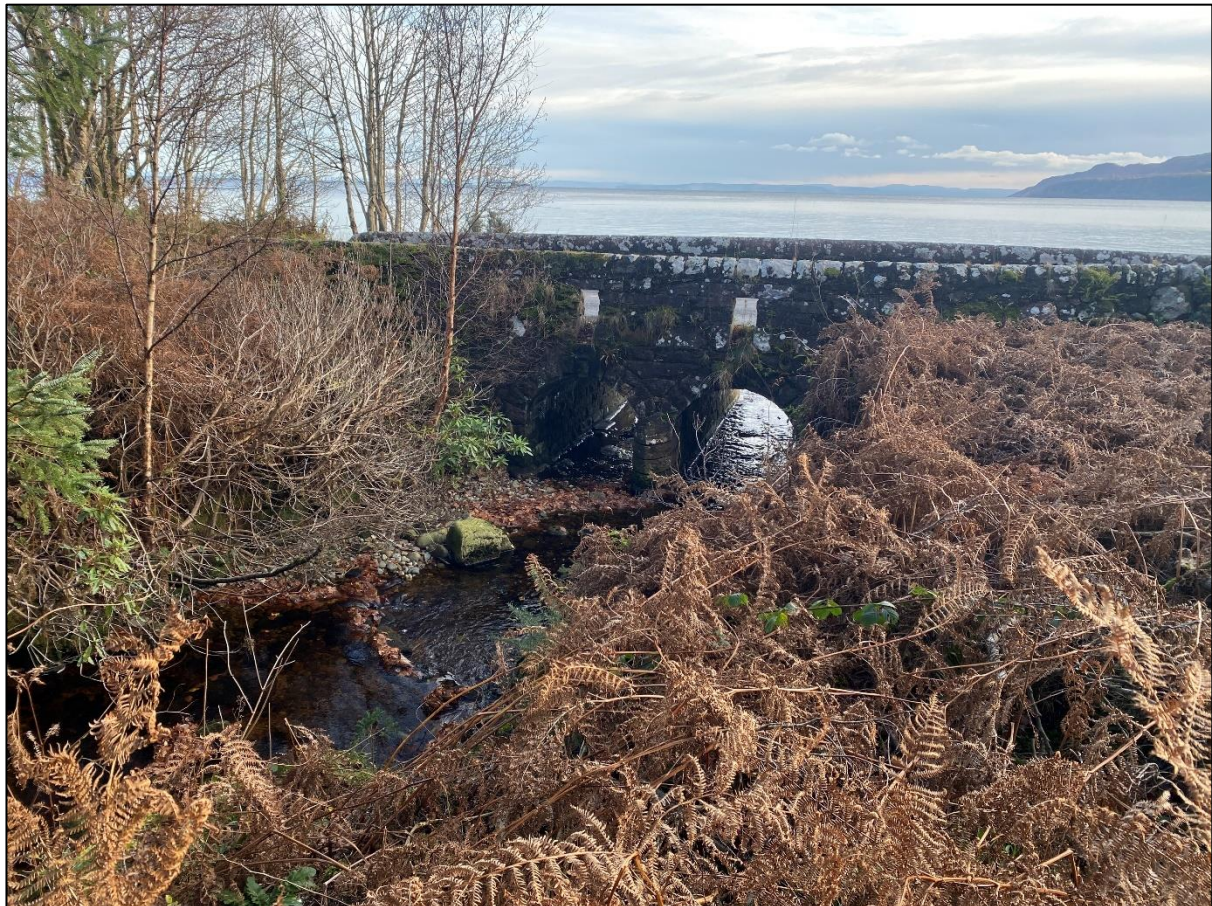
The Merkland Burn is a steep and energetic watercourse that flows through a wooded gorge dominated by bedrock. At the downstream end of the survey extent, where Merkland Burn discharges into the Firth of Clyde, the channel passes through a double arched culvert under the A841 (see Figure 3.7), which in certain conditions is a possible barrier to fish passage. Upstream of the culvert, there is a run with a boulder weir, which is potentially passable, and small areas of barform which have mixed substrate sizes from gravels to boulders. Hard reinforcement is present on both banks and overhanging trees are also present on both banks providing shade and cover for fish.

Figure 3.7. Culvert under the A841

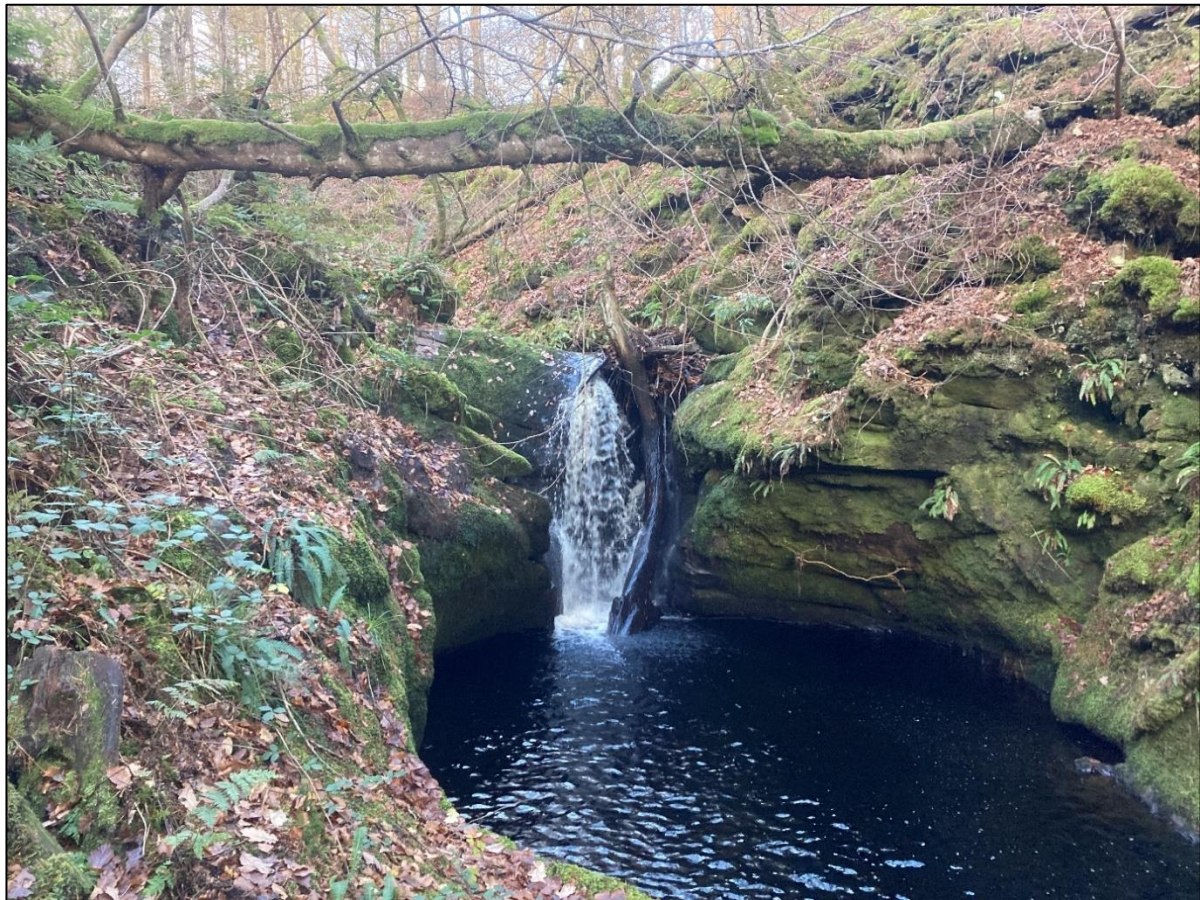
Upstream of this area, there is a pool with some LWD present which can provide fish cover from predators and increase storage of substrates. However, from here to where the forestry track crosses over the channel, the channel form and slope changes. The channel is within a deep gorge and becomes predominately a steep bedrock channel with various cascade-step-pool complexes present. Exposed bedrock is present throughout and is the dominant substrate. Five cascades are likely fish passage obstacles with one impassable falls present. LWD is present throughout and three of these obstacles are made more difficult to navigate due to debris dams gathering (see Figure 3.8, overleaf). Overhanging trees are present along both banks.

Figure 3.8. Impassable falls and debris dam

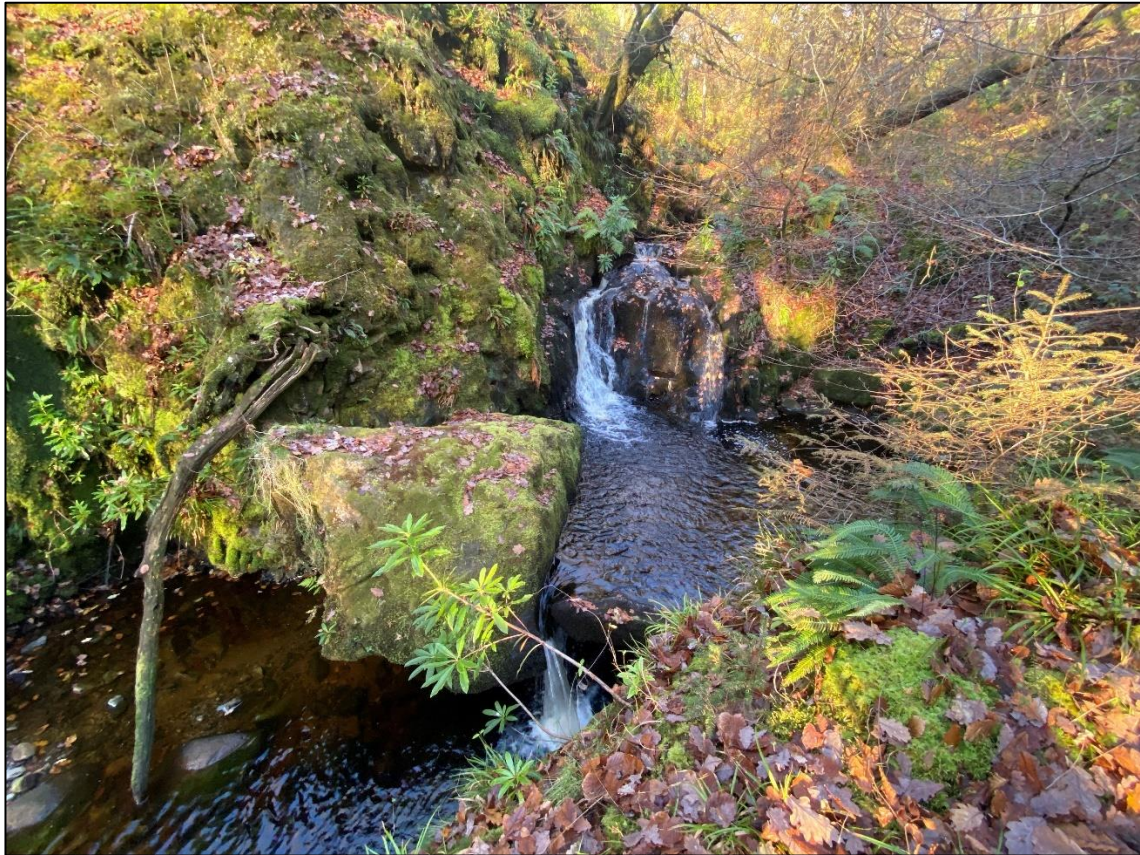
The channel form upstream of the NV section is of a similar character (see Figure 3.9, overleaf) to below. There is some storage of substrates in the channel. However, these are probably mobile and have been deposited behind bedrock or boulders. The channel remains in a steep gorge and is NV in places. Fourteen further fish passage obstacles are present through this section with two impassable falls present just downstream of the forestry track bridge (see Figure 3.10, overleaf). LWD is again present along with three debris dams. Erosion is apparent in a few places and has caused a small landslip (see Figure 3.11, overleaf). Overhanging trees continue along both banks.

Figure 3.9. Cascade-step-pool

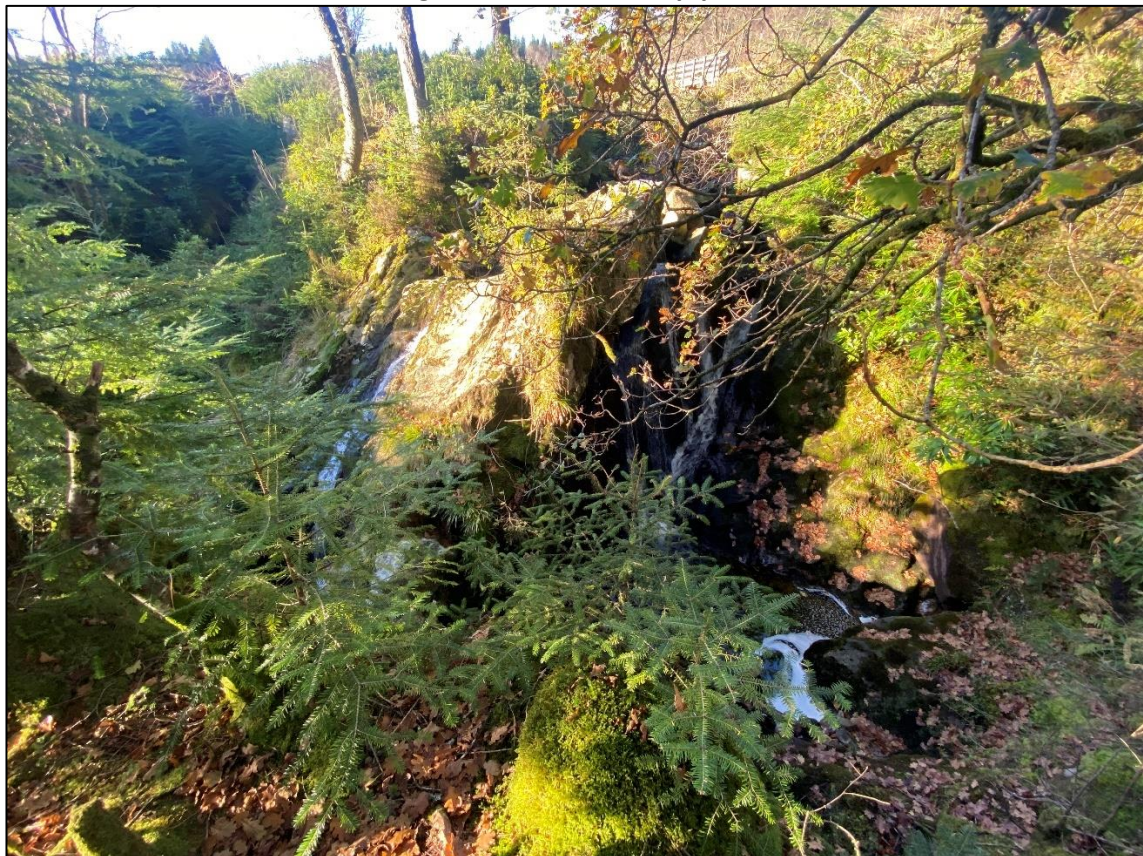
Figure 3.10. Impassable falls

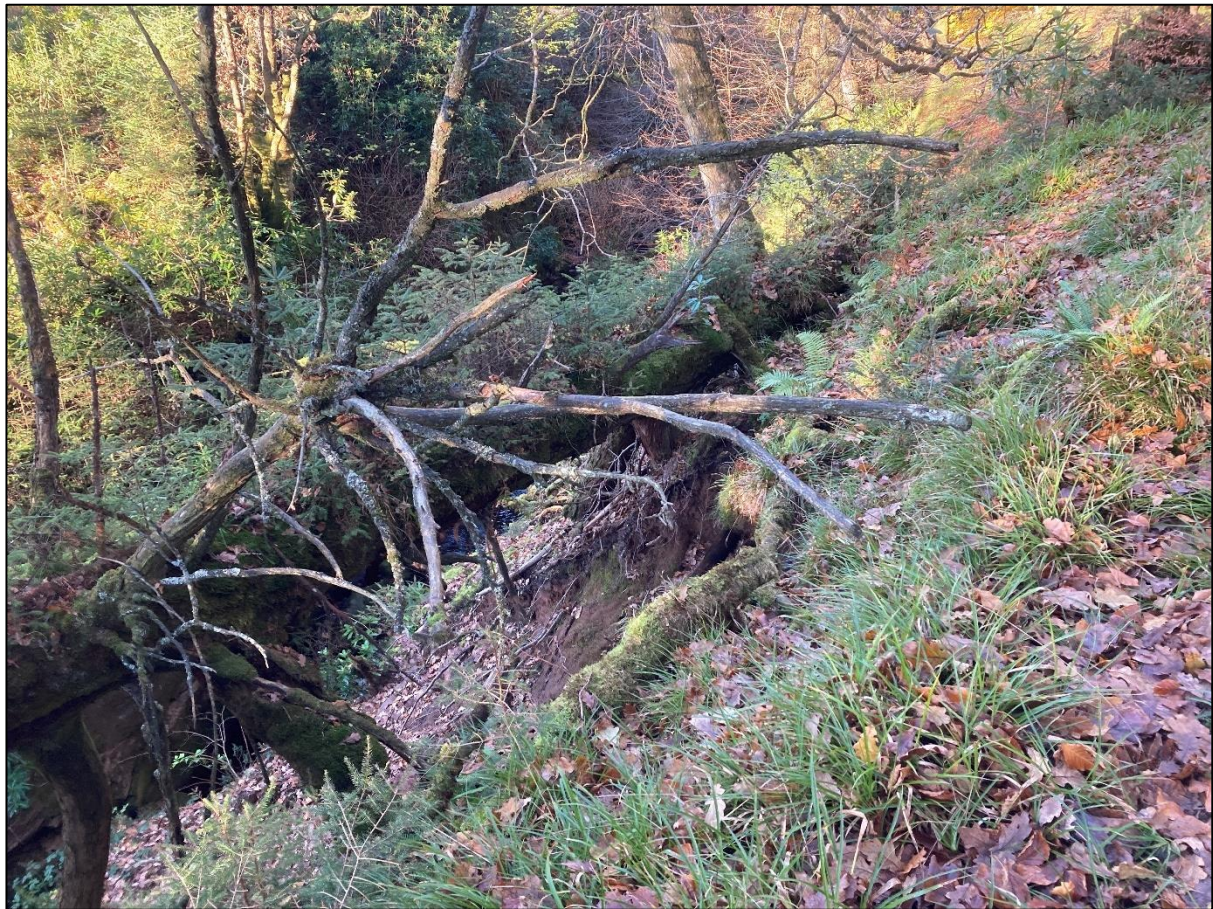
Figure 3.11. Landslip along riverbank

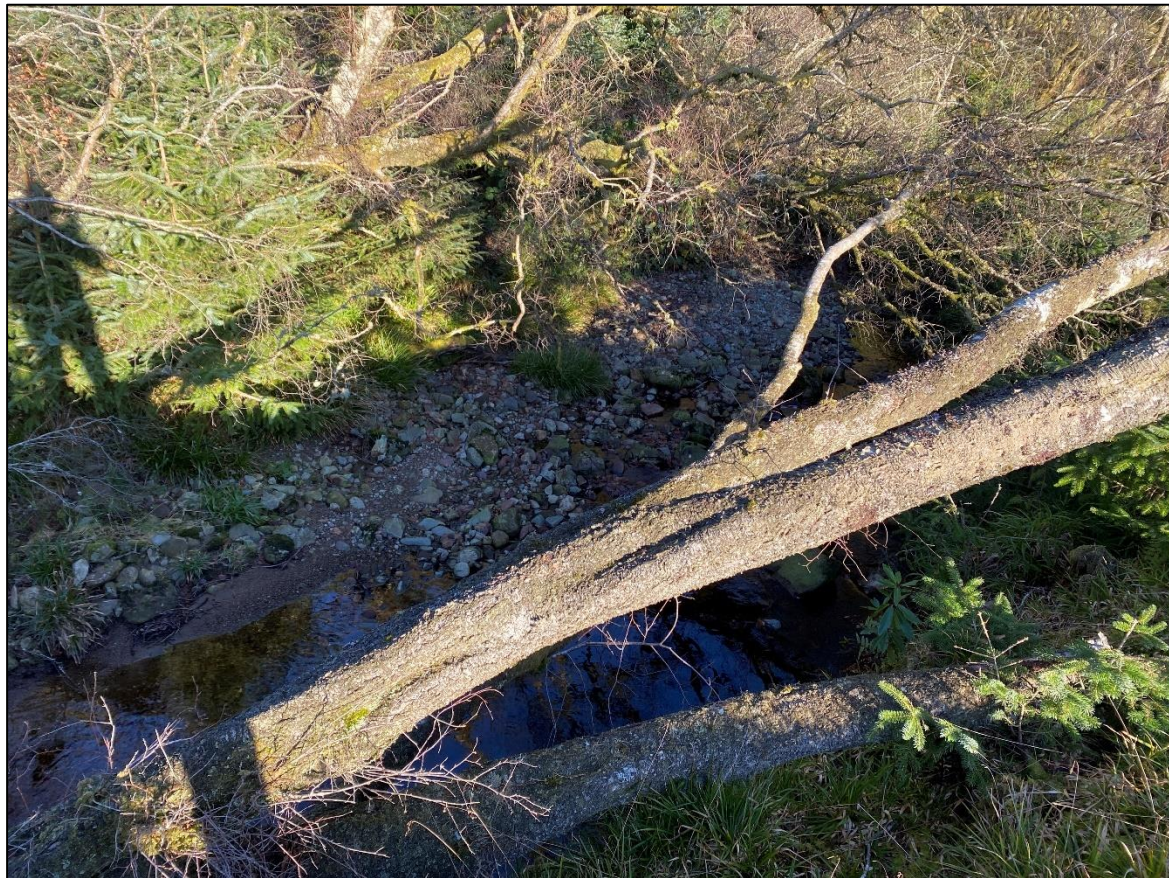
The forestry track bridge is supported by hard reinforcement. Upstream of the hard reinforcement on the Left-Hand Bank (LHB) there is an undercut bank. There is a reduced channel slope immediately upstream of the bridge and as a result there is increased substrate storage, predominately cobble and gravel/pebble, as shown by the presence of barforms (see Figure 3.12, overleaf). Flow types also consist of runs and riffles with cobble and boulder substrates within the channel. LWD is present with overhanging trees along both banks. The channel becomes NV shortly upstream of here due to dense vegetation.

Figure 3.12. Substrate storage in the form of a cobble gravel/pebble barform

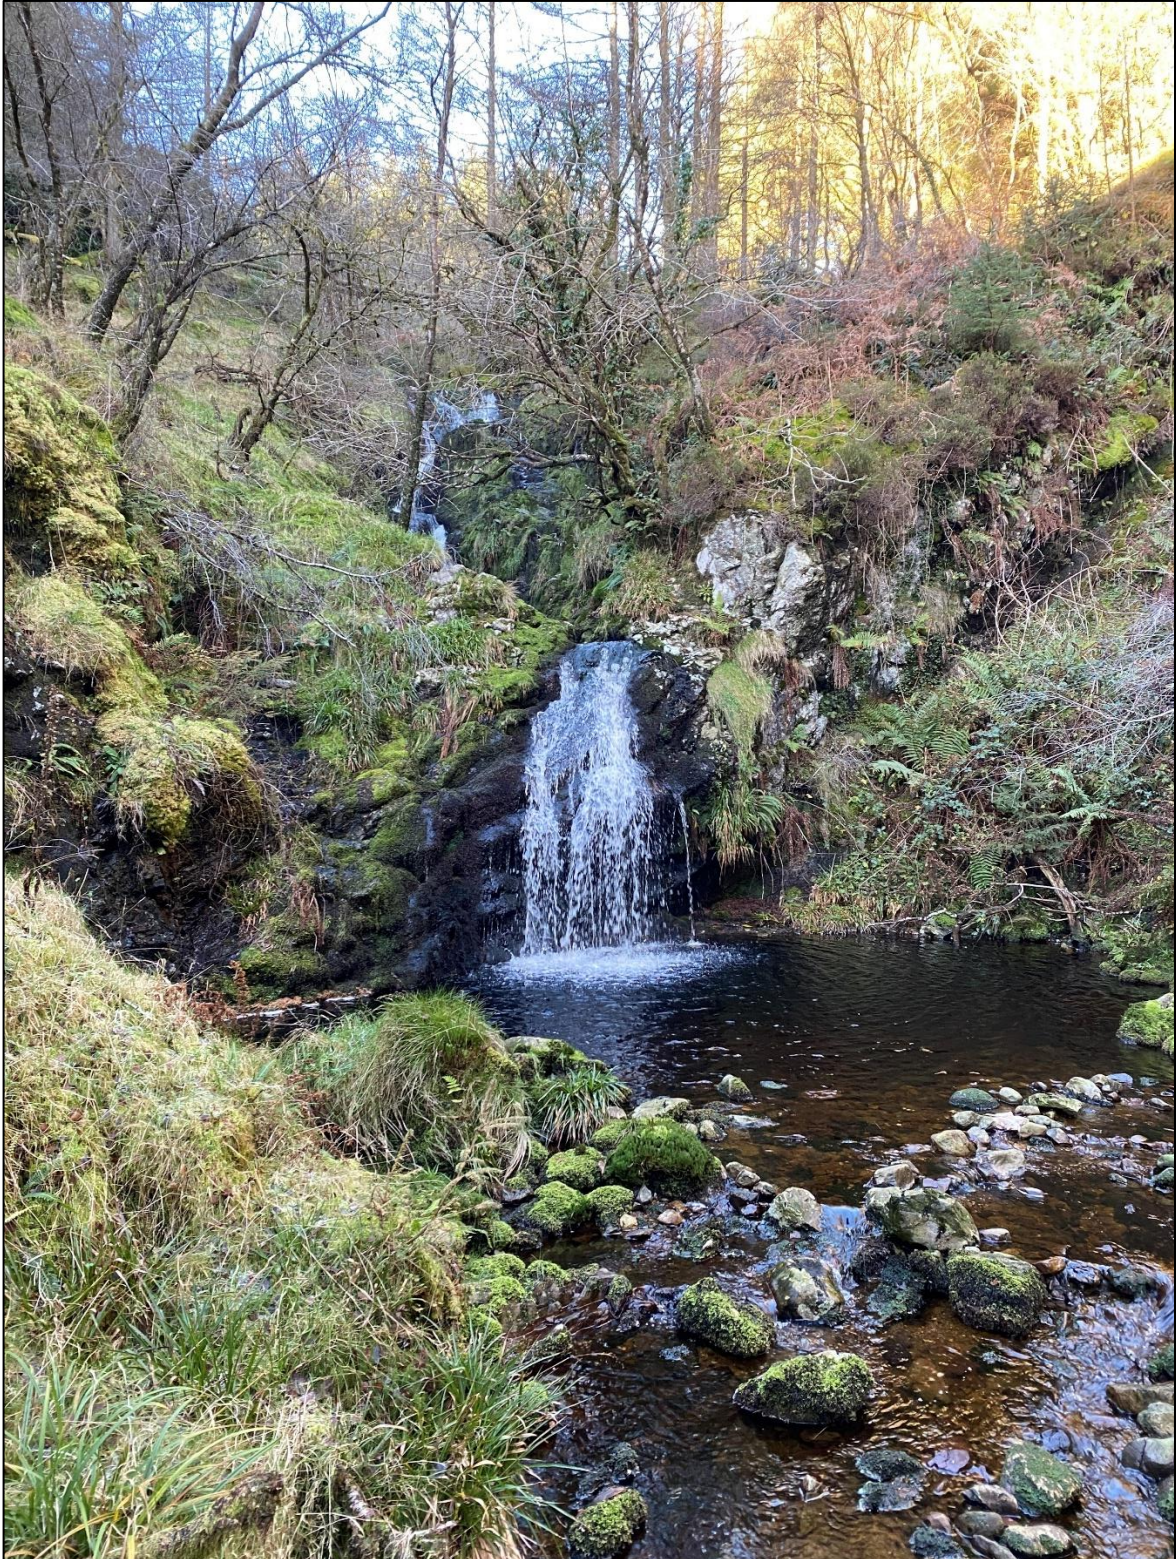
Closer to the proposed intake, the channel slope remains high and is set within another steep sided gorge. Flow types are dominated by bedrock cascades, chutes and freefalls, several of which are likely impassable, broken up by areas of pool. There are eight fish passage obstacles recorded here and three impassable falls (see Figure 3.13, overleaf). LWD and overhanging trees are again present throughout with one debris dam forming. There is a short section of hard reinforcement with what appears to be an old gate over the channel (see Figure 3.14, overleaf). At the proposed intake, bedrock cascades are present and there is no habitat for fish.

Figure 3.13. Impassable bedrock cascades and freefalls

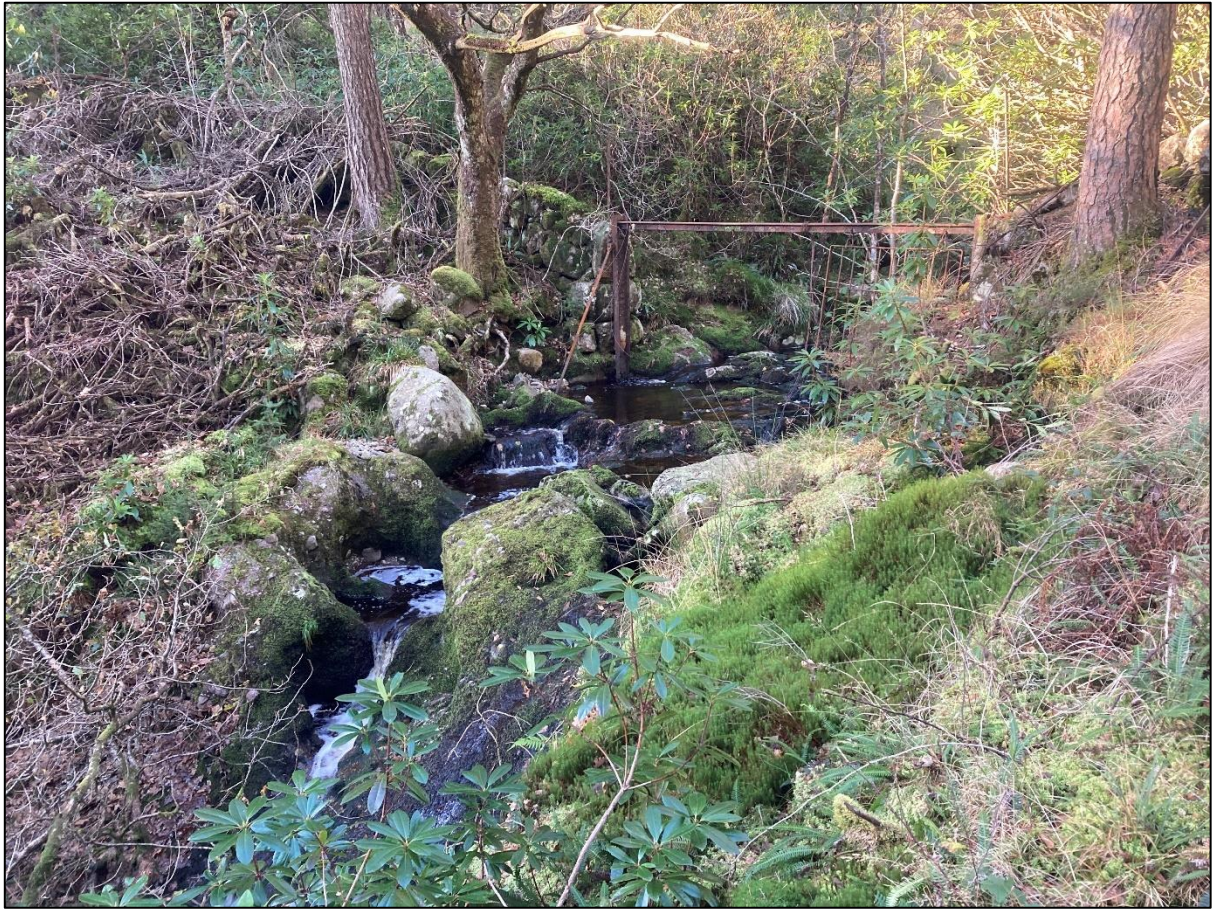
Figure 3.14. Old gate over channel
