## **TWMA Dales Industrial Estate, Peterhead Site Review and Site Investigation Design for PPC/A/1000175**

**March 2025**

Client: Igne  
 Project Title: TWMA Dales Industrial Estate, Peterhead  
 Report Title: Site Review and Site Investigation Design for PPC/A/1000175  
 Document number: 14891  
 Project number: 379860

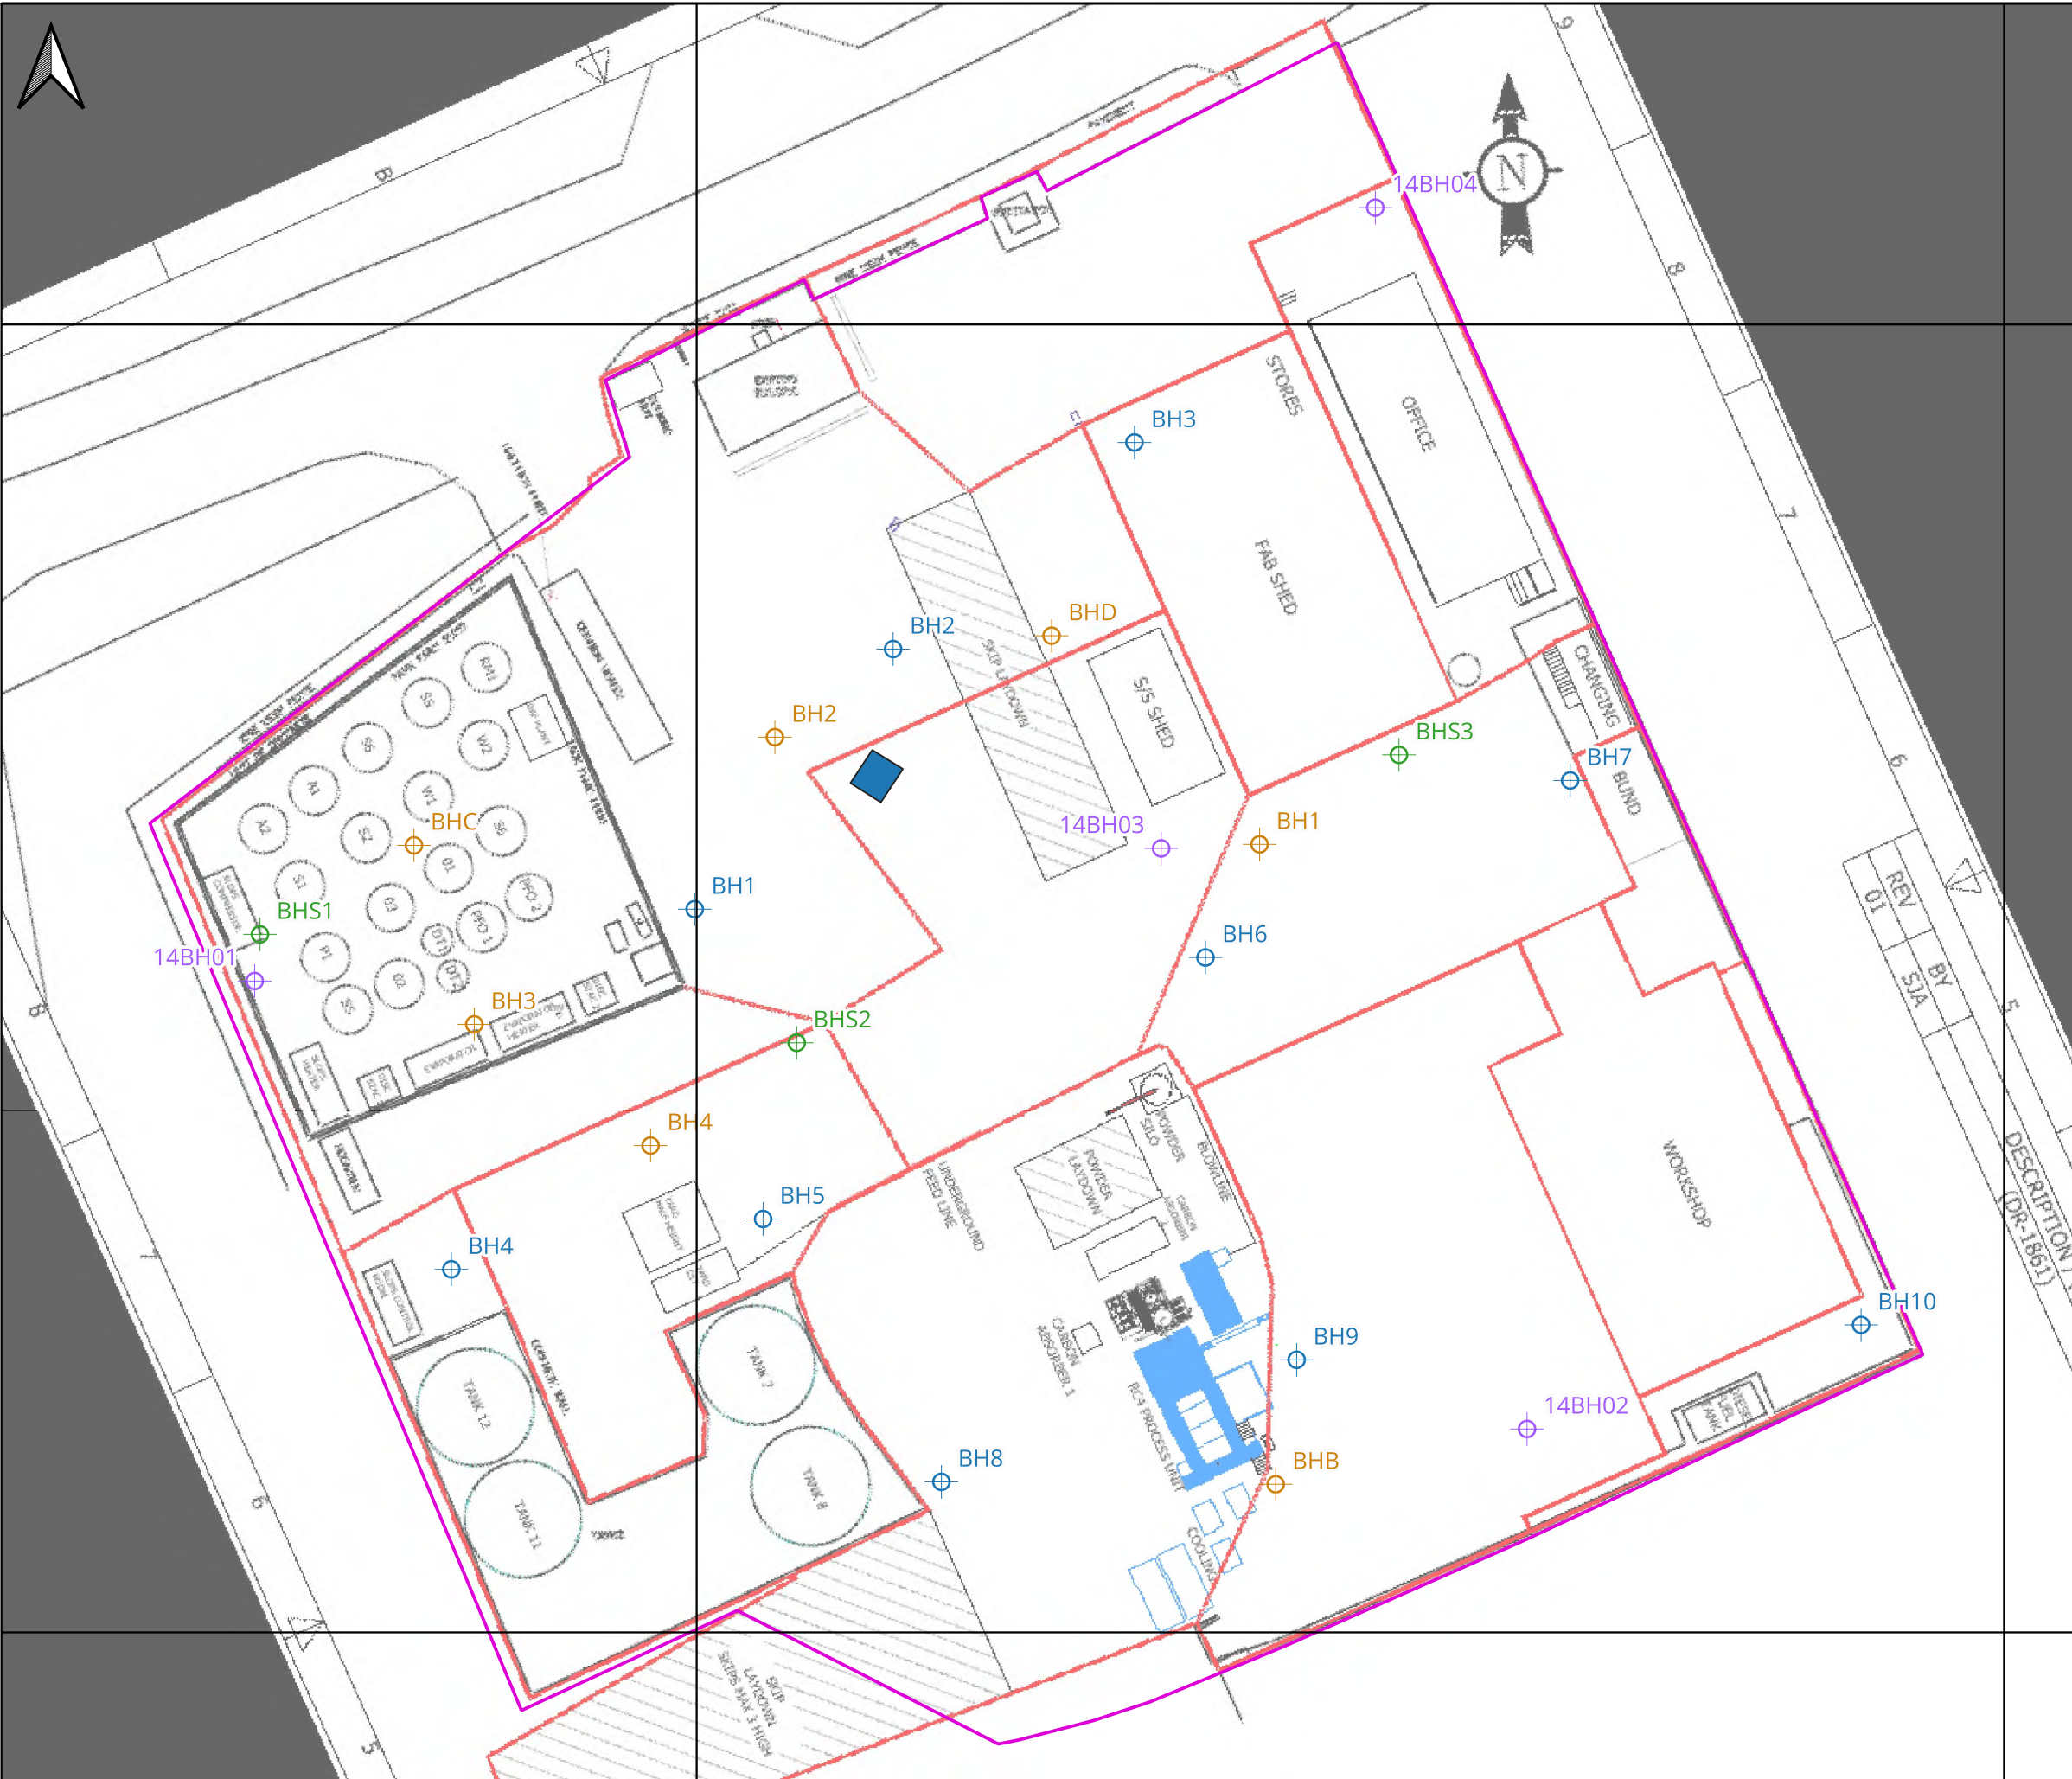
- PPC boundary
- Washbay catch pit
- 2005 LDG-GSS boreholes (approx)
- 2006 SLR boreholes
- 2014 boreholes
- Proposed monitoring boreholes

| Borehole | Rationale |
|---|---|
| BH1 | In proximity to and expected to be downgradient of Slops Tank Farm and in vicinity of damaged ground surfacing. |
| BH4 | Within area of OBMC, slops and raw materials storage and handling. Proximal to poor condition/ damaged OBMC tank bund and ground surfacing. Potential upgradient location on site. |

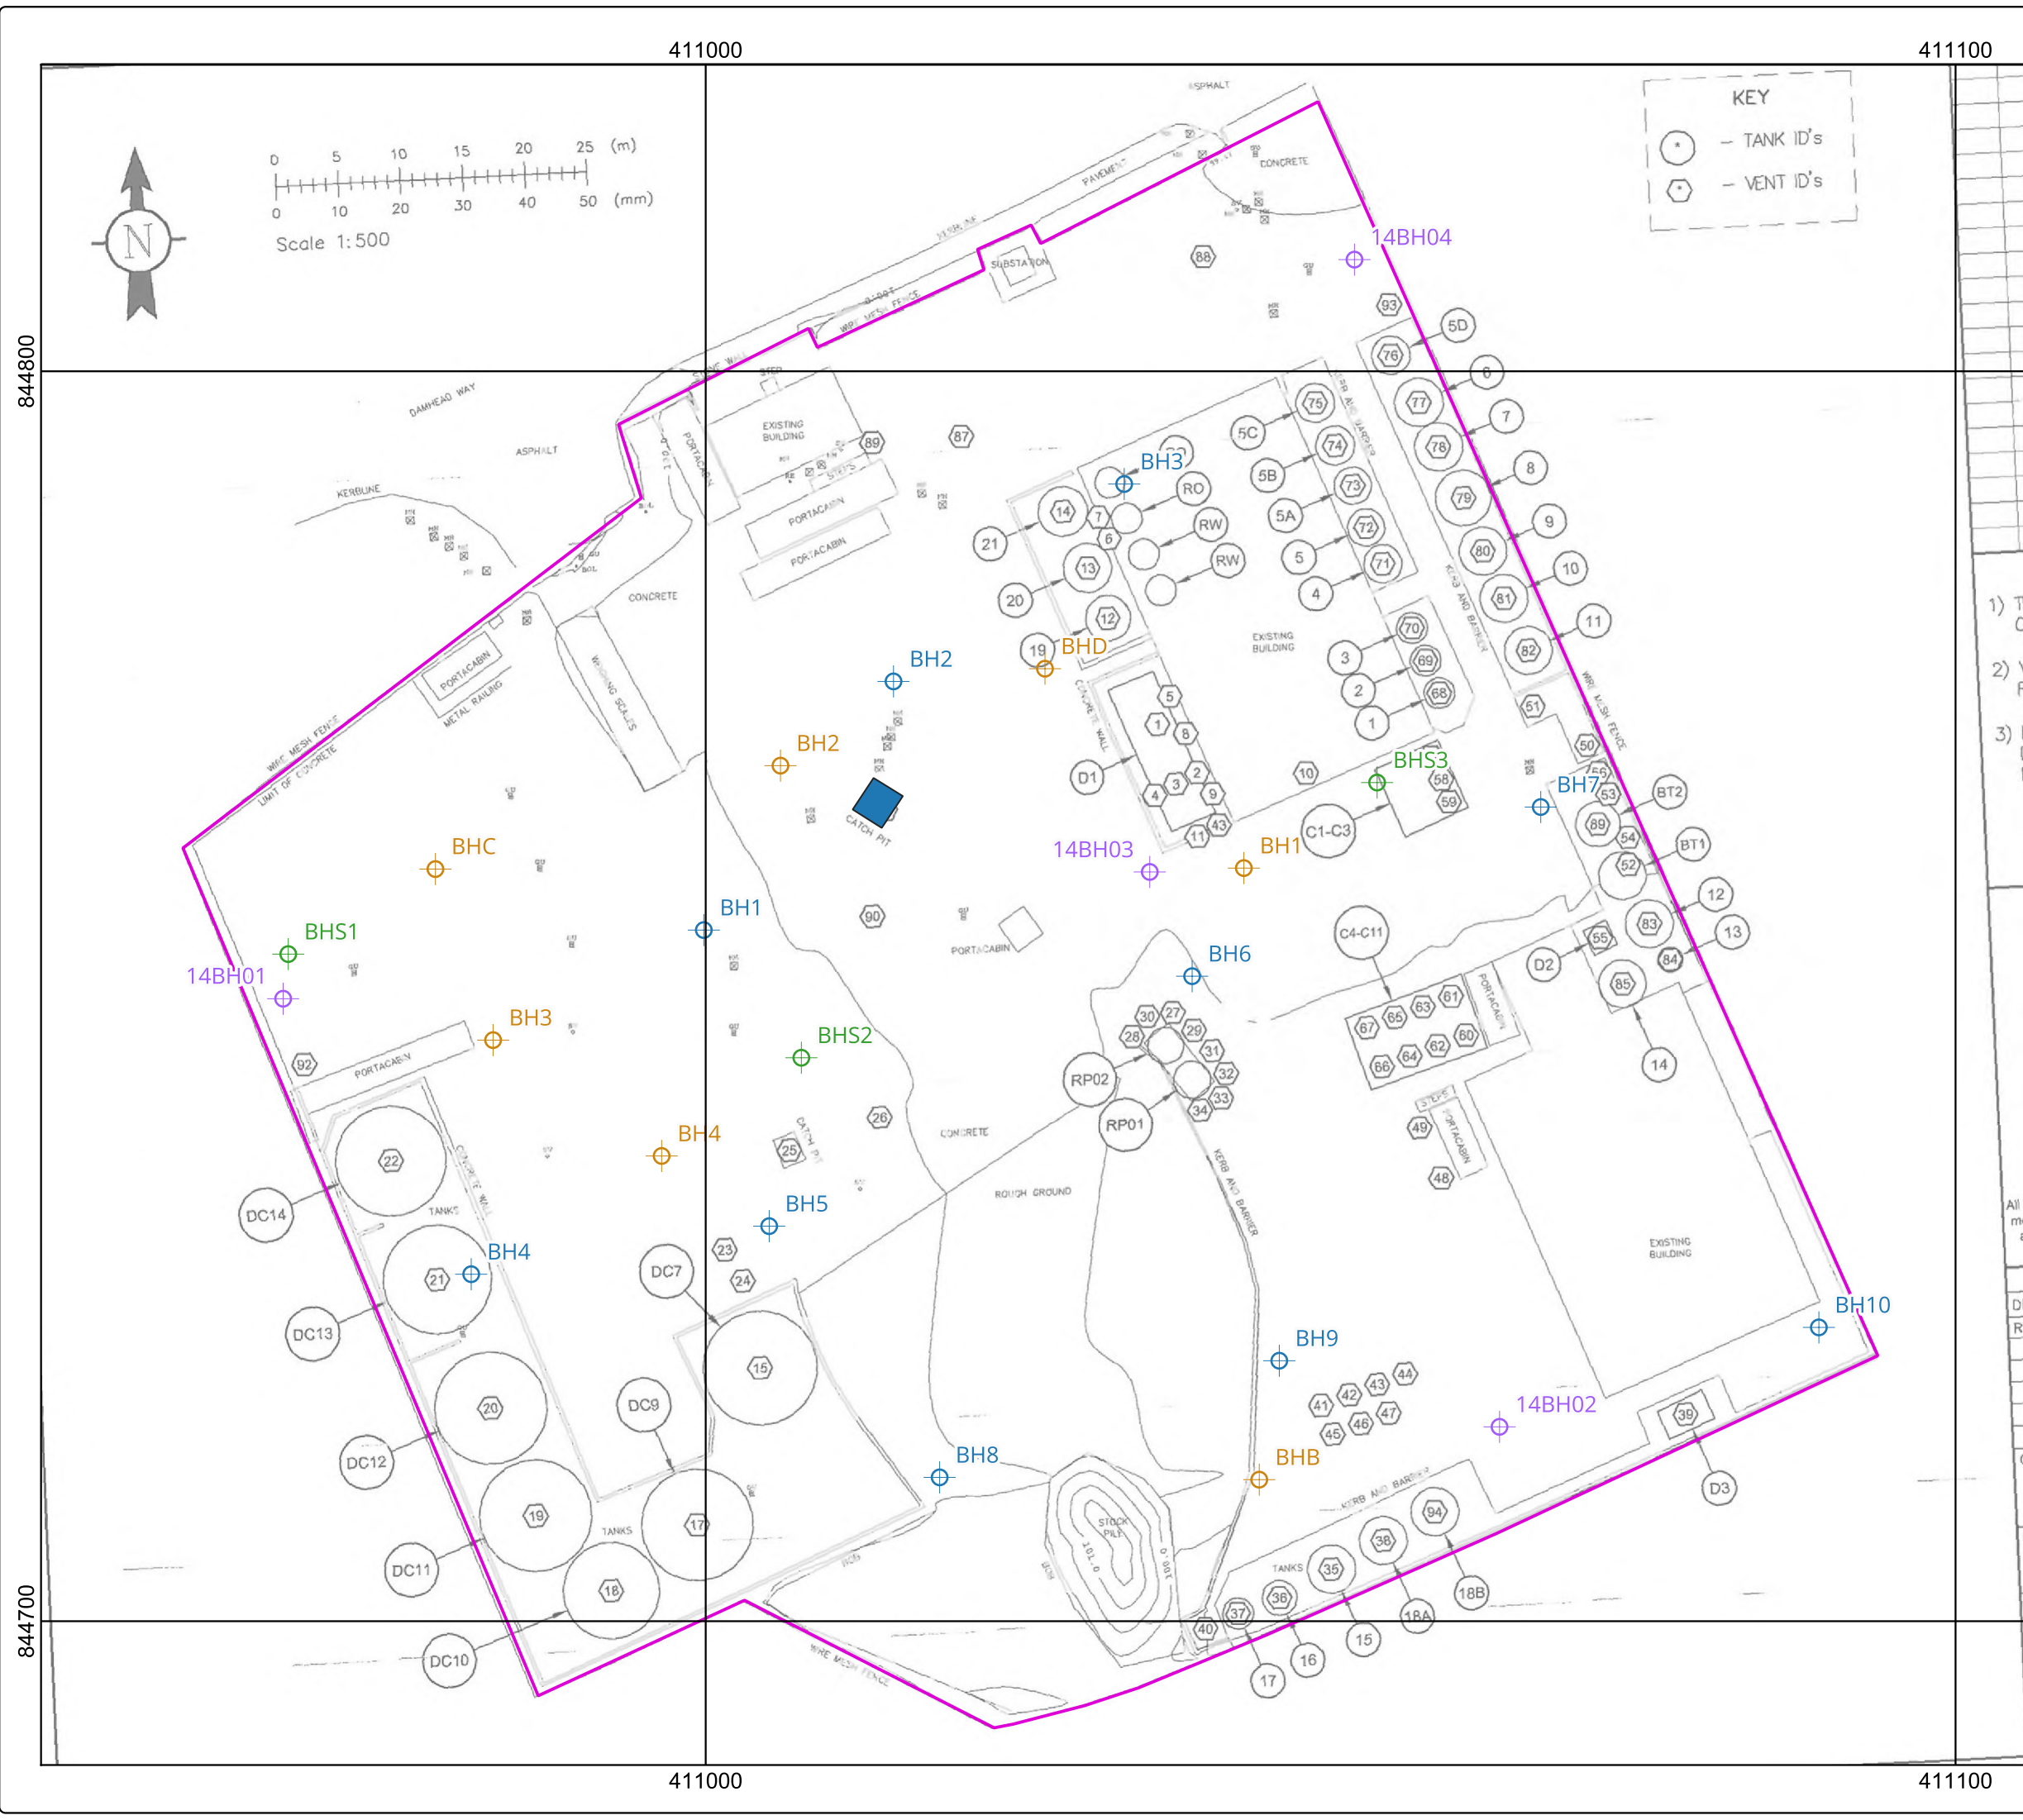
- PPC boundary
- Washbay catch pit
- 2005 LDG-GSS boreholes (approx)
- 2006 SLR boreholes
- 2014 boreholes
- Proposed monitoring boreholes
