# Balliemeanoch Pumped Storage Hydro

Environmental Impact Assessment  
Report

Volume 5: Appendices  
Appendix 11.1 Walkover and  
Water Quality Results

ILI (Borders PSH) Ltd

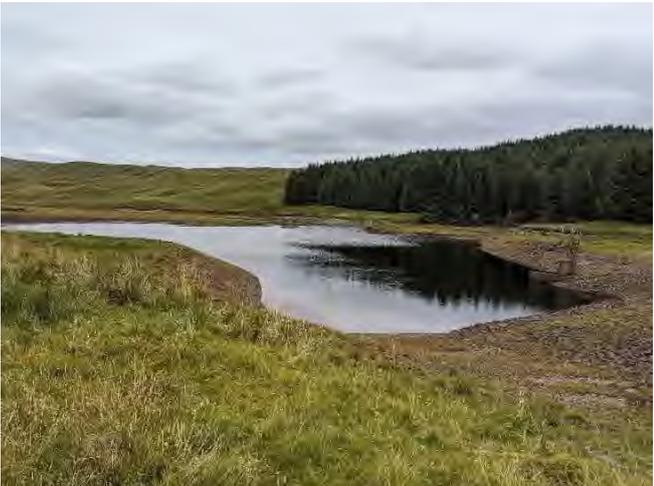
Sampling Location	Description	Photo
<p><b>LochA</b></p>	<p><i>Beochlich</i></p> <ul style="list-style-type: none"> <li>• Damned at the southwest corner. The bed of the loch is silty. Water level within the loch appeared to be low.</li> <li>• Water is clear with no odour. No evidence of pollution (e.g. oil, sheens or foam).</li> <li>• Water likely to be oligotrophic with low primary productivity.</li> </ul>

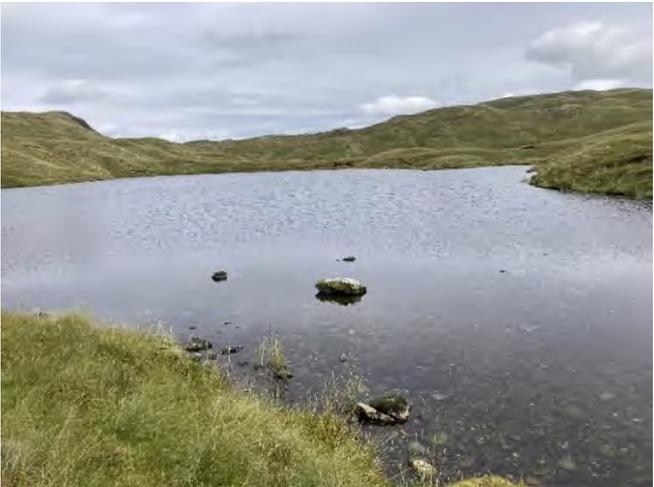
<p><b>LochB</b></p>	<p><i>Lochan Airigh</i></p> <ul style="list-style-type: none"> <li>• Gravel and cobbles noted on the bed of the loch.</li> <li>• Water is clear with no odour. No evidence of pollution (e.g. oil, sheens or foam).</li> <li>• Water likely to be oligotrophic with low primary productivity.</li> </ul>

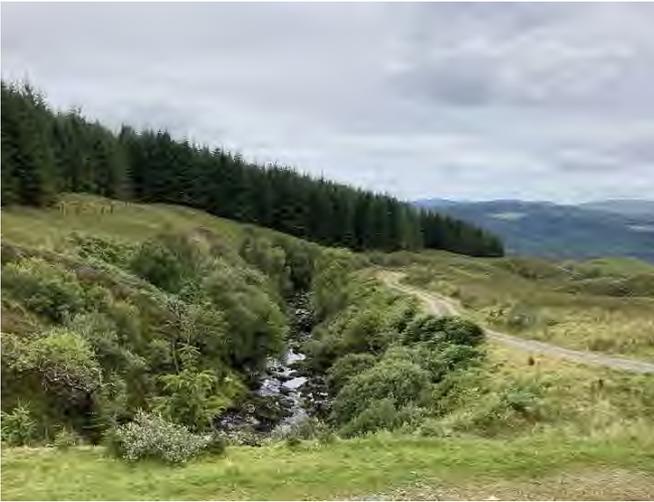
<p><b>RiverA</b></p>	<p><i>Allt Beochlich</i></p> <ul style="list-style-type: none"> <li>• High gradient river with bedrock typology. Channel is characterised by numerous, steps and pools, waterfalls and rocky rapids. Some deposition of gravel and cobbles within the channel.</li> <li>• Water is clear with a slight brown tinge reflecting humic acids leached from the peaty soils, with no obvious evidence of water pollution (e.g. odour, oil sheens, foams etc.).</li> </ul>

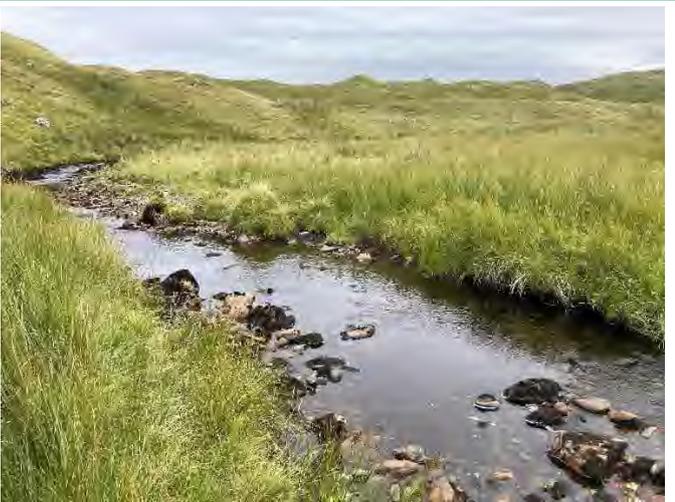
Sampling Location	Description	Photo
<b>RiverB</b>	<p><i>Allt Beochlich</i></p> <ul style="list-style-type: none"><li>• Lower gradient reach compared to RiverA sampling point. The channel has a bedrock typology with some gravel and cobble deposition. Algae present on cobbles, indicating they are stable, and not regularly moved.</li><li>• Water is clear with a slight brown tinge reflecting humic acids leached from the peaty soils, with no obvious evidence of water pollution (e.g. odour, oil sheens, foams etc.).</li></ul>

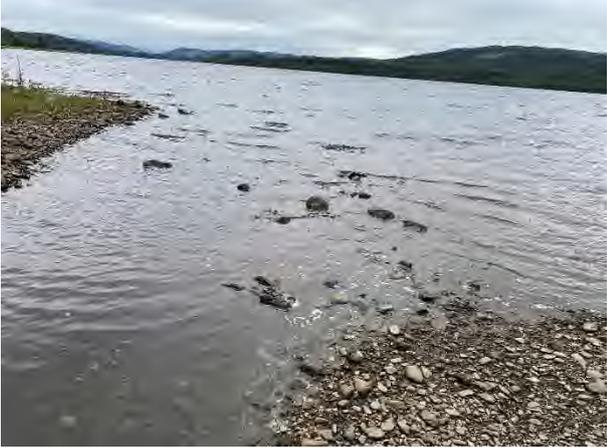
Description	Photo
<p><i>Loch Awe</i></p> <ul style="list-style-type: none"> <li>• Photo was taken where Allt Beochlich enters Loch Awe.</li> <li>• Large loch with deposition of pebbles and cobbles along the beach</li> </ul>

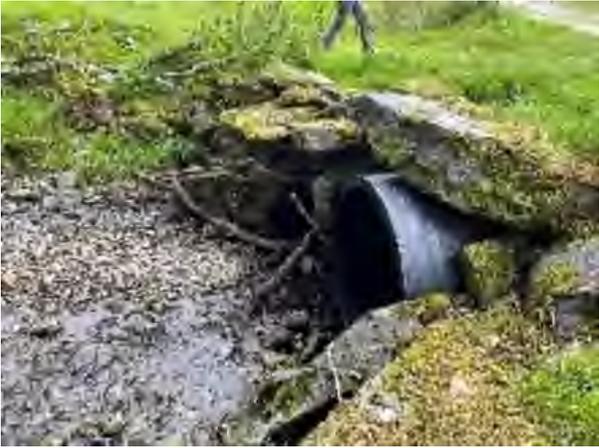
<p><i>Allt a' Gheataidh</i></p> <ul style="list-style-type: none"> <li>• High gradient river with bedrock typology. Some deposition of gravel and cobbles within the channel.</li> <li>• Water is clear with a slight brown tinge reflecting humic acids leached from the peaty soils, with no obvious evidence of water pollution (e.g. odour, oil sheens, foams etc.).</li> </ul>

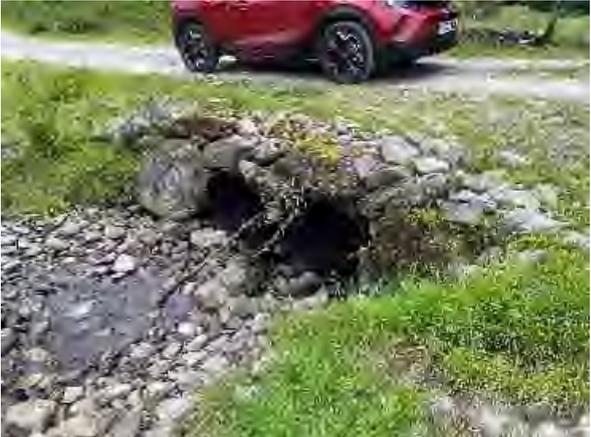
<p><i>Allt a' Chroisaid</i></p> <ul style="list-style-type: none"> <li>• High gradient river with bedrock typology. Some deposition of gravel and cobbles within the channel.</li> <li>• Water is clear with a slight brown tinge reflecting humic acids leached from the peaty soils, with no obvious evidence of water pollution (e.g. odour, oil sheens, foams etc.).</li> </ul>

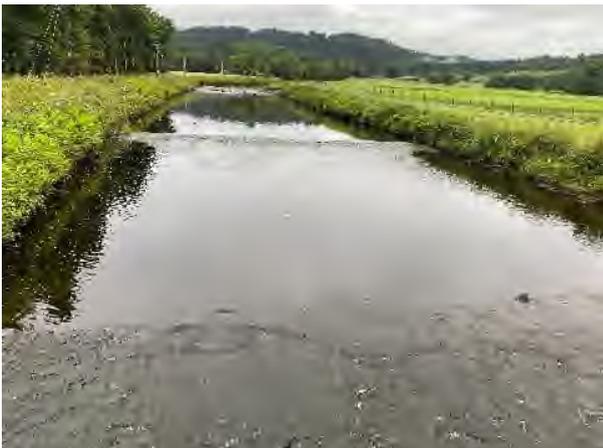
Description	Photo
<p><i>Claddich River</i></p> <ul style="list-style-type: none"> <li>• Wide River with deposition of gravel, cobble and sands within the channel. Some evidence of underlying bedrock.</li> <li>• Water is clear with a slight brown tinge reflecting humic acids leached from the peaty soils, with no obvious evidence of water pollution (e.g. odour, oil sheens, foams etc.).</li> </ul>

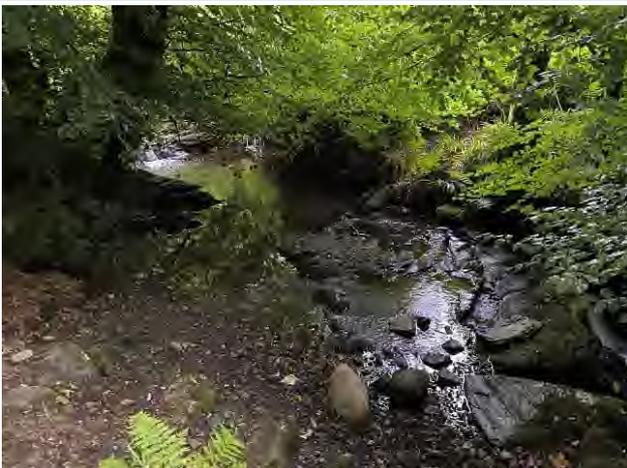
<p><i>Crom Allt</i></p> <ul style="list-style-type: none"> <li>• River with a bedrock typology and some deposition of gravel and cobbles within the channel.</li> <li>• Water is clear with a slight brown tinge reflecting humic acids leached from the peaty soils, with no obvious evidence of water pollution (e.g. odour, oil sheens, foams etc.).</li> </ul>
