**Portintruan Distillery - Proposed Water Supply Boreholes 2023**  
*BH5 & 7 Pumping Test Report*

January 2024 (HighWater Ref Singh-Port Ellen)

Project Ref: HW004

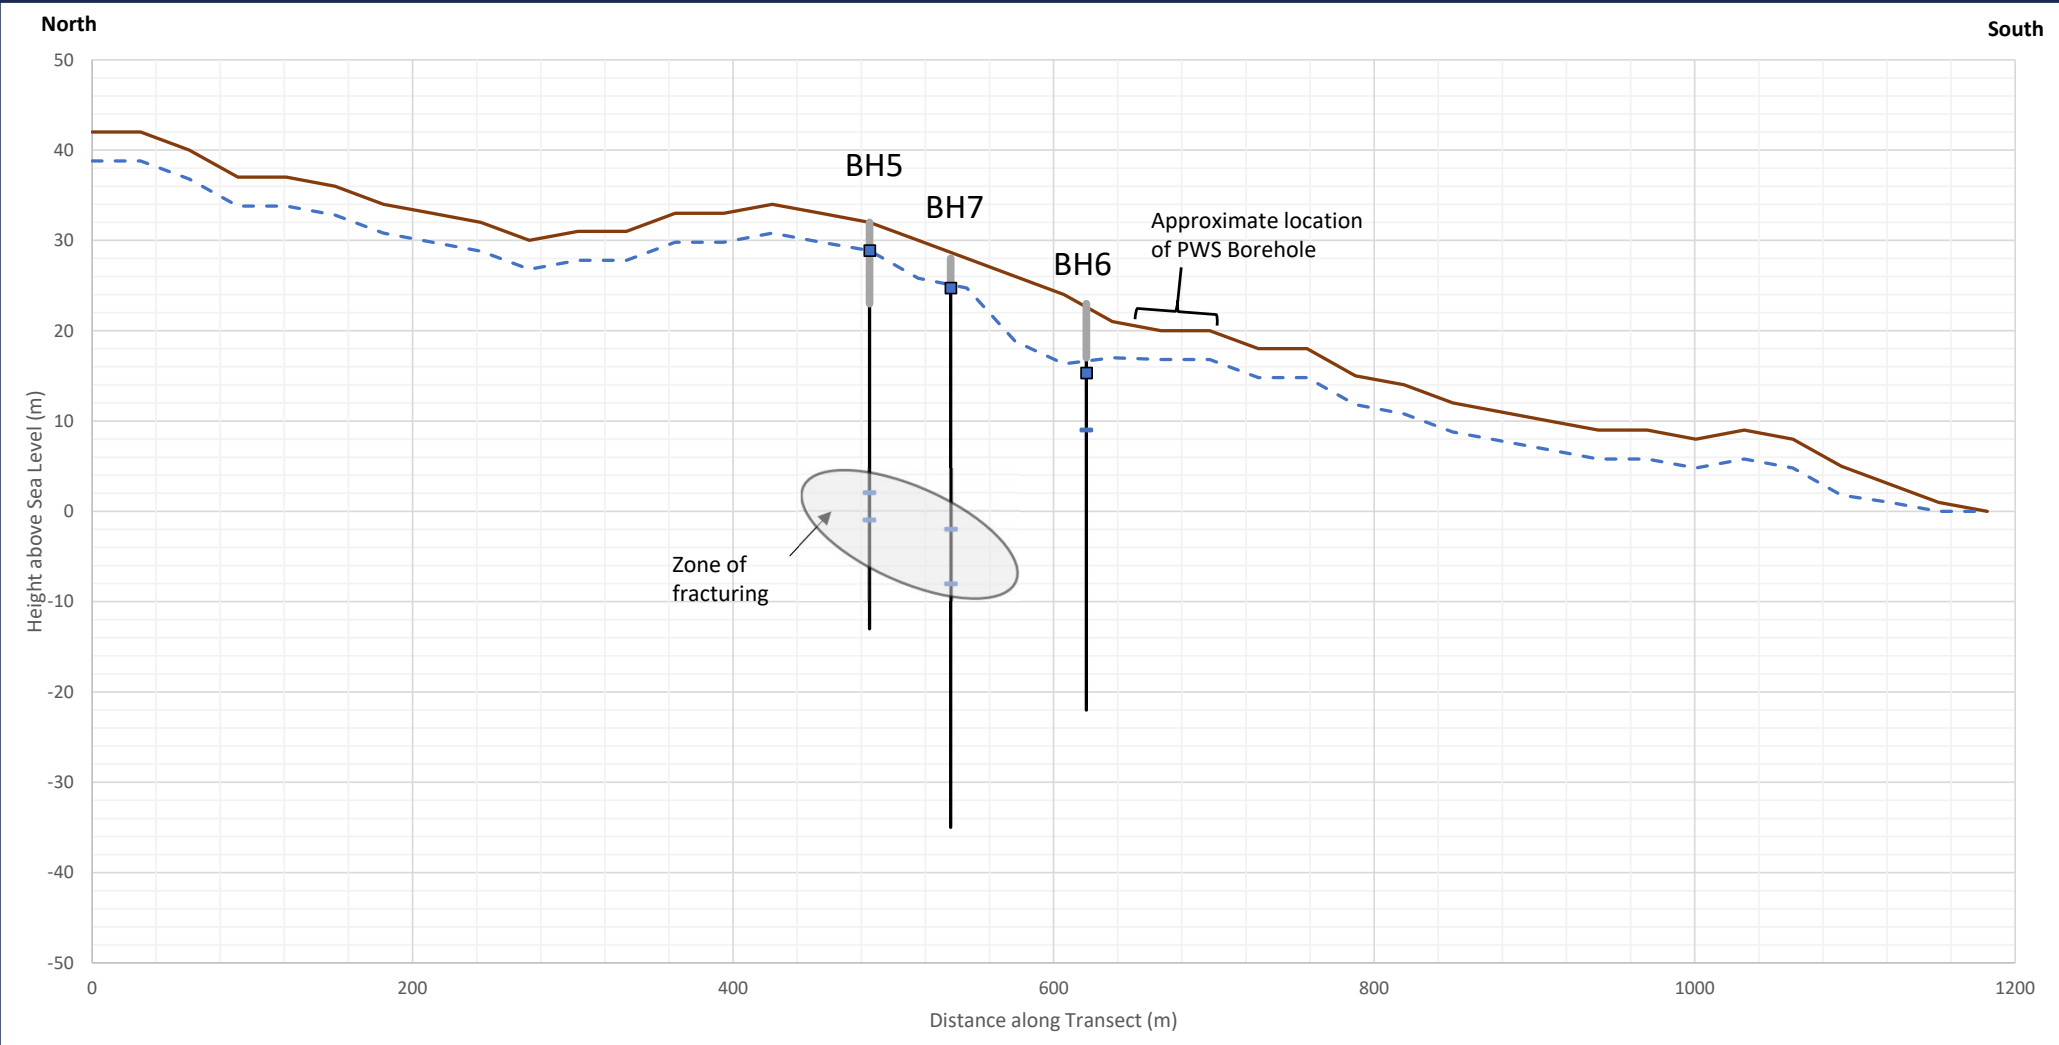
**Figure 5: North South Conceptual Geological Cross-Section**

Ground Surface Elevation	Water Strikes
Measured Static Water Level	Inferred Saturated Water Level
BH Casing

Groundwater levels observed in all boreholes are seen to be close to ground surface (within 10m). Observed static groundwater levels are shown on cross sections shown on **Figure 5** (north-south) and **Figure 6** (west – east). This demonstrates that the bedrock 'aquifer' as described above, generally has a significant saturated thickness.

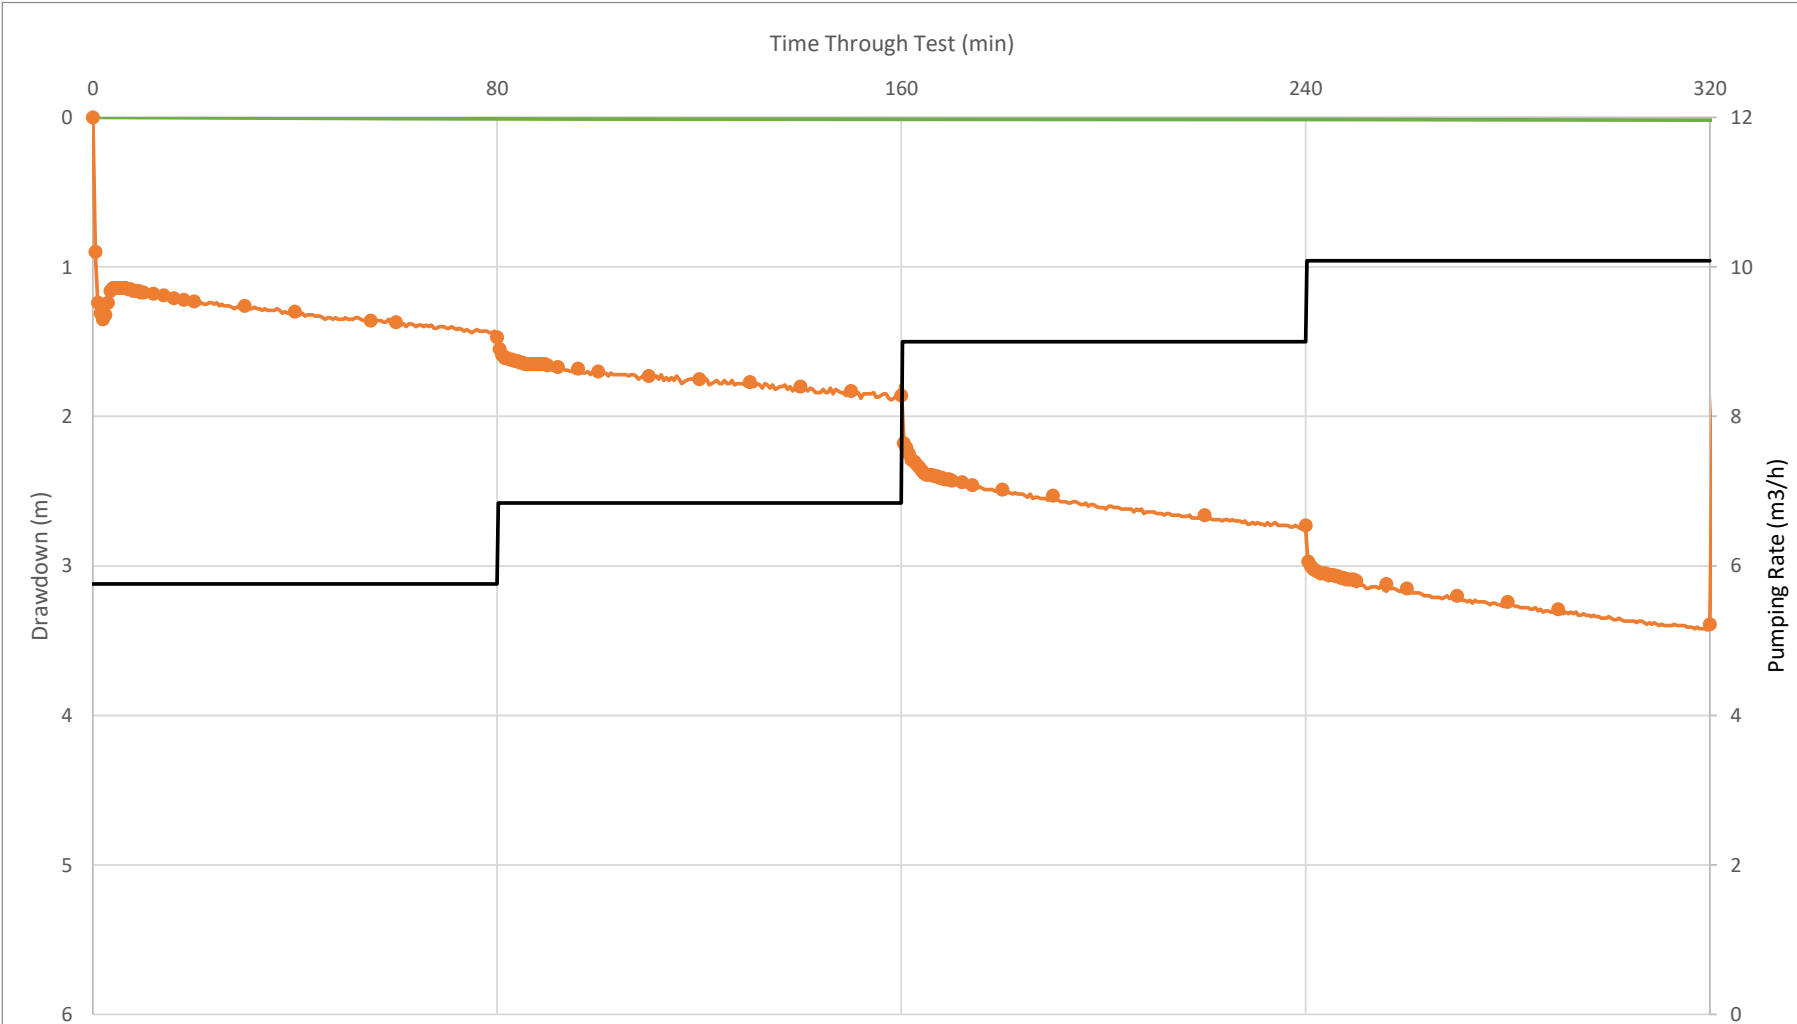
**Figure 9: BH7 Step Test**

— BH7 Drawdown (Logger)  
 — BH6 Drawdown (Logger)

● BH7 Drawdown (Manual)  
 — Pumping Rate

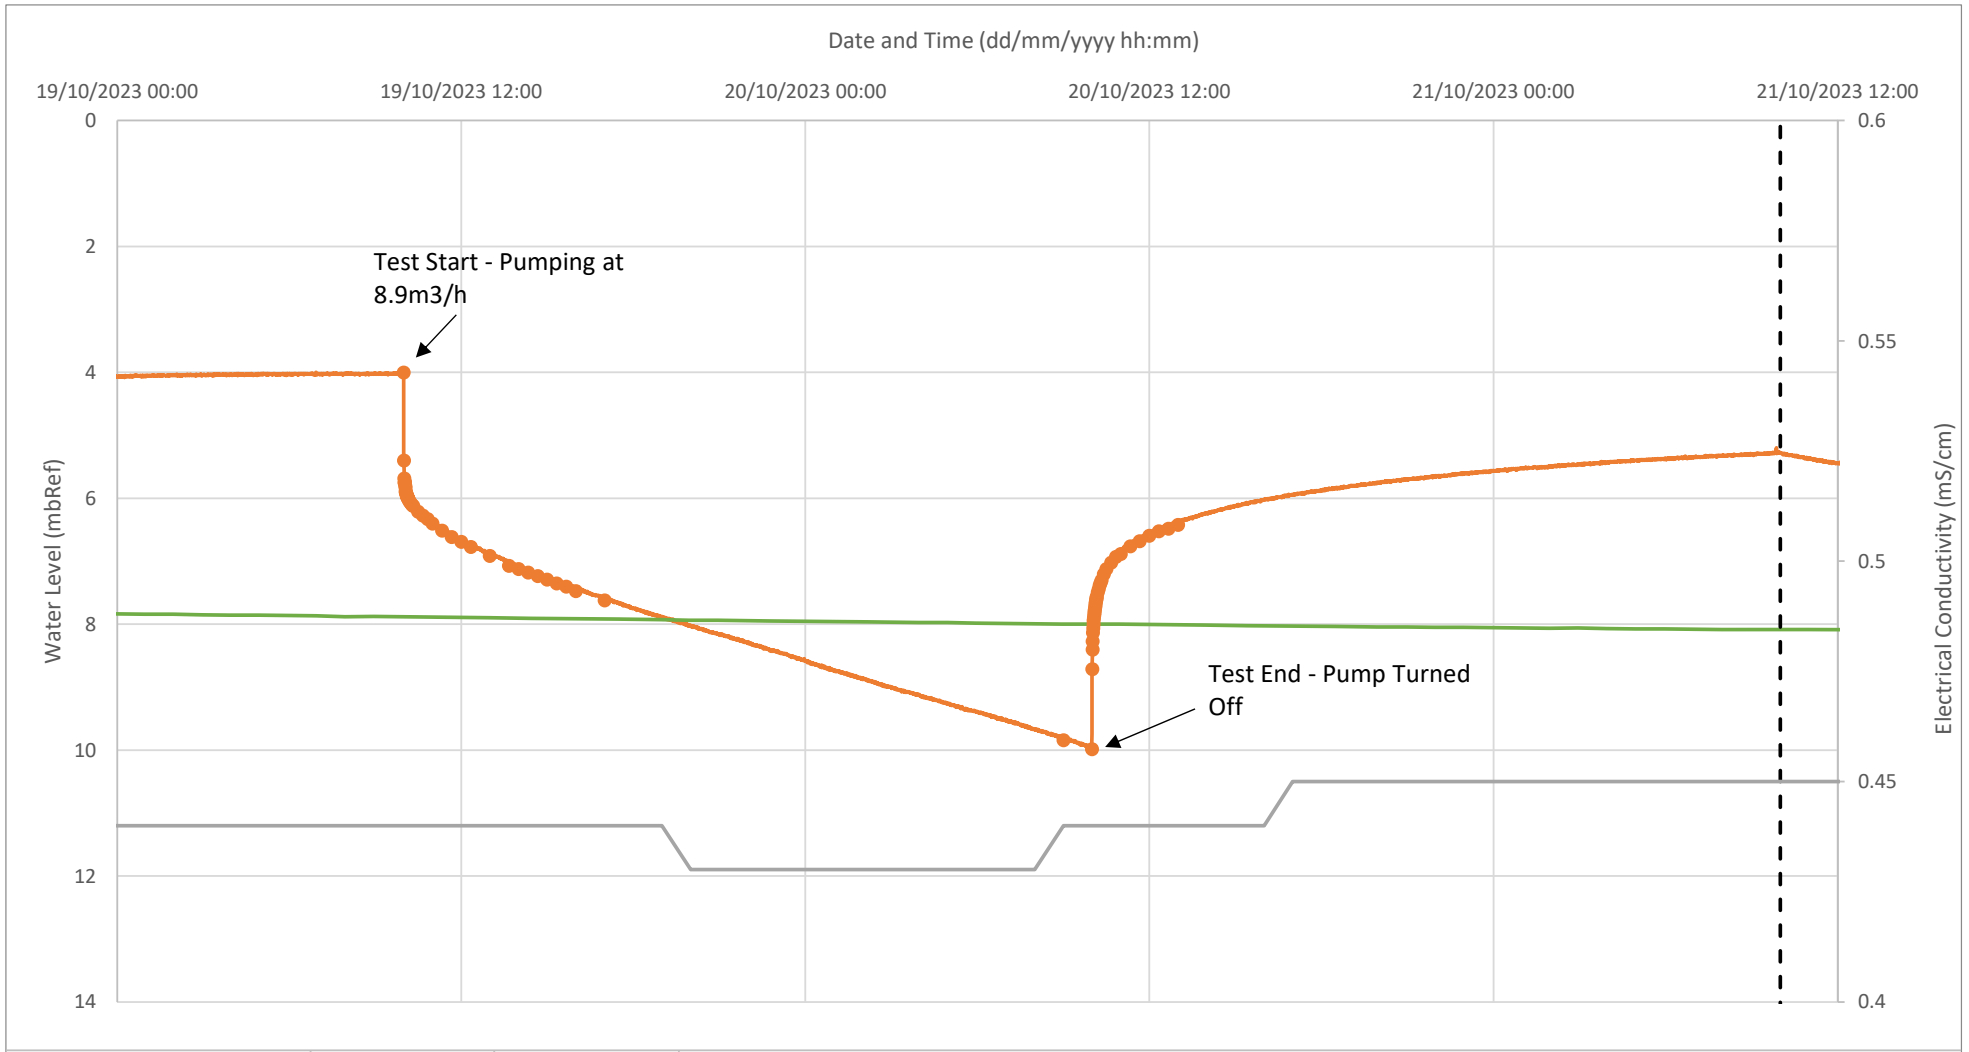
**Figure 11:** BH7 Contsant Rate Test

— Electrical Conductivity (Logger)

For BH7, the average pumping rate achieved during the 24-hour CRT was 8.9m<sup>3</sup>/h (213.6m<sup>3</sup>/d). There was a total drawdown of 5.98m observed in the pumping borehole at the end of the test. Most of the drawdown occurred within the first 10 minutes. After this the water level continued to decline, albeit at a reduced but consistent rate until the end of the test. The water level declined consistently at a rate of approximately 14cm per hour for the final 12 hours of the test.

The drawdown and recovery curves observed here are typical of boreholes drilled into hard bedrock with water inflows from defined fractures / fracture zones.

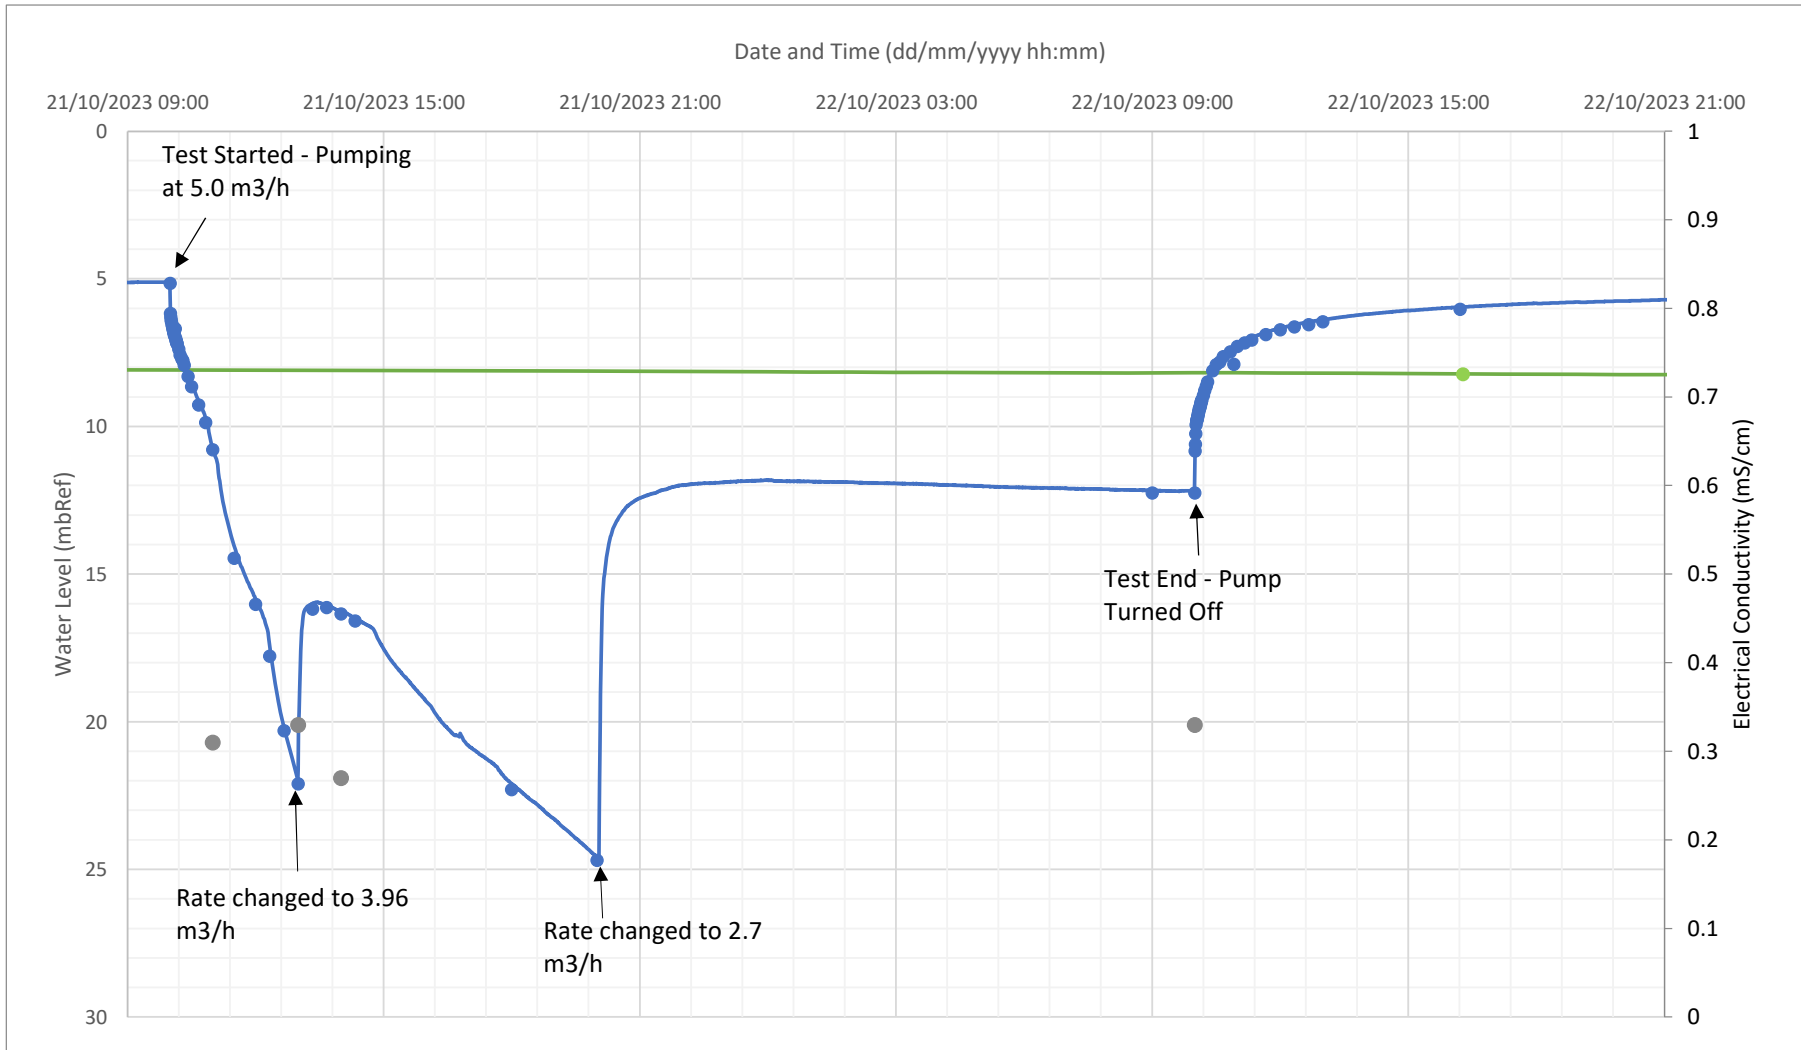
**Figure 12:** BH5 Constant Rate Test

- BH5 Water Level (Logger)
- BH6 Water Level (Logger)
- Electrical Conductivity (Manual)
- BH5 Water Level (Manual)
- BH6 Water Level (Manual)

When pumping at 2.7m<sup>3</sup>/h (0.75 l/s) the water level in the pumping borehole stabilised at a level of 12.24m below ground level (7.09m drawdown) by the end of the test. This is well above the base of the borehole at 45m depth. There was a total of 0.56m of drawdown observed in the final 10 hours of pumping.

After the cessation of pumping, full recovery to pre-test level was observed within 24 hours.
