## Merkland Fish Barrier

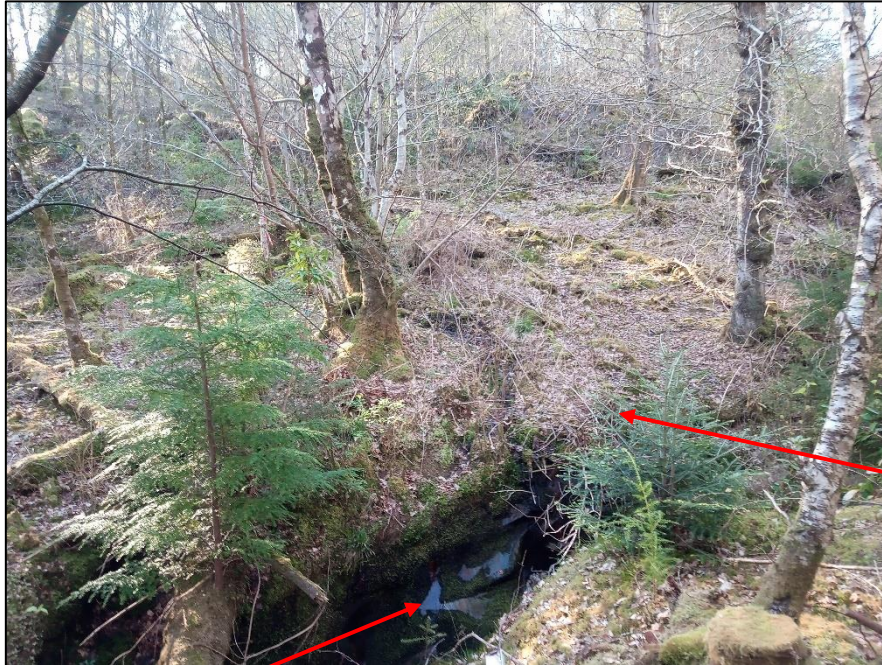
Outfall location

Deep ravine and waterfall immediately below outfall location is a barrier to upstream fish movement. Most of the depleted reach consists of these ravines with large water falls either end.

Rock shown in both images for reference

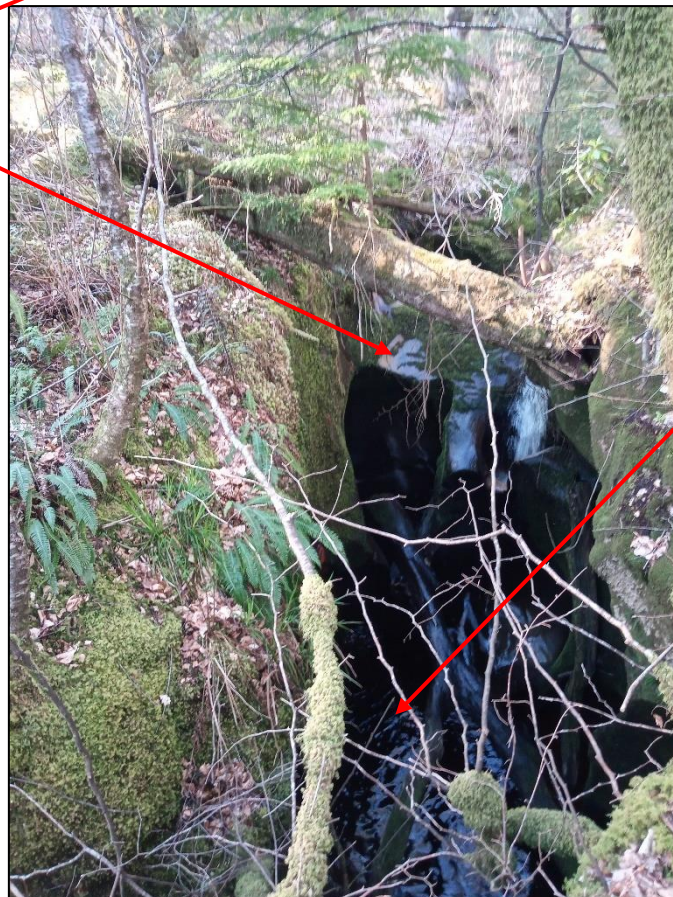
Ravine 3m – 4m deep. No safe way of measuring exactly.

Fall is vertical from immediately below outfall location.
