*TRITONIA SCIENTIFIC LTD., REPORT No: SSF-077075*

## Fish Holm, Shetland Isles: baseline seabed survey using multibeam echosounder and georeferenced 3D photogrammetry

Prepared for Scottish Sea Farms Ltd. [REDACTED]

April 2024

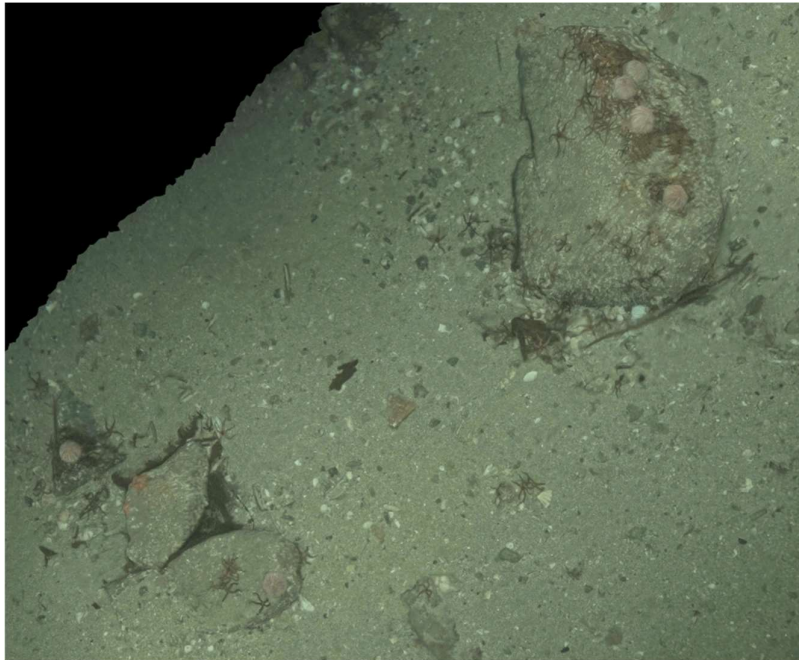
The seabed is composed of sand and scattered shells/shell fragments, becoming slightly gravelly in the NW. There are a number of exposed boulders at the NW end of the transect, colonised by urchins, brittle stars and anemones (Figure 9). Epifauna are dominated by echinoderms (sea urchins, especially *Echinus esculentus*, and several species of brittle stars and starfish). Bivalves (including scallops) are also present, but not abundant. A couple of thornback rays occur 300 to 400m from the SE end of the transect.

*Figure 9. Exposed boulders at the NW end of Transect 2 (depth 50m). The substrate under and around the boulders is representative of the seabed along the rest of the transect.*

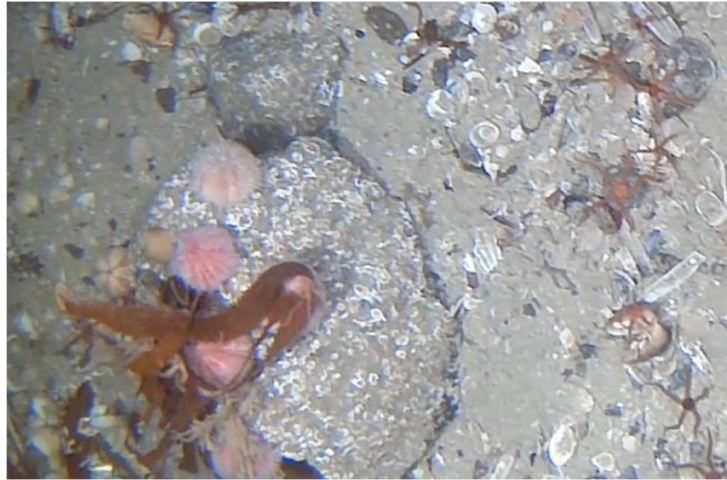
Transect 4 comprises a muddy/sandy seafloor with shells/shell fragments and gravel, and a few exposed boulders (Figure 13). Shell and gravel content is high at the SW end of the transect, but decreases rapidly to the NE (Figure 14). Epifauna are dominated by echinoderms (sea urchins, especially *Echinus esculentus*, and several species of brittlestar and starfish). Individual horse mussels (*Modiolus modiolus*) occur along the transect and are relatively abundant among and between patchy brittlestar bed at the north end (Figure 15). Other species observed include burrowing anemones, king and queen scallops and other bivalves, whelks, crabs and hermit crabs. King scallops are relatively abundant in places. Fauna are relatively sparse along the central part of the transect and broken pieces of kelp are common, possibly indicating storm damage (Figure 16). Several thornback rays and a lesser spotted dogfish or nursehound (Figure 17) were also observed.

*Figure 13. Exposed boulders colonised by urchins, anemones and keelworms*

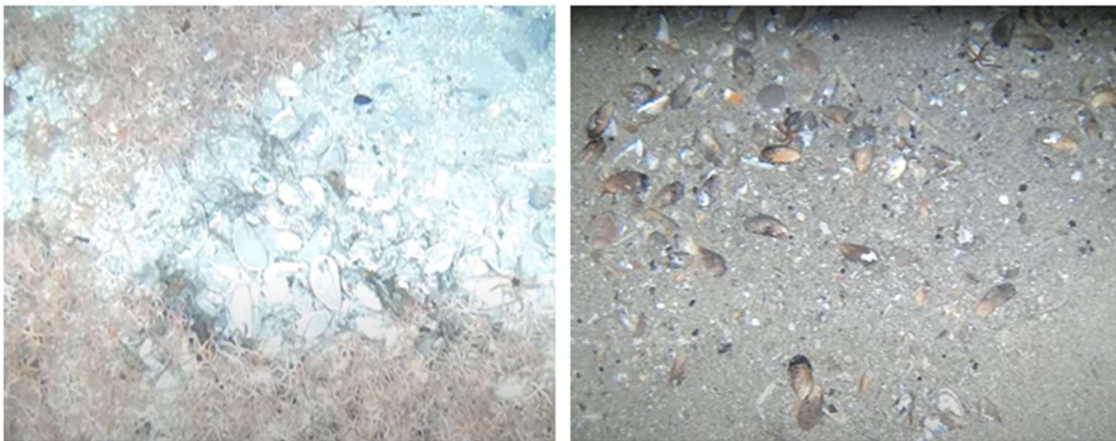
*Figure 15. Horse mussels are intermittently abundant at the N end of Transect 4.*

It is recommended that Habitat 3 should not be sampled without prior discussion with NatureScot, given the potential presence here of PMF (horse mussel bed) habitat.

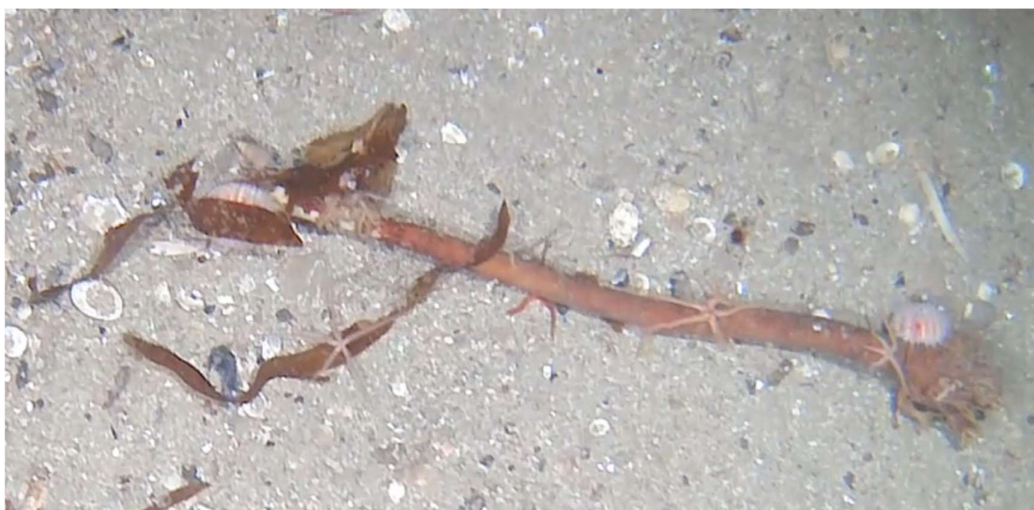
Figure 16. Broken kelp colonised by urchins and brittlestars.

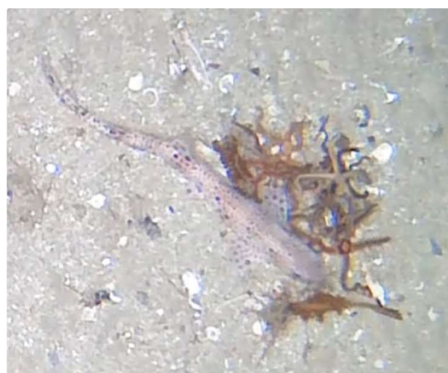
Figure 17: Lesser spotted dogfish or nursehound (unclear which)

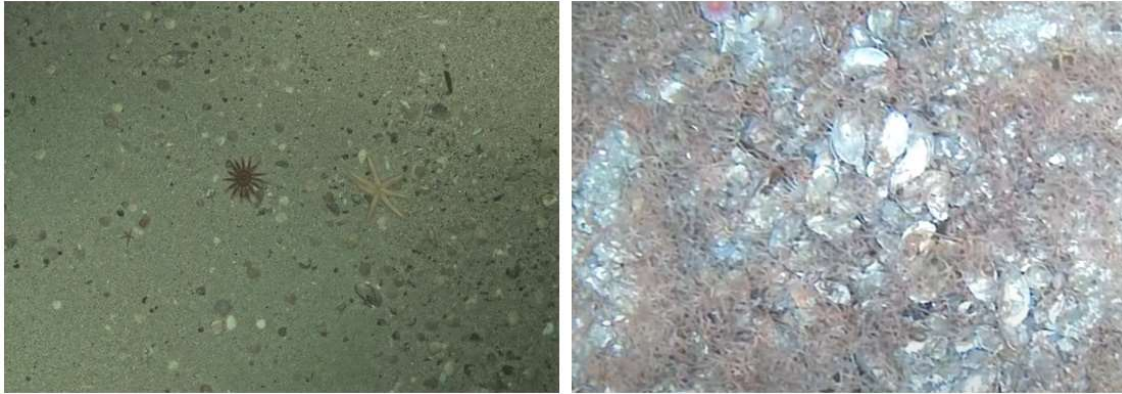
Transect 5 comprises a sandy seafloor with shells/shell fragments and gravel (Figure 18). Epifauna are dominated by echinoderms (sea urchins, especially *Echinus esculentus*, and several species of brittlestar and starfish), with brittlestars especially abundant in places. Where these form beds horse mussels are frequently seen, suggesting that horse mussel bed may underlie the brittlestars. Other species observed include burrowing anemones, whelks, scallops and other bivalves. A gurnard and a monkfish were also captured in the data on this transect (Figure 19).

Figure 18: Image representative of the seabed substrate along Transect 5. Left: sandy sediment with shells/shell fragments and gravel, fauna dominated by echinoderms. Right: Partial brittlestar bed with horse mussels and shells.

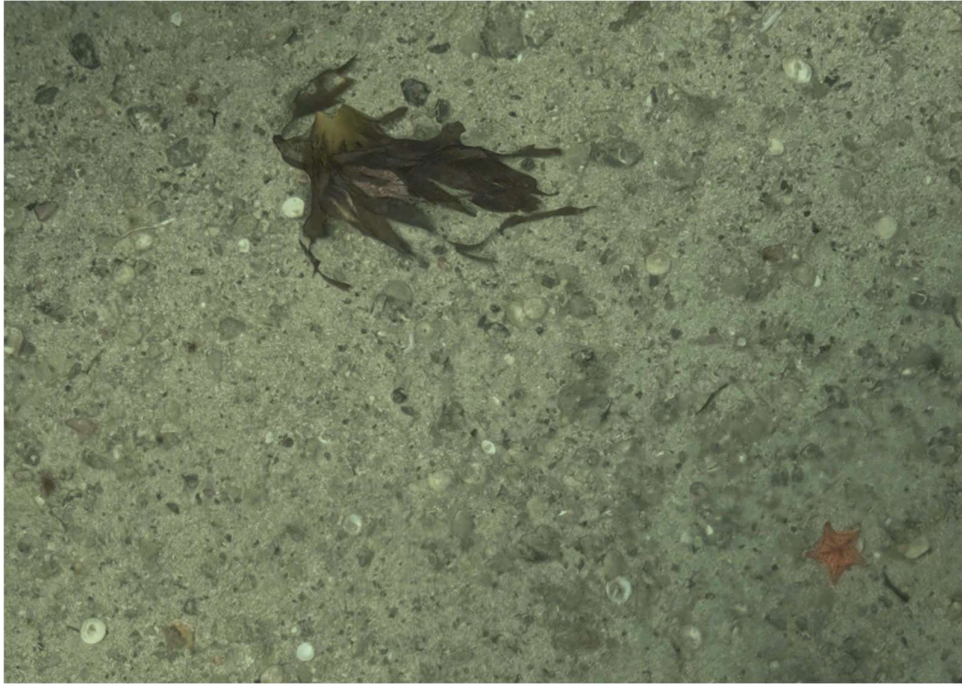
*Figure 22. Plot A: Sandy seabed, with gravel and shells/shell fragments. Fauna dominated by echinoderms (urchins, starfish and brittlestars), although these are fairly sparsely distributed. Some bivalves also present, including king scallops and horse mussels.*

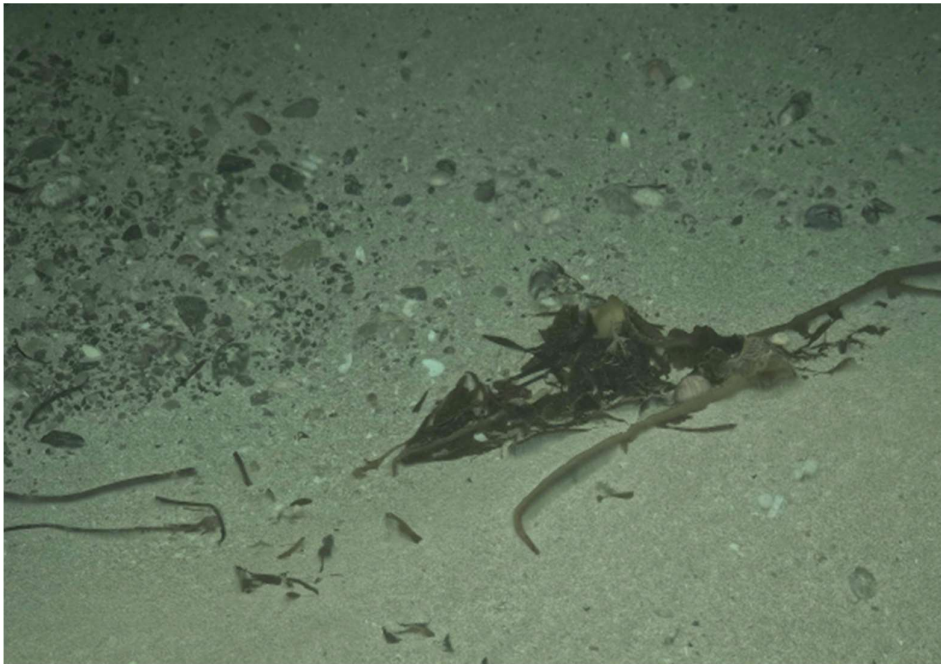
*Figure 23. Plot B: Sandy seabed, with gravel present in varying quantities. Fauna are dominated by echinoderms, and are fairly sparsely distributed within the plot area. Water depth 43m.*

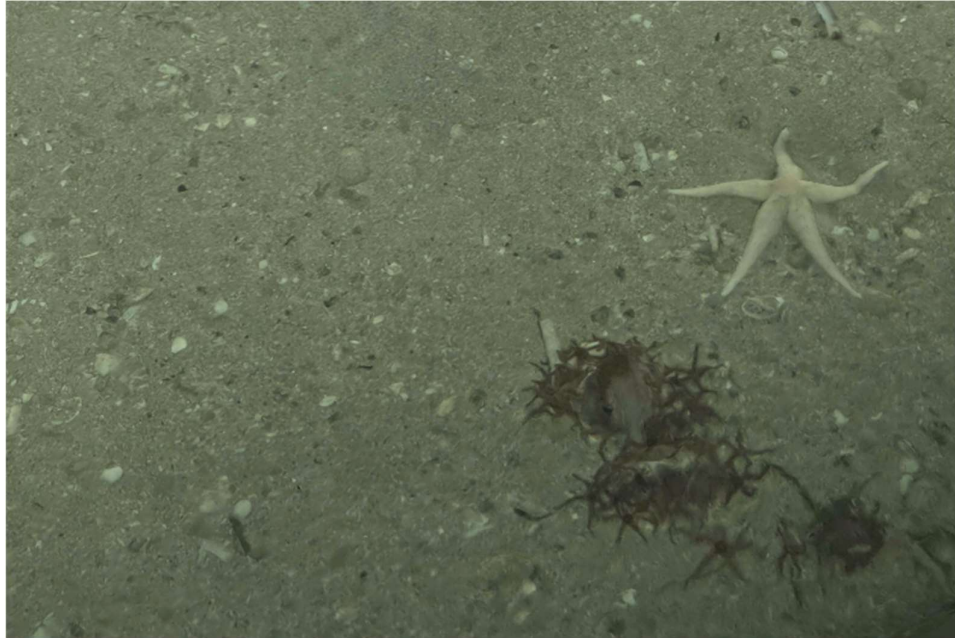
*Figure 26. Plot E: Sandy seabed with scattered shells and shell fragments. Epifauna dominated by echinoderms. Water depth 53-58m.*

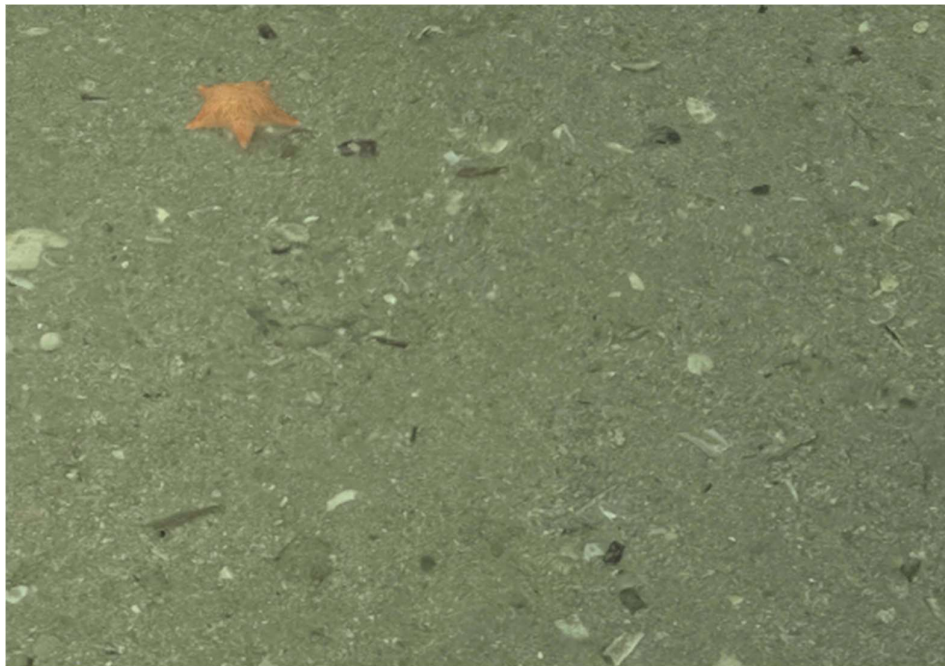
*Figure 27. Plot F: Sandy seabed with scattered shells and shell fragments. Epifaunal distribution is fairly sparse, and dominated by echinoderms. Scallops are also occasionally present, but not abundant. Thornback rays (3) also occur within the plot area.*

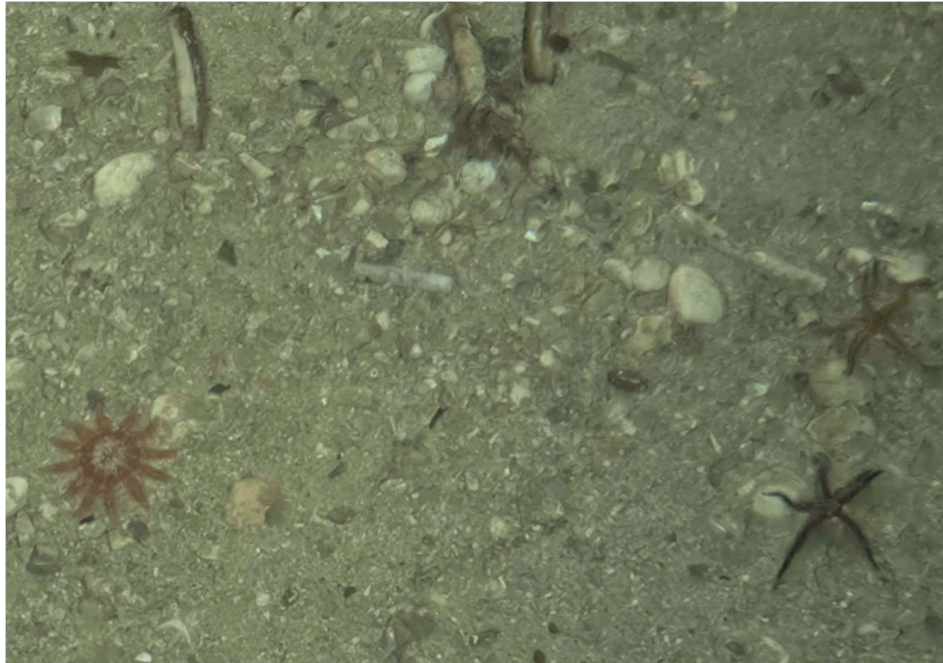
*Figure 28. Plot G: Sandy seabed with scattered shells and shell fragments. Abundant epifauna dominated by echinoderms, with some scallops also present although not abundant.*

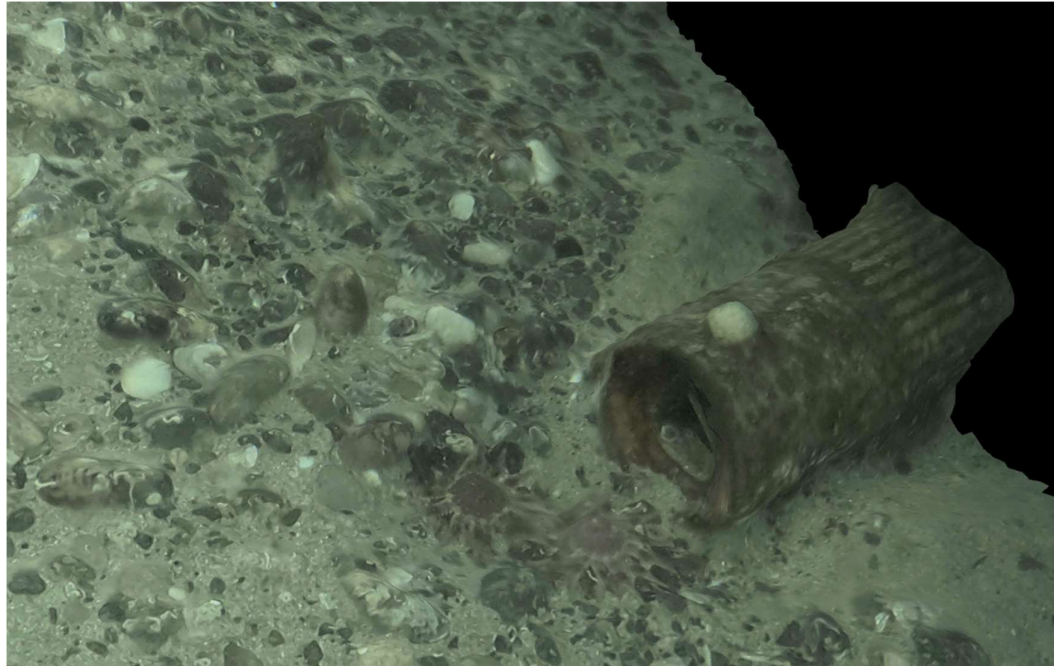
**Marine litter:** There was little evidence of marine litter/debris within the surveyed area, limited to the rope in Figure 29 and a single observation of a piece of pipe partially visible at the edge of the data in T5 (Figure 32).

*Figure 32: Photogrammetry image showing a piece of pipe on the seabed at 60.45261°N, - 1.12349°E (east side of Transect 5). Two sunstars are outside the mouth of the pipe, and a number of horse mussels (*Modiolus modiolus*) are among the gravel/stones scattered about.*
