**Argyll and Summer Isles Sites**

**Benthic ROV Survey**

**Shuna**

**P836 – January 2021**

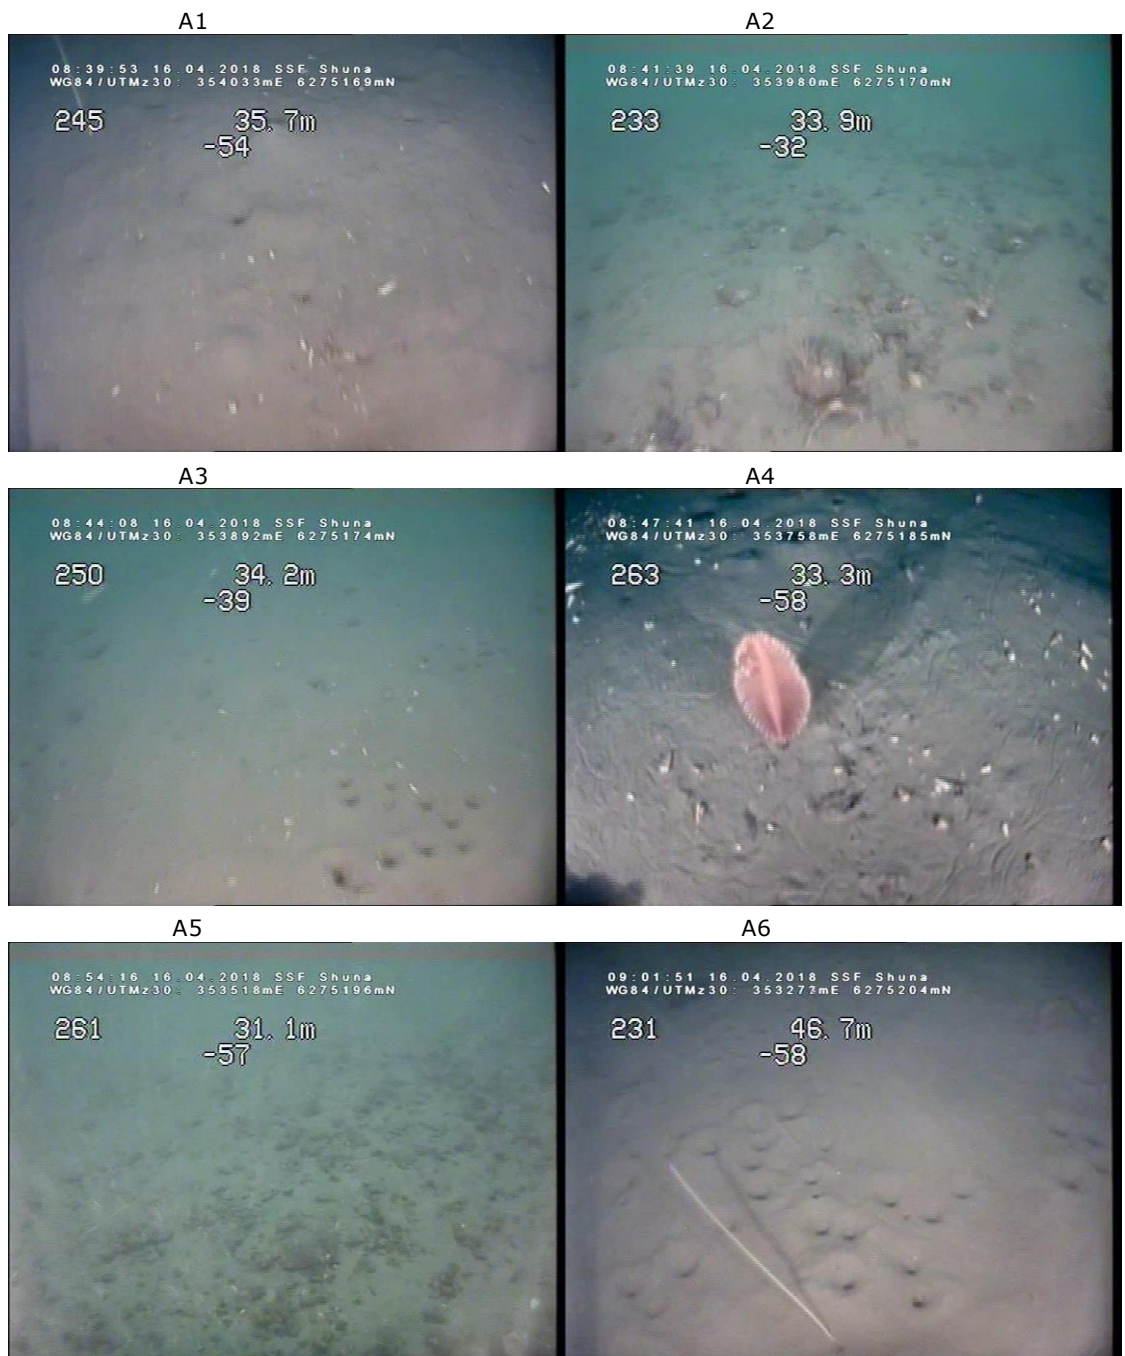
Figure 3.2 Seabed Images, Transect A, Shuna, April 2018

Slight variations in seabed characteristics were observed throughout the Shuna site during the April 2018 survey. Water depths ranged from approximately 9 m in the southern part of the survey area off the coast to 47 m in the northwest. Sediments in shallow areas less than 20 m were heterogeneous and consisted of variable proportions of fine sands, gravel, and shell fragments with scattered pebbles, cobbles and occasional boulders. At depths greater than 20 m, the composition of sediments transitioned to fine sands and muds with common patches of coarse material including pebbles and cobbles, as well as aggregations of shells (possibly *Turritella spp.*; most frequently observed along transect C). Soft muds dominated at depths greater than 30 m throughout the north and west of the survey area.

Numerous *Nephrops* burrows were observed throughout the soft muds of the survey area. The squat lobster *Munida rugosa* was commonly observed on the sediment surface or inhabiting these burrows across depths of approximately 30 m and greater. The sea pens *Pennatula phosphorea* and *Funiculina quadrangularis* appeared widespread in low densities, with low numbers of other epibenthic fauna including common starfish (*Asterias rubens*) and crustaceans (possibly including the shrimp-like *Callinassa subterranea* and/or *Calocaris macandreae*). An isolated patch of Northern feather stars (*Leptometra celtica*) was recorded in association with coarse sediments at 34 m along transect A.

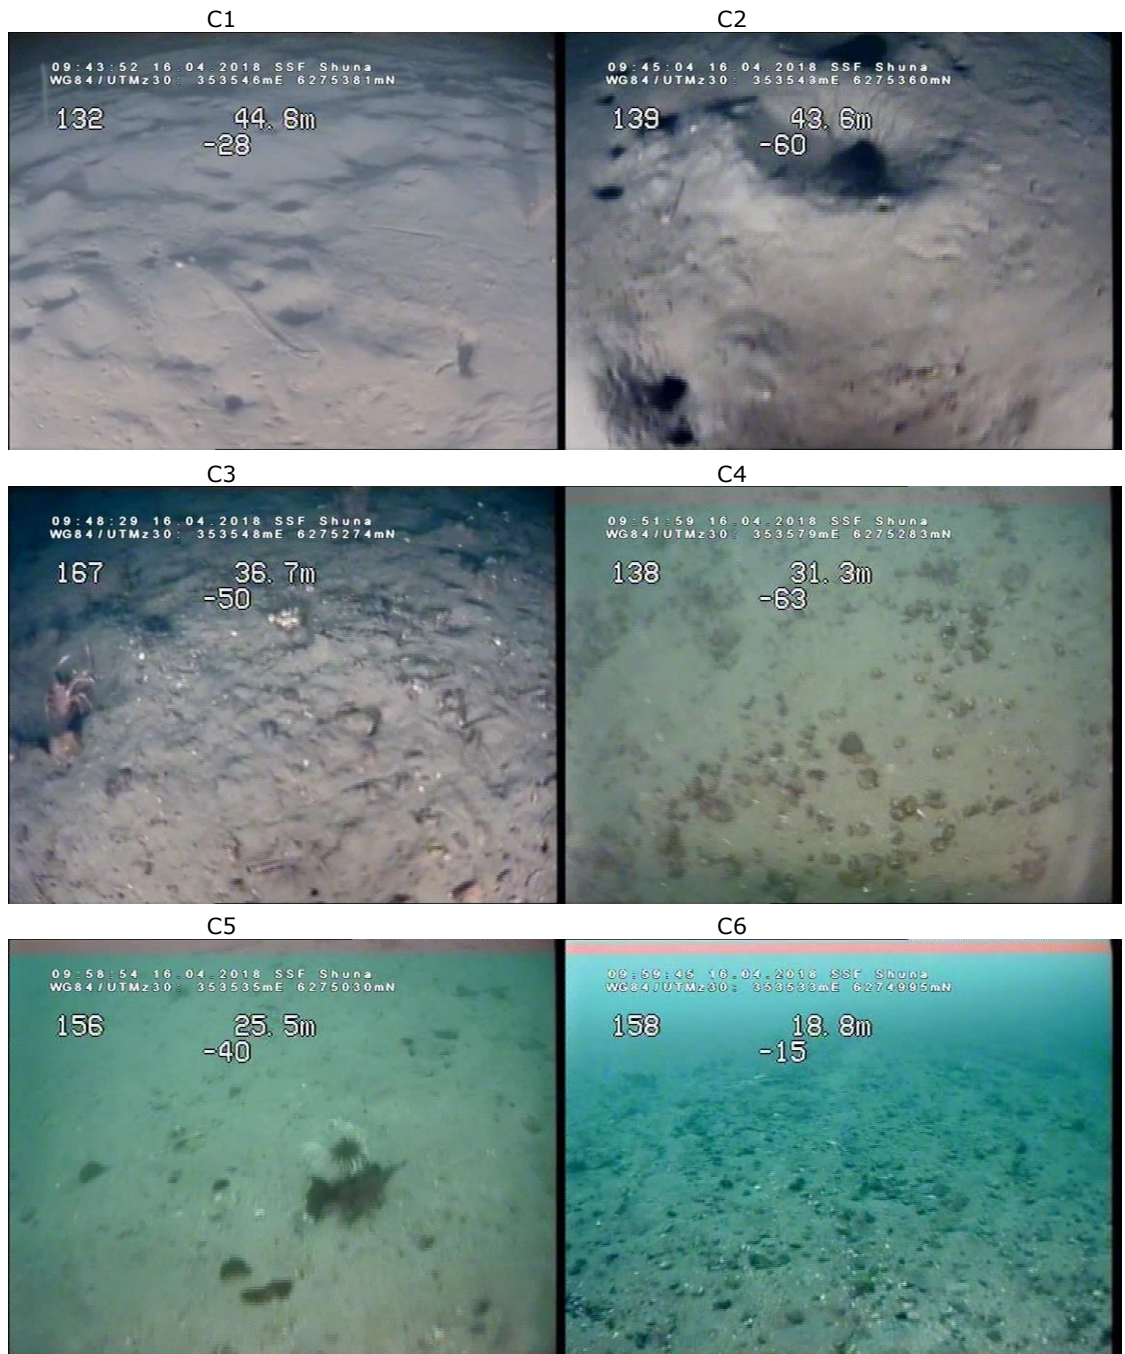
Figure 3.4 Seabed Images, Transect C, Shuna, April 2018

On single occasions along transect C, a Thornback Ray (*Raja clavata*) was observed at 45 m depth, and a Fireworks anemone (*Pachycerianthus multiplicatus*) at 25 m.

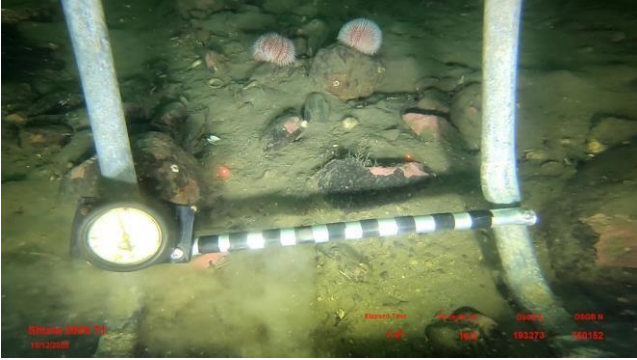
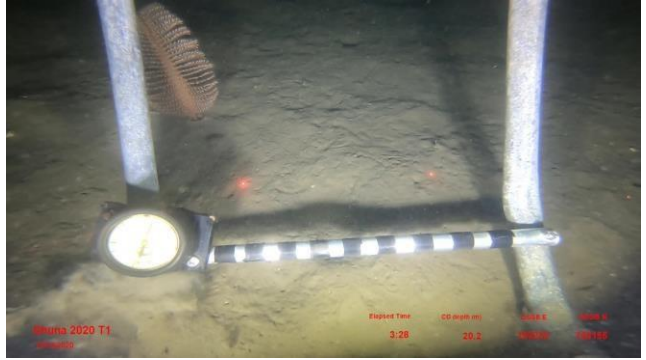
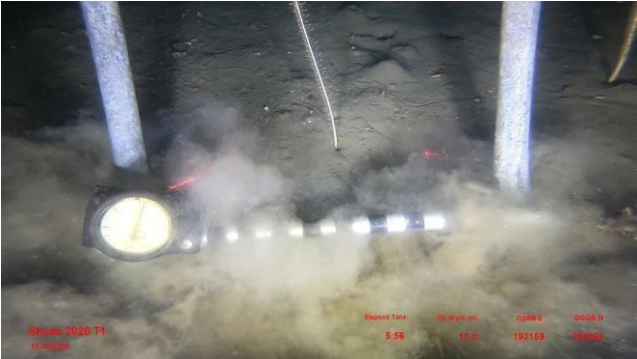
**Figure 3.5 Seabed Images, Transect T1A and T1B, Shuna, December 2020**

Similar seabed characteristics were observed during the December 2020 survey. Fine to medium sands with empty shells and shell fragments were observed at the beginning of transect T1A, east of the survey area at the shallowest depths of 12-13 m. Pebbles and occasional cobbles were encrusted with pink coralline algae and hydroids with scattered *E. esculentus* and *M. rugosa*. Progressing west towards the Shuna fish farm site, from around 17-20 m depth sediments transitioned to sandy muds with megafaunal burrows and low densities of sea pens *P. phosphorea* and *F. quadrangularis*. *M. rugosa* was occasionally observed at burrow entrances.

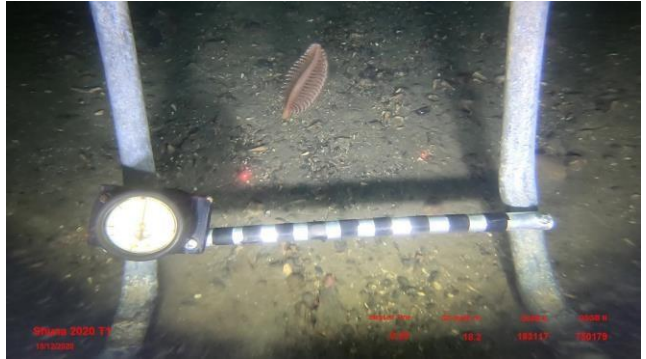
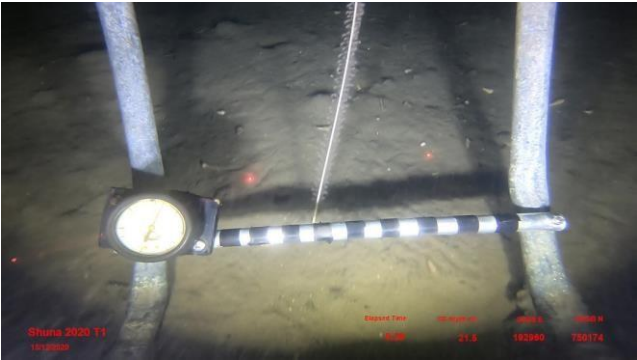
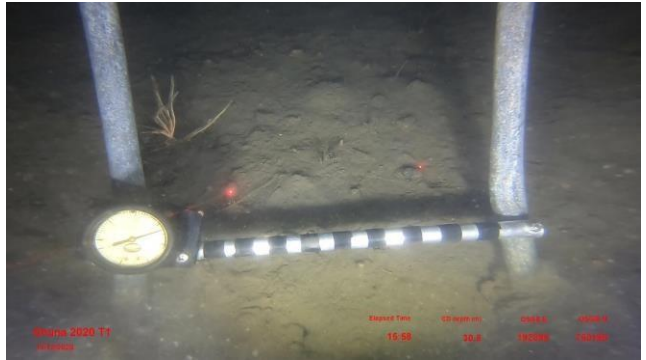
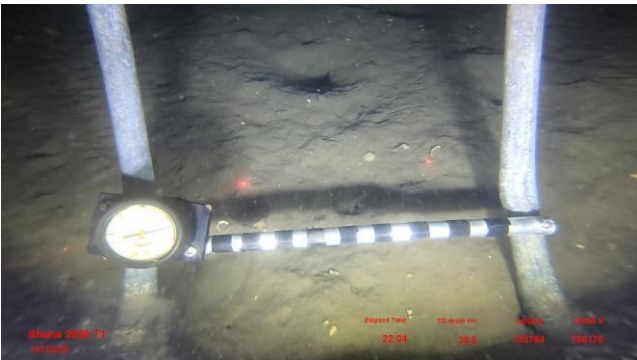
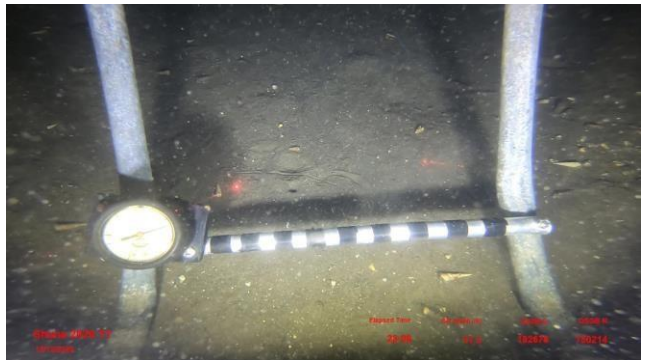
Within transect T1B areas of fine to medium sands with shell fragments, encrusted pebbles and cobbles, and scattered *Turitella spp.* were present at the beginning and near the middle of the transect. Elsewhere sandy muds with megafaunal burrows were observed with low densities of *P. phosphorea* and *F. quadrangularis*. Low numbers of epifauna present around burrowed muds included *A. rubens*, *M. rugosa*, as well as hermit crabs (*Pagurus bernhardus*) toward the end of transect T1B at the deepest parts of 30-32 m depth. Two *L. celtica* individuals were observed in the middle of transect T1B at 30.9 m depth.

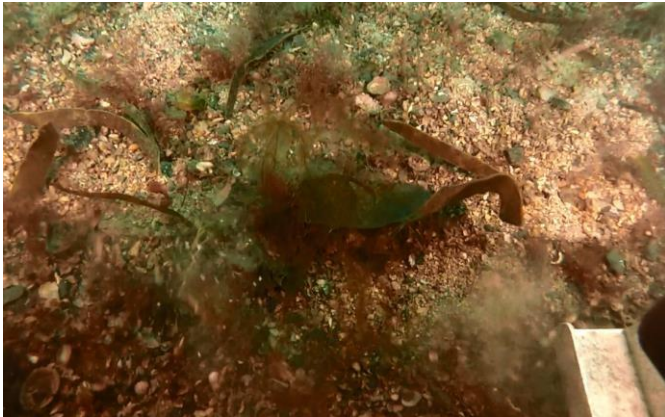
Mixed coarse sediments

- Heterogeneous fine sands with gravel, shells, pebbles and cobbles in shallow waters less than 20 m depth across transects A-C, and between 13-17 m depth across transects T1A and T1B, resembled the SS.SMx.CMx biotope complex. Sparse visible fauna in these areas included *E. esculentus*, *M. rugosa* and sparse patches of kelp debris. Due to image clarity of footage collected along transects A-C, there was difficulty in distinguishing infaunal species characteristic of specific biotopes within the complex (e.g. burrowing anemone *Cerianthus lloydii*), meanwhile no further characterising infauna, including *C. lloydii*, was observed along transects T1A and T1B.

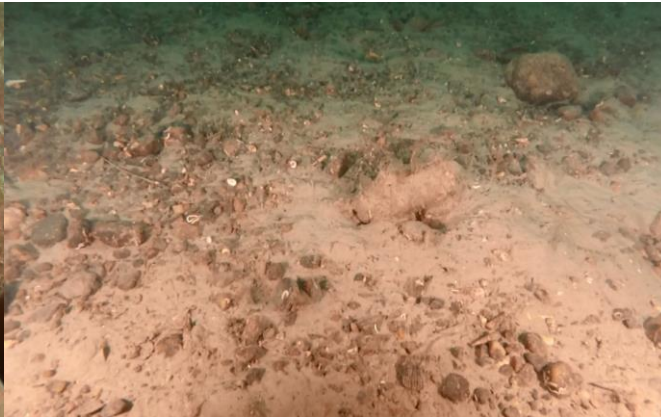
Muddy sediments with scattered shells, cobbles, and pebbles

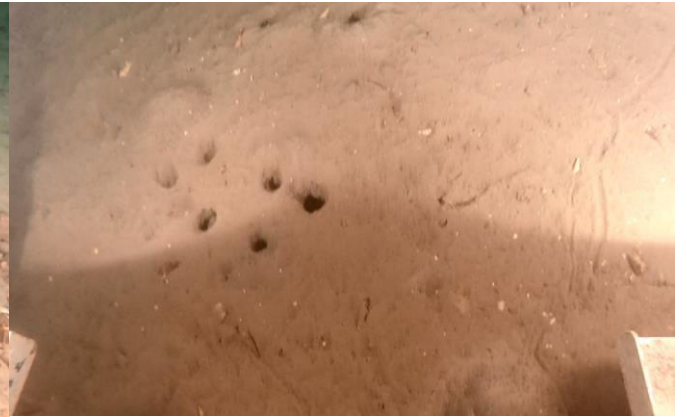
Soft burrowed muds

- Areas of the soft muddy habitat observed in deeper waters below approximately 40 m across transects A-C, and below 17-20 m across transects T1A and T1B, shared characteristics with the SS.SMu.CFiMu.SpMmeg biotope. Burrows (thought to mainly belong to *Nephrops*) were widespread below these respective depths, with sea pens *P. phosphorea* and *F. quadrangularis* present in low densities. Close representations of the SS.SMu.CFiMu.SpMmeg biotope include toward the end of transect B which shows concentrated burrows and both sea pen species situated near the burrows. Characterising species of this biotope observed in low numbers included *A. rubens*, *Turritella spp.*, and *P. bernhardus* (JNCC, 2015). This biotope is listed on the OSPAR List of Threatened and/or Declining Species and Habitats, but is not an Annex I habitat in the Habitats Directive (EU Habitats Directive 92/43/EEC). SS.SMu.CFiMu.SpMmeg is a component biotope of the 'burrowed mud' broad habitat, which is a Priority Marine Feature (PMF) in Scotland's seas (Howson et al., 2012).

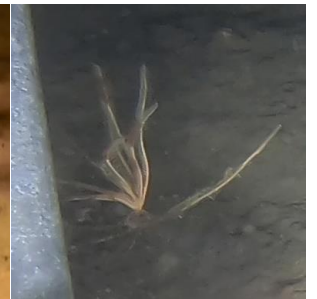
*L. celtica*  
Northern feather star

- There was an isolated patch of *L. celtica* on coarse sediments observed along transect A, and two further *L. celtica* individuals on sandy muds in the middle of transect T1B. *L. celtica* is not an Annex II species in the Habitats Directive but is identified as a PMF in Scotland.
