# Merkland Burn Micro-Hydro - Species Protection Plan for the Killarney Fern

**Date: 21/04/2023**

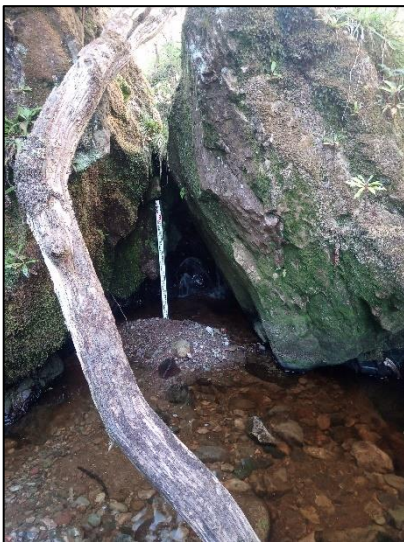
Figure 5 - Killarney Fern Cave [20/04/23]

A small proportion of the river's flow enters the rear of the cave and passes underneath the fern and on the opposite wall of the cave (a few hundred mm away) water continuously drips down the rock face, across common bryophyte species.

The water which enters the rear of the cave enters from the base of a deep pool which has formed behind the boulder. The point at which water enters the cave from the pool is significantly lower than the outlet of the pool through which the majority of the burns water flows. Therefore, water preferentially flows into the cave even at the lowest water levels.

Main outlet of pool ~1m above the point at which water enters the cave.

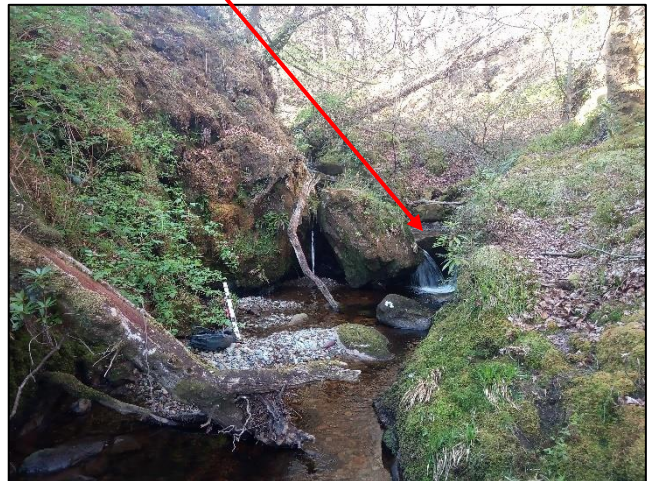
Figure 4 - Killarney Fern Site [20/04/23]

The KF was found in a single location along the depleted reach at NS 01973 38858, approximately 500mm above the low water line on the underside of a large boulder, at the bottom of a ravine and which forms a small cave against the side of the ravine. A deep pool of water surrounds the boulder and extends directly beneath the fern's position on the boulder. This pool is retained by a few large boulders ~6m downriver from the entrance of the cave.

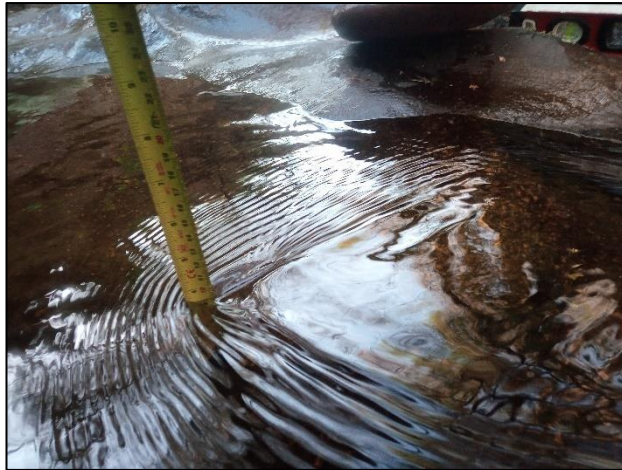
Figure 11 - Depth of water flowing over V-notch

Width	Depth	Flow Rate	Q-Value
500mm	95mm	11.1Ltr/s	~96

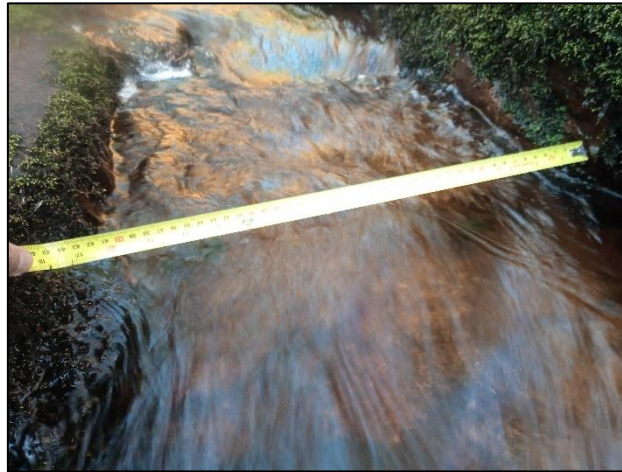
Figure 13 - Rectangular notch ~35m upriver of KF site

Width	Depth	Flow Rate	Q Value
400mm	70mm	10.2Ltr/s	~96

During low flow conditions (<~Q80), all of the river flow passes through a 400mm x 200mm natural rectangular notch to one side of the watercourse which has formed between a boulder and the bedrock river bank.

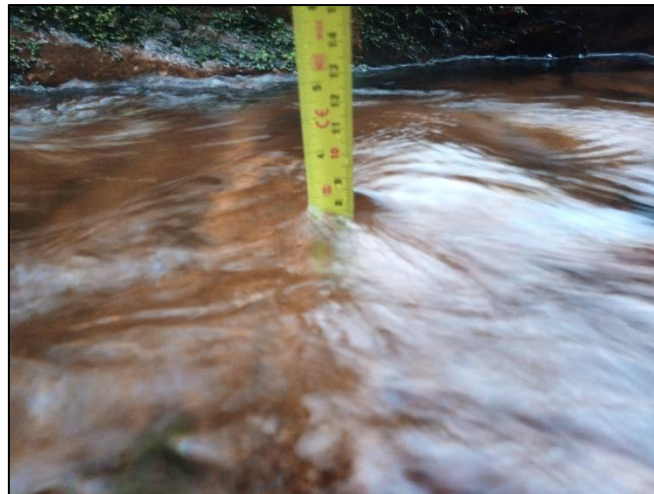
Figure 14 - Depth of rectangular notch, measurements taken every 100mm.

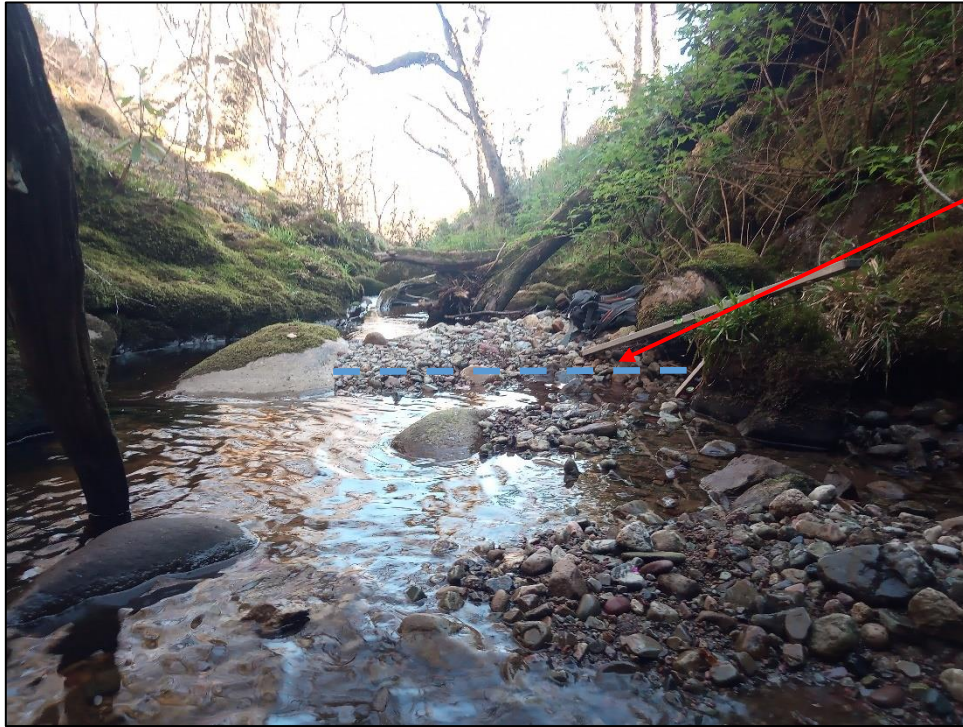
Low concrete wall installed to fix in place boulders which form pool that floods KF cave.

Figure 15 - View downriver from KF cave. Blue line indicating potential wall to maintain KF cave pool

The position and height of these boulders can be maintained over the long term by casting a small amount of concrete to fix them in place. This can be done in a manner which maintains the size of the natural notch that regulates low water levels, while not impacting the level of the pool during medium to high flows.
