Marine Aquaculture Site Loch Hourn Appendix 9. Habitat Assessment - Loch Hourn Fish Farm (BSL)

Mowi Scotland Limited November 2021

Habitat Assessment Survey – Loch Hourn Fish Farm

Benthic Solutions Ltd

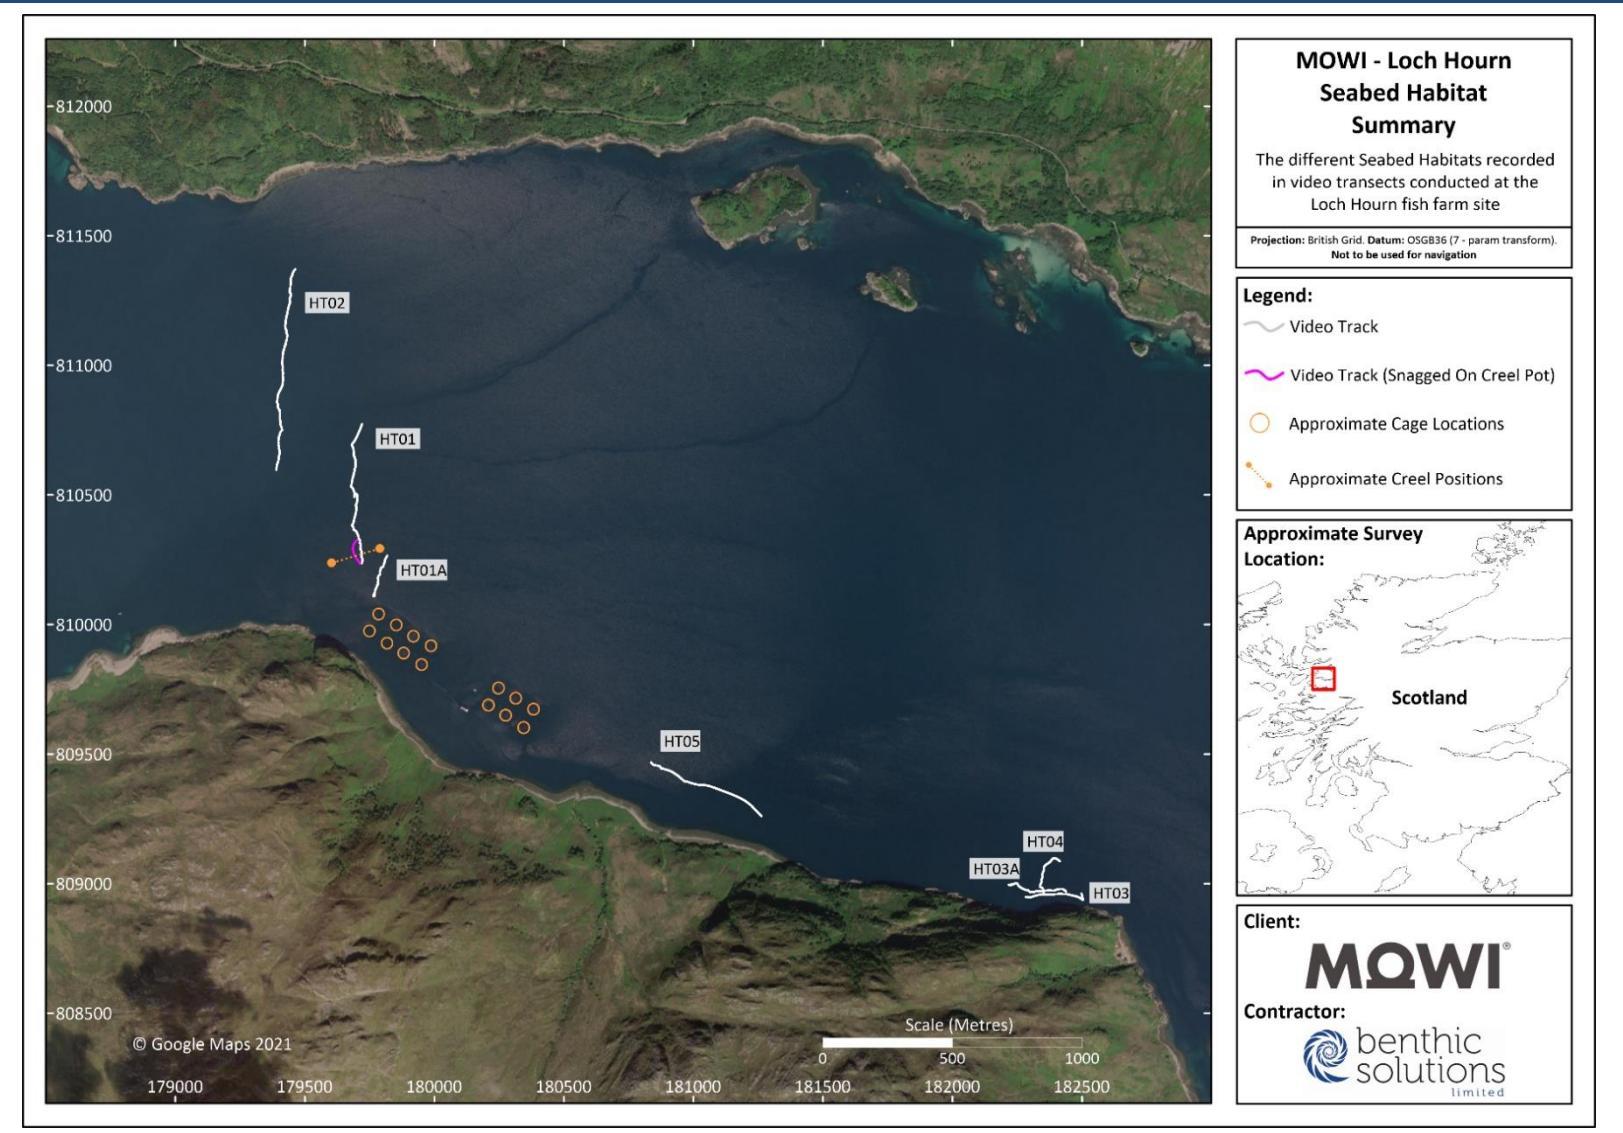
Figure 5.1 Camera Transects Overview at Loch Hourn

Visual survey operations were carried out using a towed underwater camera system acquiring high quality stills and HD video. The scope of the survey was to carry out five video assessment lines on the seabed surrounding the Loch Hourn fish farm. These were based on the following:

- One approximately 700m long survey line running north of the Loch Hourn fish farm, towards an area previously demarcated by GeMS as 'burrowed mud' and starting approximately 50m northwest of the farm. The transect was split into two separate survey lines due to a creel pot entanglement, with the two constituent lines measuring approximately 150m and 650m.

- One approximately 750m survey line running north of the Loch Hourn fish farm, adjacent to an area previously demarcated as 'burrowed mud' and starting approximately 600m northwest of the farm.

- Two 150m transects arranged in a cruciform pattern approximately 2km east of the fish farm, centred on an area of previously sighted northern feather stars (*Leptometra celtica*).

- An additional 450m long BSL-proposed transect, starting 500m east of the farm and running south-southeast to assess any habitats and potential environmental impacts east of the farm.

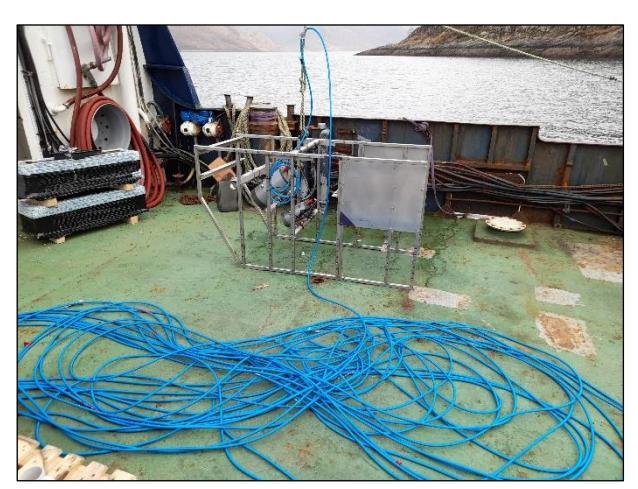
Figure 6.1 Towed Camera System

The video survey was carried out using Benthic Solutions MOD 4.3 camera system fitted onto a tow-frame (Figure 6.1). This consists of a stainless-steel tow-frame on which the camera system is mounted at approximately 45° viewing angle <1m from the seabed and illuminated by a 2000lux LED light and twin parallel scaling lasers (8cm separation).

The system is lowered to the seabed and is ideally towed at an optimal speed of 0.5 to 1 knot (0.25-0.54 m/sec). However, as the vessel struggled to maintain any steering at this speed, variable speeds of up to 2 knots (1m/sec) were encountered during the survey. The unit was maintained at, or just above, the seabed, for the majority of the footage along the line. Periods where the seabed was not visible were limited to sections where the seabed deepened quickly, areas of increased turbidity, or when the frame was partially lifted to prevent the camera from damage due to contact with hard substrate (cobbles, boulders and bedrock).

The seabed and orientation of the camera equipment were continuously monitored from the surface where the tow cable was adjusted using a capstan to maintain contact with the seabed. This surface video feed was annotated with vessel speed and position and recorded separately to the high-definition video data. Both datasets were time-stamped to support later data harmonisation. Further details for the camera system are provided in Appendix I.

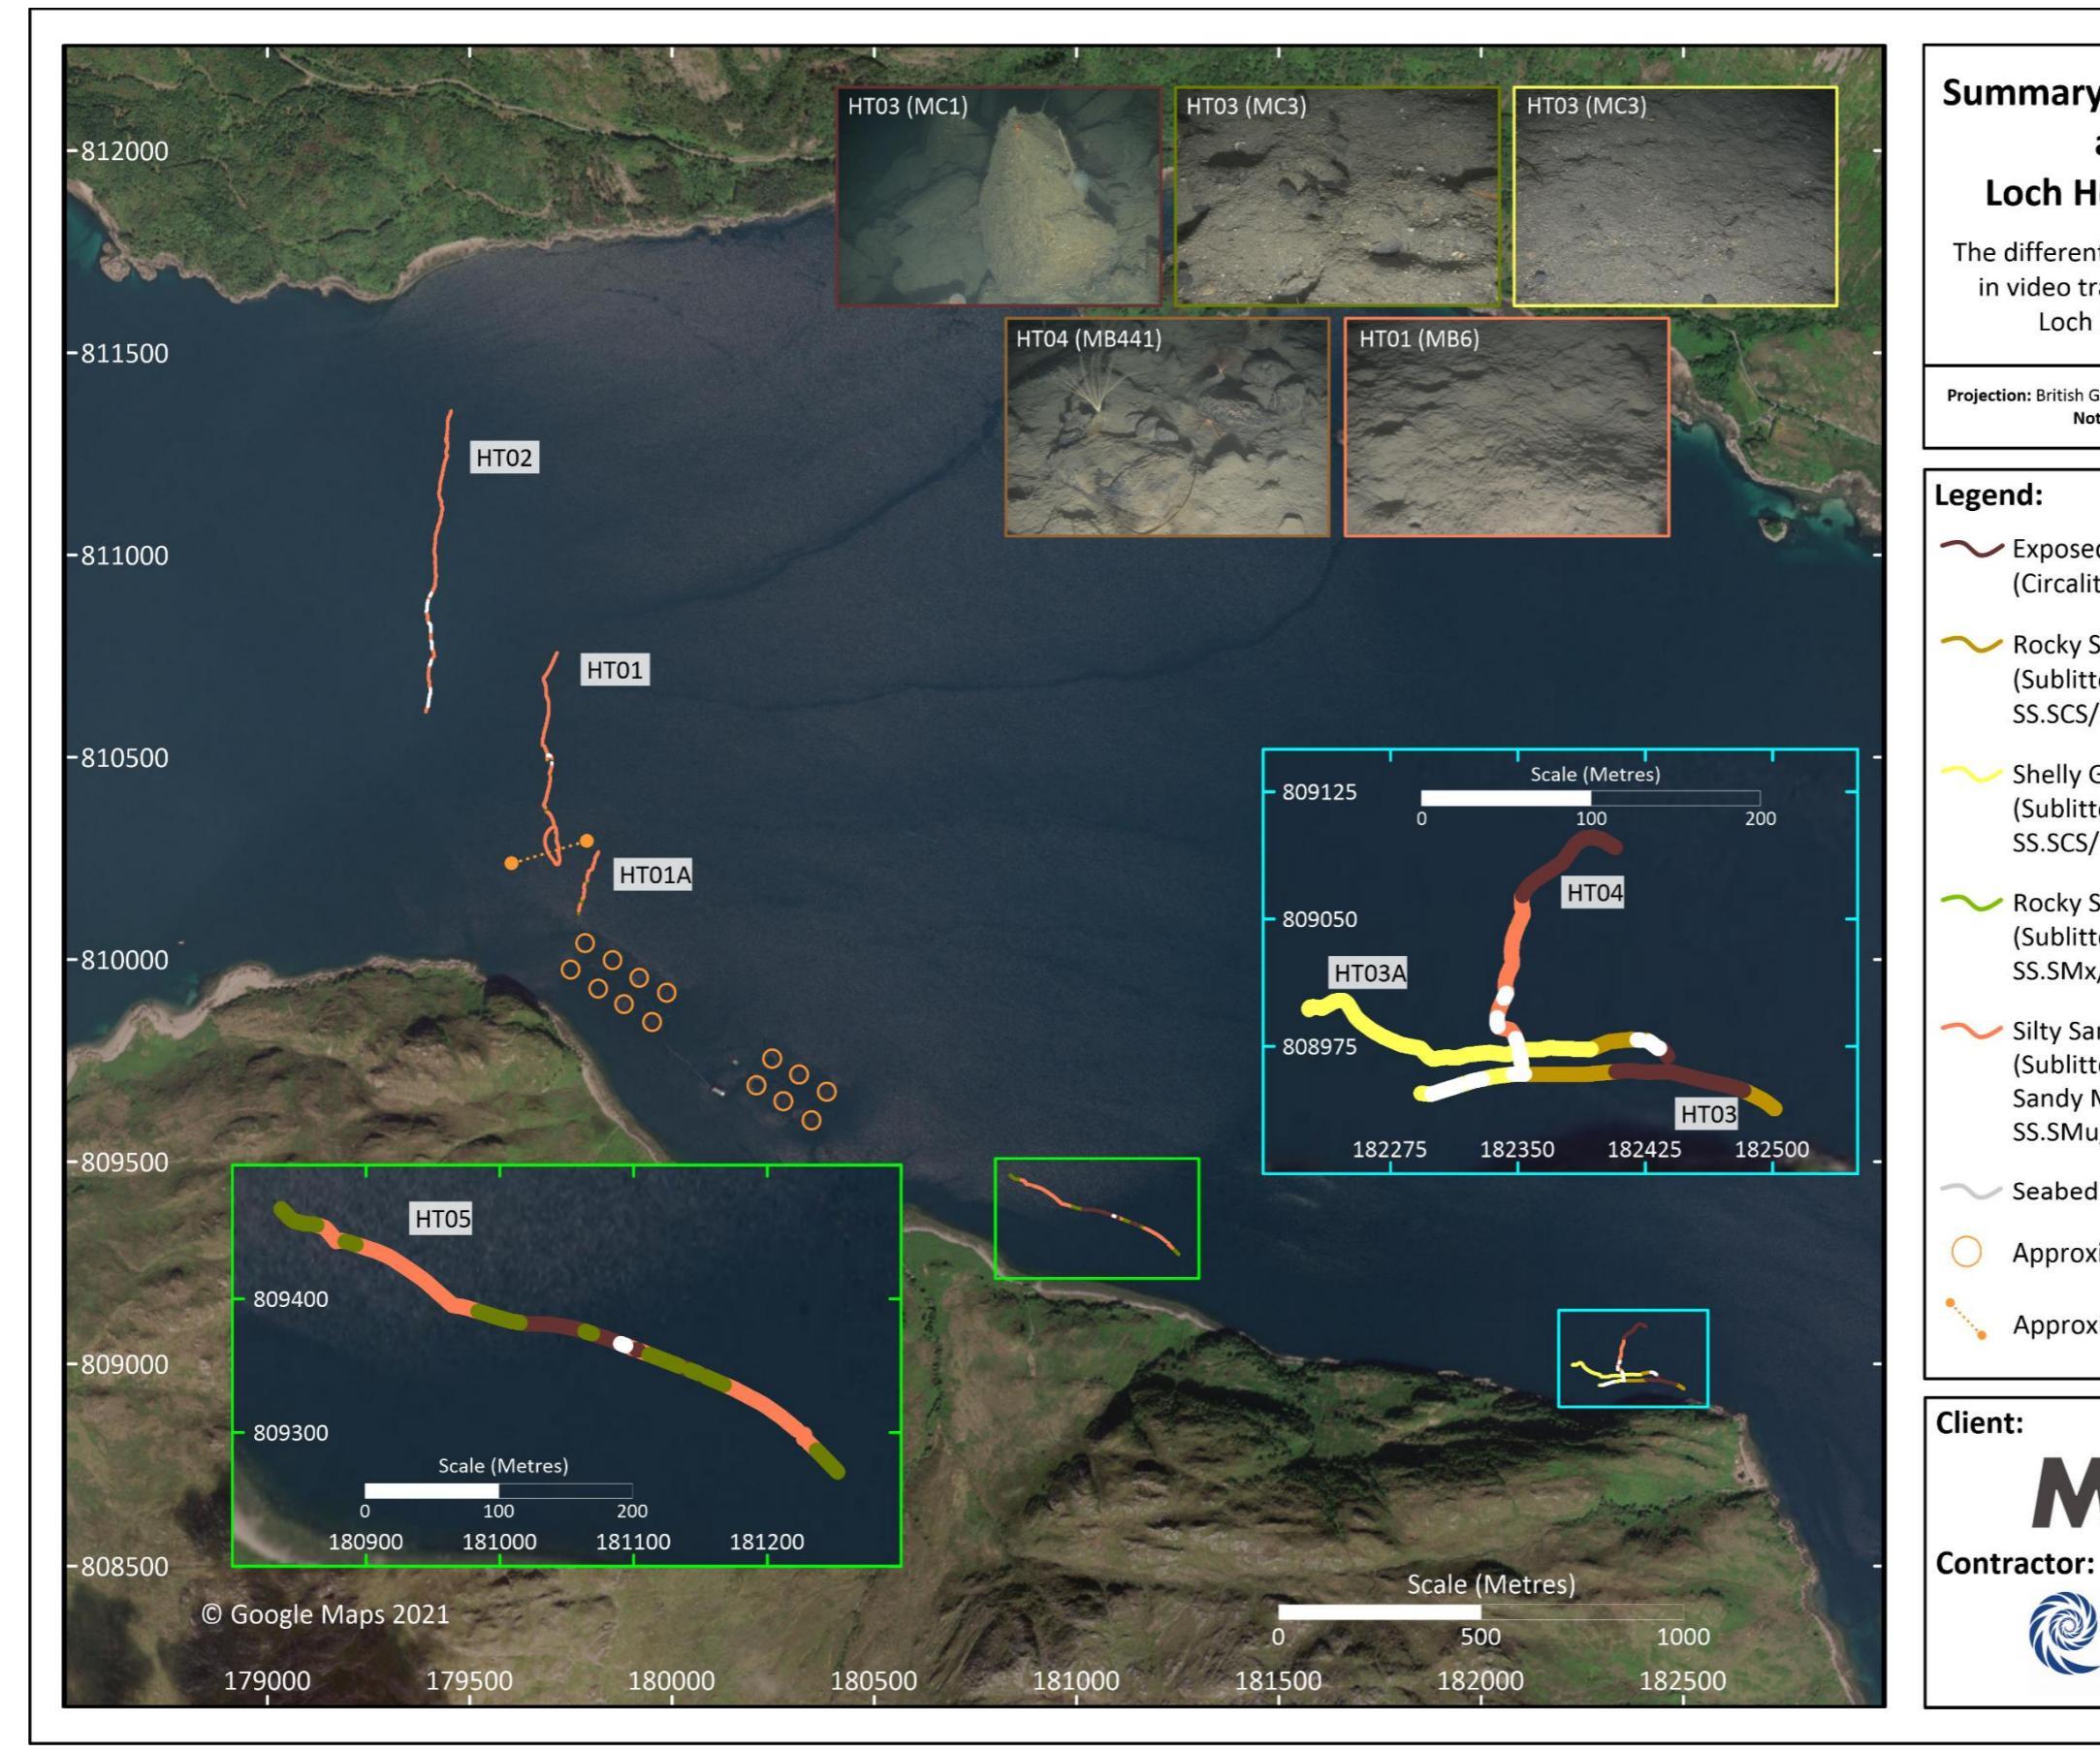
Figure 8.1 Summary of Habitats Along Each Transect

Using the seabed substrate categories outlined in Table 8.1, it was possible to delineate sections of camera transects characterised by different substrate (Figure 8.1). The video footage recorded across the site shows that the shallower coastal regions (<35m water depth) recorded along transects HT03 and HT03A were dominated by exposed bedrock and coarser rocky/shelly gravelly sand substrate types. The majority of exposed bedrock was observed along the eastern transects (HT03, HT03A, HT04 and HT05), in the form of geogenic reef with the steep vertical surfaces providing suitable attachment points for a range of sessile and encrusting organisms. Deeper areas (>35m) along transects HT01, HT01A and HT02 were less exposed to energetic water movements and hence were dominated by bioturbated silty sand. Transects HT04 and HT05 were situated in a transition zone between the shallow coarser substrate and the deeper finer substrate, with both transects revealing a mix of exposed bedrock, pebbles and cobbles in conjunction with bioturbated silty sand.

Summary of Seabed Habitats around the Loch Hourn Survey Area

The different Seabed Habitats recorded in video transects conducted at the Loch Hourn fish farm site

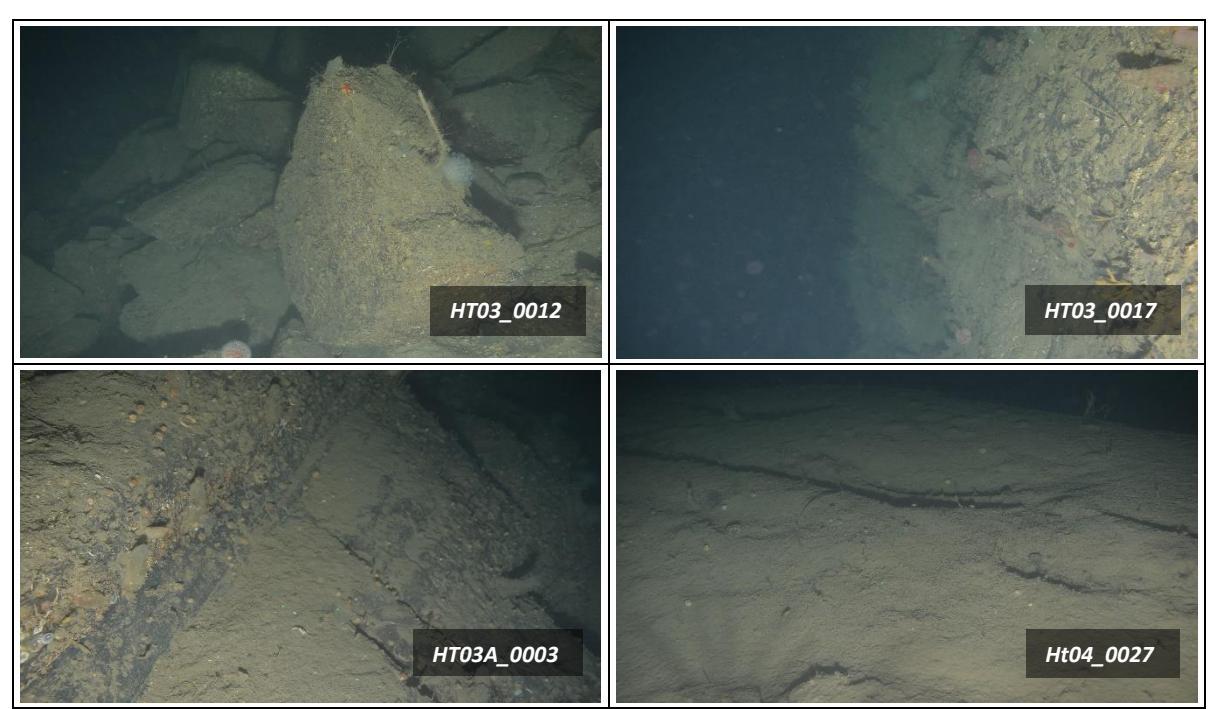
Figure 8.2 Example Images of Exposed Bedrock Habitat

Bedrock exposures were recorded to the east of the fish farm along transects HT03, HT03A, HT04 and HT05 that were close to coastal regions of the survey area (Figure 8.1). This substrate type was generally recorded as a continuous structure that had slight variations in morphology depending on where it was located. For example, exposed bedrock along transect HT04 formed tabletop shelves with relatively low-lying steep edges whereas exposed bedrock formed more prominent cliffs along transects HT03, HT03A and HT05. Both morphologies of bedrock found in the survey area had steep vertical sides colonised by dense epifaunal assemblages, while the horizontal surfaces were covered by a layer of sediment. The combination of the habitat, faunal community and the sedimentation of the horizontal surfaces are best described by the biotope of CR.LCR.BrAs.AmenCio – Solitary ascidians, including Ascidia mentula and Ciona intestinalis, on wave sheltered circalittoral rock. The biotope is dominated by ascidians, Serpulidae tubes, Devonshire cup corals and pink coralline algae on upper faces of wave-sheltered (often sealochs) circalittoral bedrock, boulders and cobble slopes with little tidal flow. Conspicuous epifauna included the northern feather star (Leptometra celtica), the Devonshire cup coral (Caryophyllia smithii), hydroids (Tubulariidae sp.), sponges (Phakellia ventilabrum), anemones (Actiniaria sp.), tall seapens (Funiculina quadrangularis), coralline algae, sea squirts (Ascidiacea sp. and Ciona intestinalis), bryozoan turf and Serpulidae tubes. Mobile fauna was also observed on the exposed bedrock and included crustaceans such as squat lobsters (Munida sp.) and edible crabs (*Cancer pagurus*), along with echinoderms such as cushion stars (*Porania pulvillus*), spiny starfish (Marthasterias glacialis), common sea urchin (Echinus esculentus) and other starfish species (Asteroidea sp.).

Given the elevation and extent of the bedrock formations, the areas delineated would classify as JNCC Annex I reefs, which are described as: *"Rocky reefs occur where bedrock or stable boulders and cobbles arise from the surrounding seabed creating a habitat that is colonised by many different marine animals and plants. Rocky reefs can be very variable in terms of both their structure and the communities they support. They provide a home to many species such as corals, sponges and sea squirts as well as giving shelter to fish and crustaceans such as lobsters and crabs" (JNCC, 2016). As illustrated in Figure 8.2, the bedrock exposures observed during the current survey were colonised by encrusting coralline algae and sessile epifauna including hydroids, sea squirts and Devonshire cup corals.*

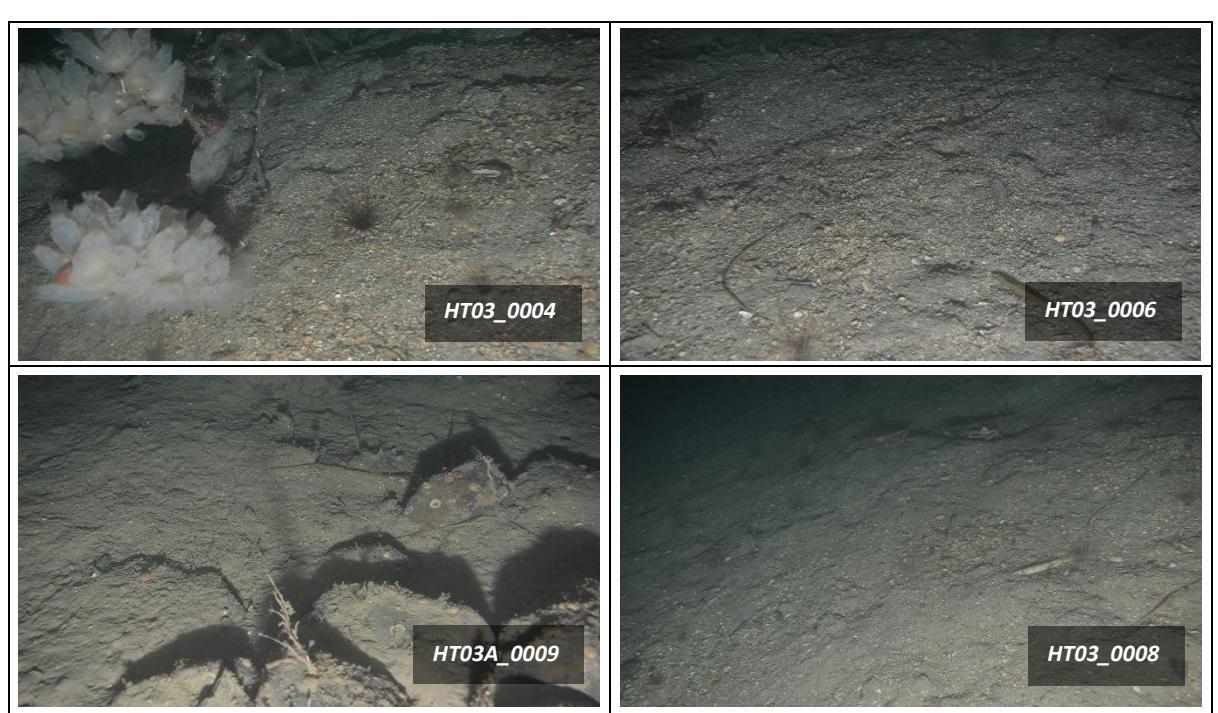
Figure 8.3 Example Images of Coarse Sediment Habitat Variation

This coarse sediment type was isolated to the shallower transects HT03, HT03A and HT04, which were 2km east of the Loch Hourn fish farm. The composition of this substrate was of fragmented shell and coarser material overlying sand, with the rocky variant (pebbles and cobbles) exclusively observed along transects HT03 and HT03A near the exposed bedrock (Figure 8.1). The most abundant species observed within this substrate type was the tube anemone (*Cerianthus lloydii*), with other conspicuous fauna present at lower abundances such as starfish (Asteroidea sp.), squat lobsters (*Munida* sp.), anemones (Actiniaria sp.), grey gurnard (*Eutrigla gurnardus*) and sea squirts (Ascidiacea sp. and *Ciona intestinalis*). The rocky variant of this substrate type provided more attachment points for sessile species such as Serpulidae tubes and provided a refuge for squat lobsters (*Munida* sp.). The substrate type and associated fauna is illustrated in Figure 8.3 and could be further refined to the biotope, 'circalittoral coarse sediment' (SS.SCCS). The habitat may be characterised by robust infaunal polychaetes such as *Mediomastus fragilis* and *Lumbrineris* spp.; however, no grab sampling was undertaken to enable a more detailed biotope description so the characterisation of this habitat was limited to a combination of the substratum, water depth and conspicuous fauna.

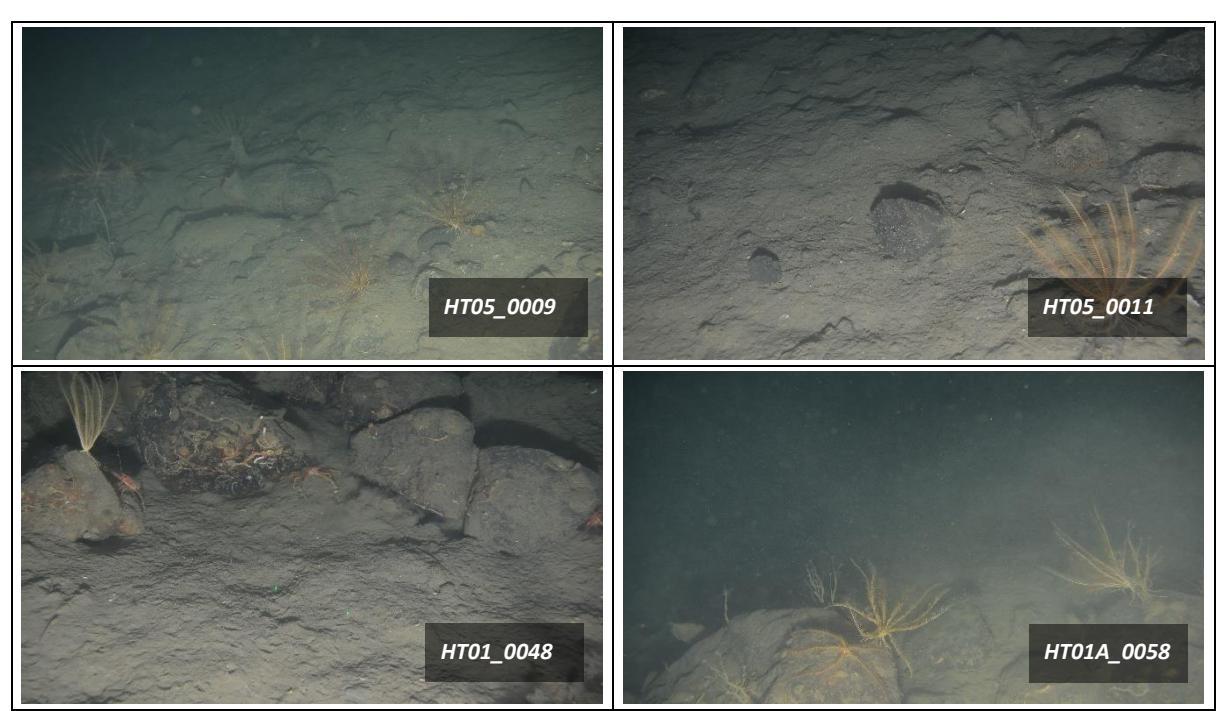
Figure 8.4 Example Images of Mixed Sand Habitat

Mixed sediments composed of muddy silty sand with pebbles and shells fragments were observed across the transects HT04, HT01, HT01A and HT05, with a greater occurrence observed along transect HT05 due to the weathering of exposed bedrock providing a supply of pebbles and cobbles to the underlying silty sand substrate (Figure 8.1). Rocky substrate enabled attachment points for Devonshire cup corals (Caryophyllia smithii), feather duster worms (Sabellidae sp.), Serpulidae tubes, cushion stars (Porania pulvillus), spiny starfish (Marthasterias glacialis), northern feather star (Leptometra celtica), common whelk eggs (Buccinum sp. eggs), bryozoan turf, sponges (Phakellia ventilabrum), hydroids (Tubulariidae sp.), brittle stars (Ophiuroidea sp.) and sea squirts (Ascidiacea sp. and Ciona intestinalis). The rocky substrate also acted as a refuge for edible crabs (Cancer pagurus) and squat lobsters (Munida sp.). The conspicuous faunal assemblages observed were similar to those observed on exposed bedrock, so the mixed substrate represented an intermediate habitat between the exposed bedrock and silty sand habitats. The silty sand component of the substrate type provided a habitat for sessile species such as slender seapens (Virgularia mirabilis), tall seapens (Funiculina guadrangularis), tube anemones (Cerianthus Iloydii) and fireworks anemones (Pachycerianthus multiplicatus), and more mobile species such as the common dragonet (*Callionymus lyra*). This habitat type generally conformed to the biotope 'sublittoral mixed sediments' (SS.SMx), but further refinements to the biotope were not possible with the current conspicuous fauna dataset. Example images are presented in Figure 8.4.

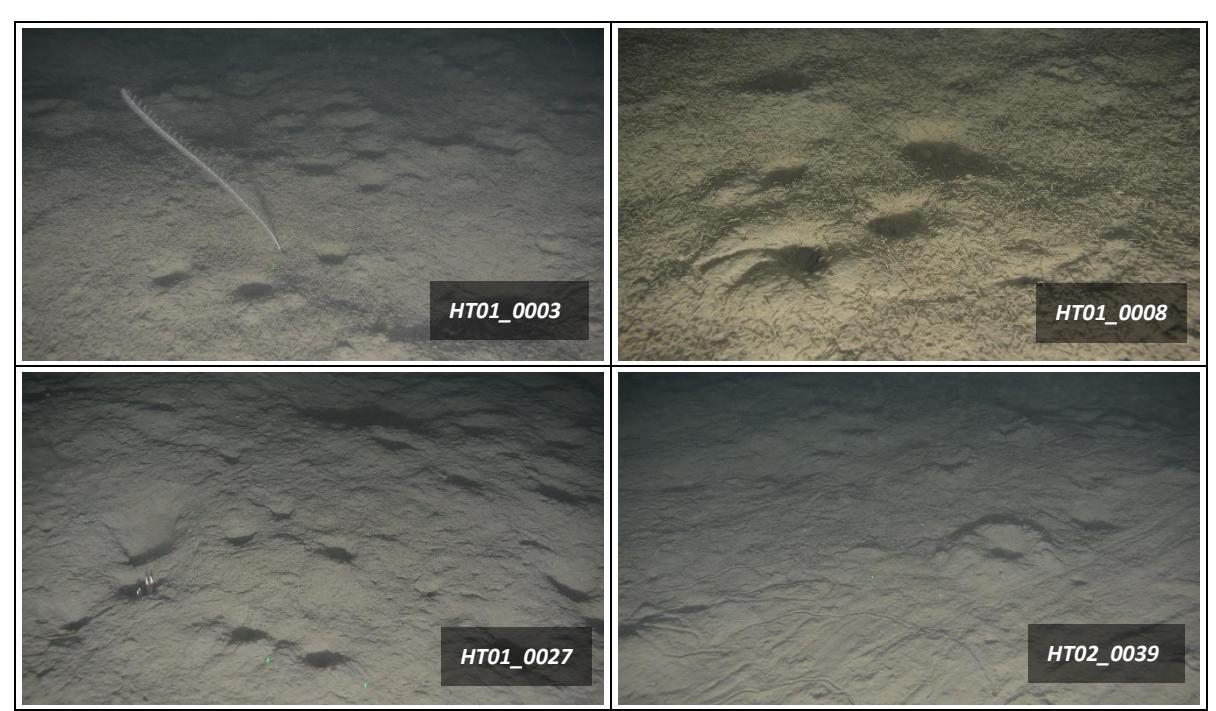
Figure 8.5 Example Images of a Fine to Medium Sand Habitat

This sediment type was predominantly found northeast of the fish farm along transects HT01, HT01A and HT02, which coincided with the deeper water depths (>35m) when compared to the transects closer to the coastal zone (HT03, HT03A; Figure 8.1). The substrate type consisted of silty sand with minor proportions of shell fragments and was characterised by bioturbation, "lebensspuren", burrows and furrows left behind by fishing gear (Figure 8.5). The conspicuous faunal community recorded was fairly diverse and included: Crustacea such as Norway lobsters (Nephrops norvegicus), edible crabs (Cancer pagurus), squat lobsters (Munida sp.), hermit crabs (Paguroidea sp.) and shrimps (Caridea sp. and Euphausiacea sp). Echinoderms were represented by the seven-armed starfish (Luidia ciliaris), northern feather stars (Leptometra celtica), cushion stars (Porania pulvillus), brittle stars (Ophiuroidea sp.), common sea urchins (Echinus esculentus), sea cucumbers (Holothuroidea sp.) and starfish (Asteroidea sp.). Cnidaria such as the slender seapen (Virgularia mirabilis), tall sea pen (Funiculina quadrangularis), fireworks anemone (Pachycerianthus multiplicatus) and tube anemone (Cerianthus lloydii) were also observed, along with polychaetes (Sabellidae sp.), sea squirts (Ascidiacea sp. and Ciona intestinalis) and free-swimming demersal species such as Gadidae sp., juvenile conger eels (Conger conger), gobies (Gobiiformes sp.), common dragonets (Callionymus lyra) and a thornback ray (Raja clavata).

The silty sand habitat recorded showed some affinity to the biotope SS.SMu.CSaMu- circalittoral sandy mud. The presence of burrowing macrofauna such as *Nephrops norvegicus* and associated bioturbated nature of the seabed may indicate the sediment type also has an affinity to the biotope of SS.SMu.CFiMu.SpnMeg – Seapens and burrowing megafauna in circalittoral fine mud. The presence of the tall seapen (*Funiculina quadrangularis*) and the rare fireworks anemone (*Pachycerianthus multiplicatus*) may also indicate some conformance to the SS.SMu.CFiMu.SpnMeg.Fun – Seapens,

The environmental conditions described by both the UK Post-2010 Biodiversity Framework and OSPAR habitats are commensurate with that recorded northeast of the Loch Hourn fish farm, where depositional silty sands and burrows were prevalent. The absence of the phosphorescent seapen (*Pennatula phosphorea*) from the habitat may not negate the classification, as while burrowing megafauna is an essential element of the habitat, seapens may, and by extension may not, be present (JNCC, 2014).

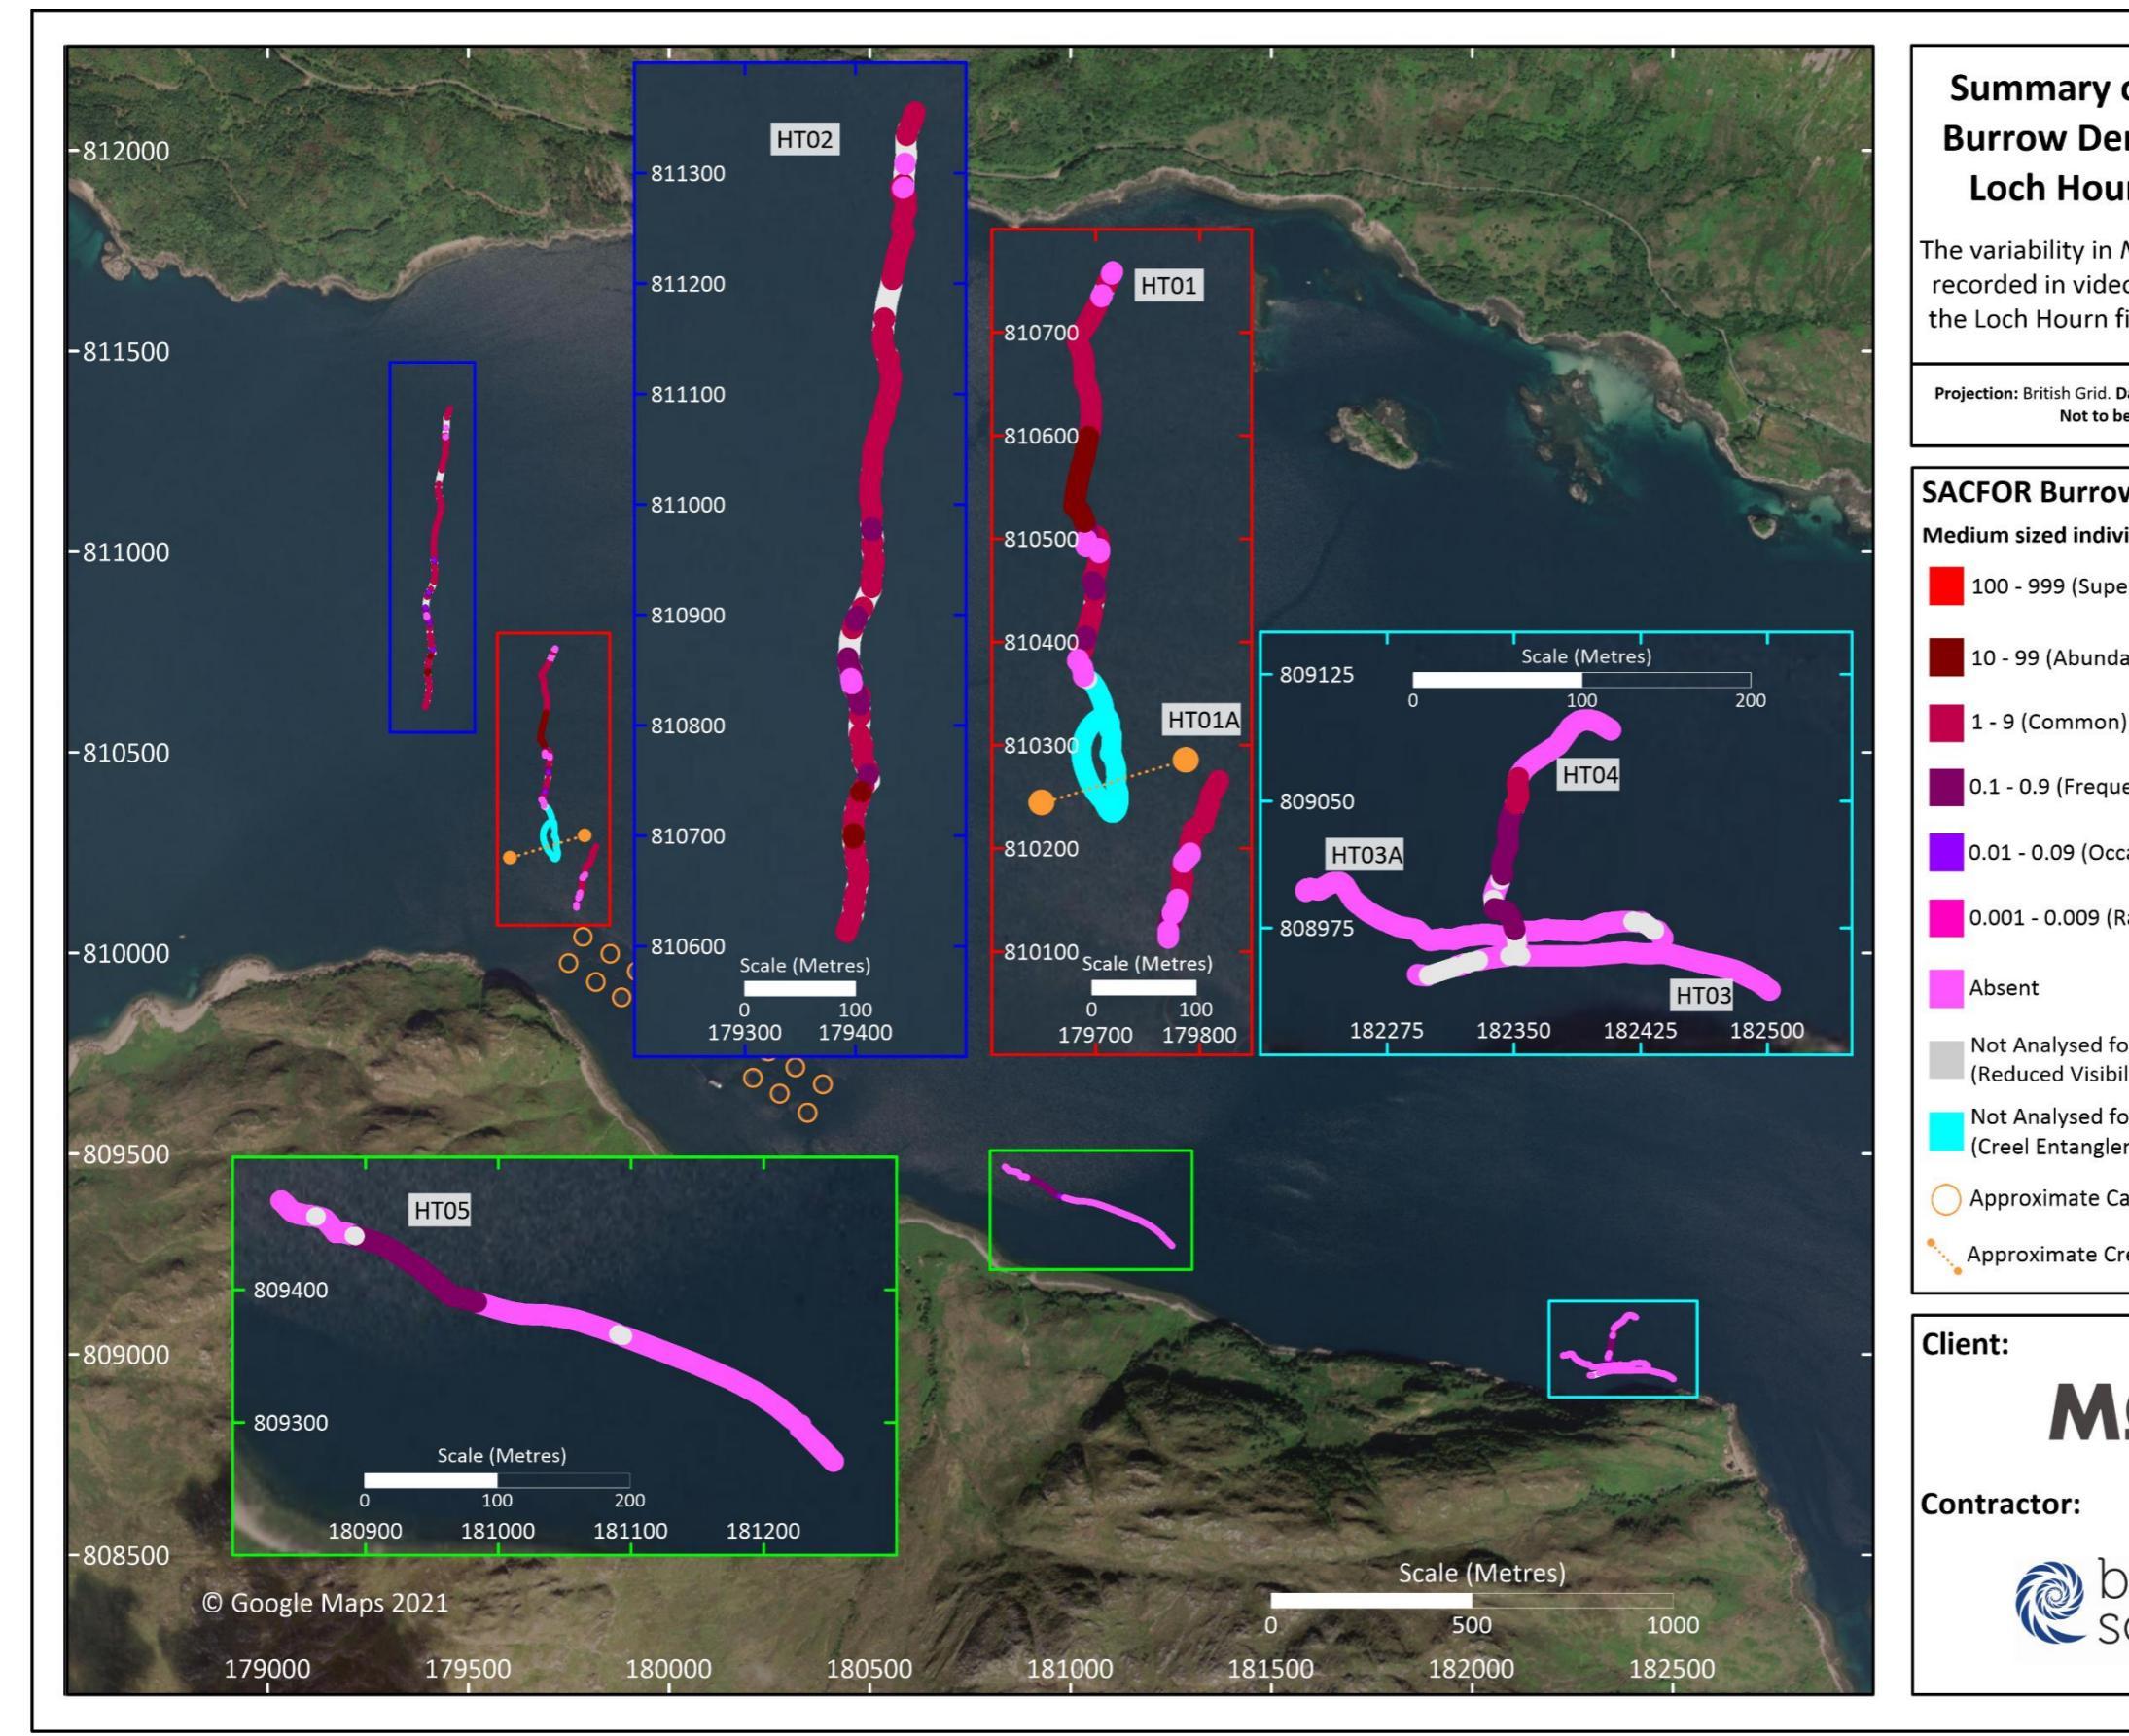
Figure 8.6 Summary of N. norvegicus Density Along Each Transect

The survey lines were split into their respective substrate categories, which were then used as independent counting intervals to mitigate against counting fatigue, especially within areas of high burrow counts. Burrows were counted and categorised based on the associated size of the Nephrops norvegicus that occupied them, using the medium (3 to 15cm) SACFOR size class for N. norvegicus burrows was the dominant size of N. norvegicus across the Loch Hourn survey area. The average burrow counts taken from two independent video assessments were combined with the distance travelled by the vessel to calculate N. norvegicus burrow density in relation to the SACFOR scale for each counting interval (Table 8.2). A conservative approach was used throughout the burrow analysis, as burrow complexes (multiple burrow openings to the same chamber) were only counted once to avoid overcounting and any sections of poor visibility attributed to increased turbidity were noted and excluded from burrow counts and density calculations. The medium burrow density for each transect across the survey area are presented in (Table 8.3) while the extent of burrow density in relation to substrate variability is mapped in (Figure 8.6).

Broad scale comparisons between each camera transects indicate that burrow densities were greater on the northwestern side of the survey area, with transects HT01, HT01A and HT02 having the greatest medium sized *N. norvegicus* burrow densities of 3.81/m² to 2.47m² and 2.83/m², respectively when compared to 0.20/m² and 0.02/m² for transects HT04 and HT05 and 0/m² for transects HT03 and HT03A, respectively (Table 8.3). These broad transect comparisons indicate that SACFOR densities across the northeastern side of the Loch Hourn survey area were 'Common' for medium sized *N. norvegicus* (3-15cm), while SACFOR densities of between 'Occasional' and 'Frequent' were seen to the east and none were evident on transects HT03 and HT03. The minimum SACFOR burrow density required for an area to be classified as burrowed mud habitat is 'Frequent', therefore the northwestern side of the Hourn survey area can be described as burrowed mud habitat, while the burrowed mud habitat to the east of the site was limited to transect HT04 (OSPAR 2010). The lower densities of *N. norvegicus* on the eastern side of the survey area can be attributed to the coarser substrate in this region, as *N. norvegicus* prefer silty and muddy sediments (Johnson et al. 2013).

When sections of consistent substrate were assessed separately during *N. norvegicus* burrow density calculations (Appendix III) slight variations in densities were evident. For example, on the northwestern side of the survey area medium sized *N. norvegicus* burrow densities ranged between 11.68/m² and 0/m², representing SACFOR classifications of 'Abundant' to 'Absent', while medium sized *N. norvegicus* burrow densities to the east ranged between 1.07/m² (Common) and 0/m² (Absent). Areas of lower *N. norvegicus* density across the survey area coincided with areas of mixed sediment (rocky silty sand) and exposed bedrock, with these habitats tending to be favoured by squat lobsters (*Munida* sp.; Figure 8.1 and Figure 8.6). Therefore, localised habitat and substrate variations existed within the broad burrowed mud habitat on the northwestern side of the fish farm and along transect HT04 to the east.

Summary of N. norvegicus **Burrow Density around the** Loch Hourn Survey Area

The variability in *Nephrops* burrow density recorded in video transects conducted at the Loch Hourn fish farm site during 2021

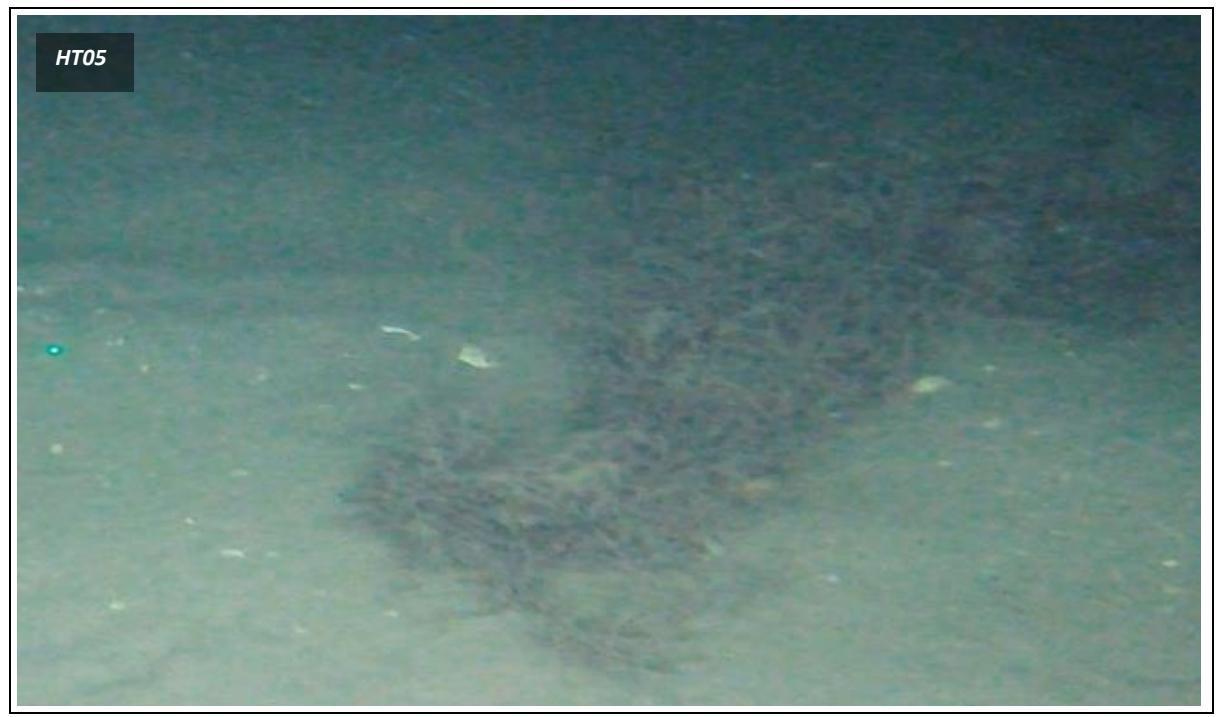
Figure 10.1 Example Image of Anthropogenic Debris

Incidences of anthropogenic debris were rare across the survey area and was limited to a single sighting of a discarded fishing net along transect HT05 (Figure 10.1). The presence of anthropogenic debris introduces additional hard substrates for epifauna to colonise and creates refuges for mobile megafauna. However, no evidence of epifaunal colonisation on the fishing net was observed from the video footage, so it was presumed that the fishing net was a recent addition to the marine environment.

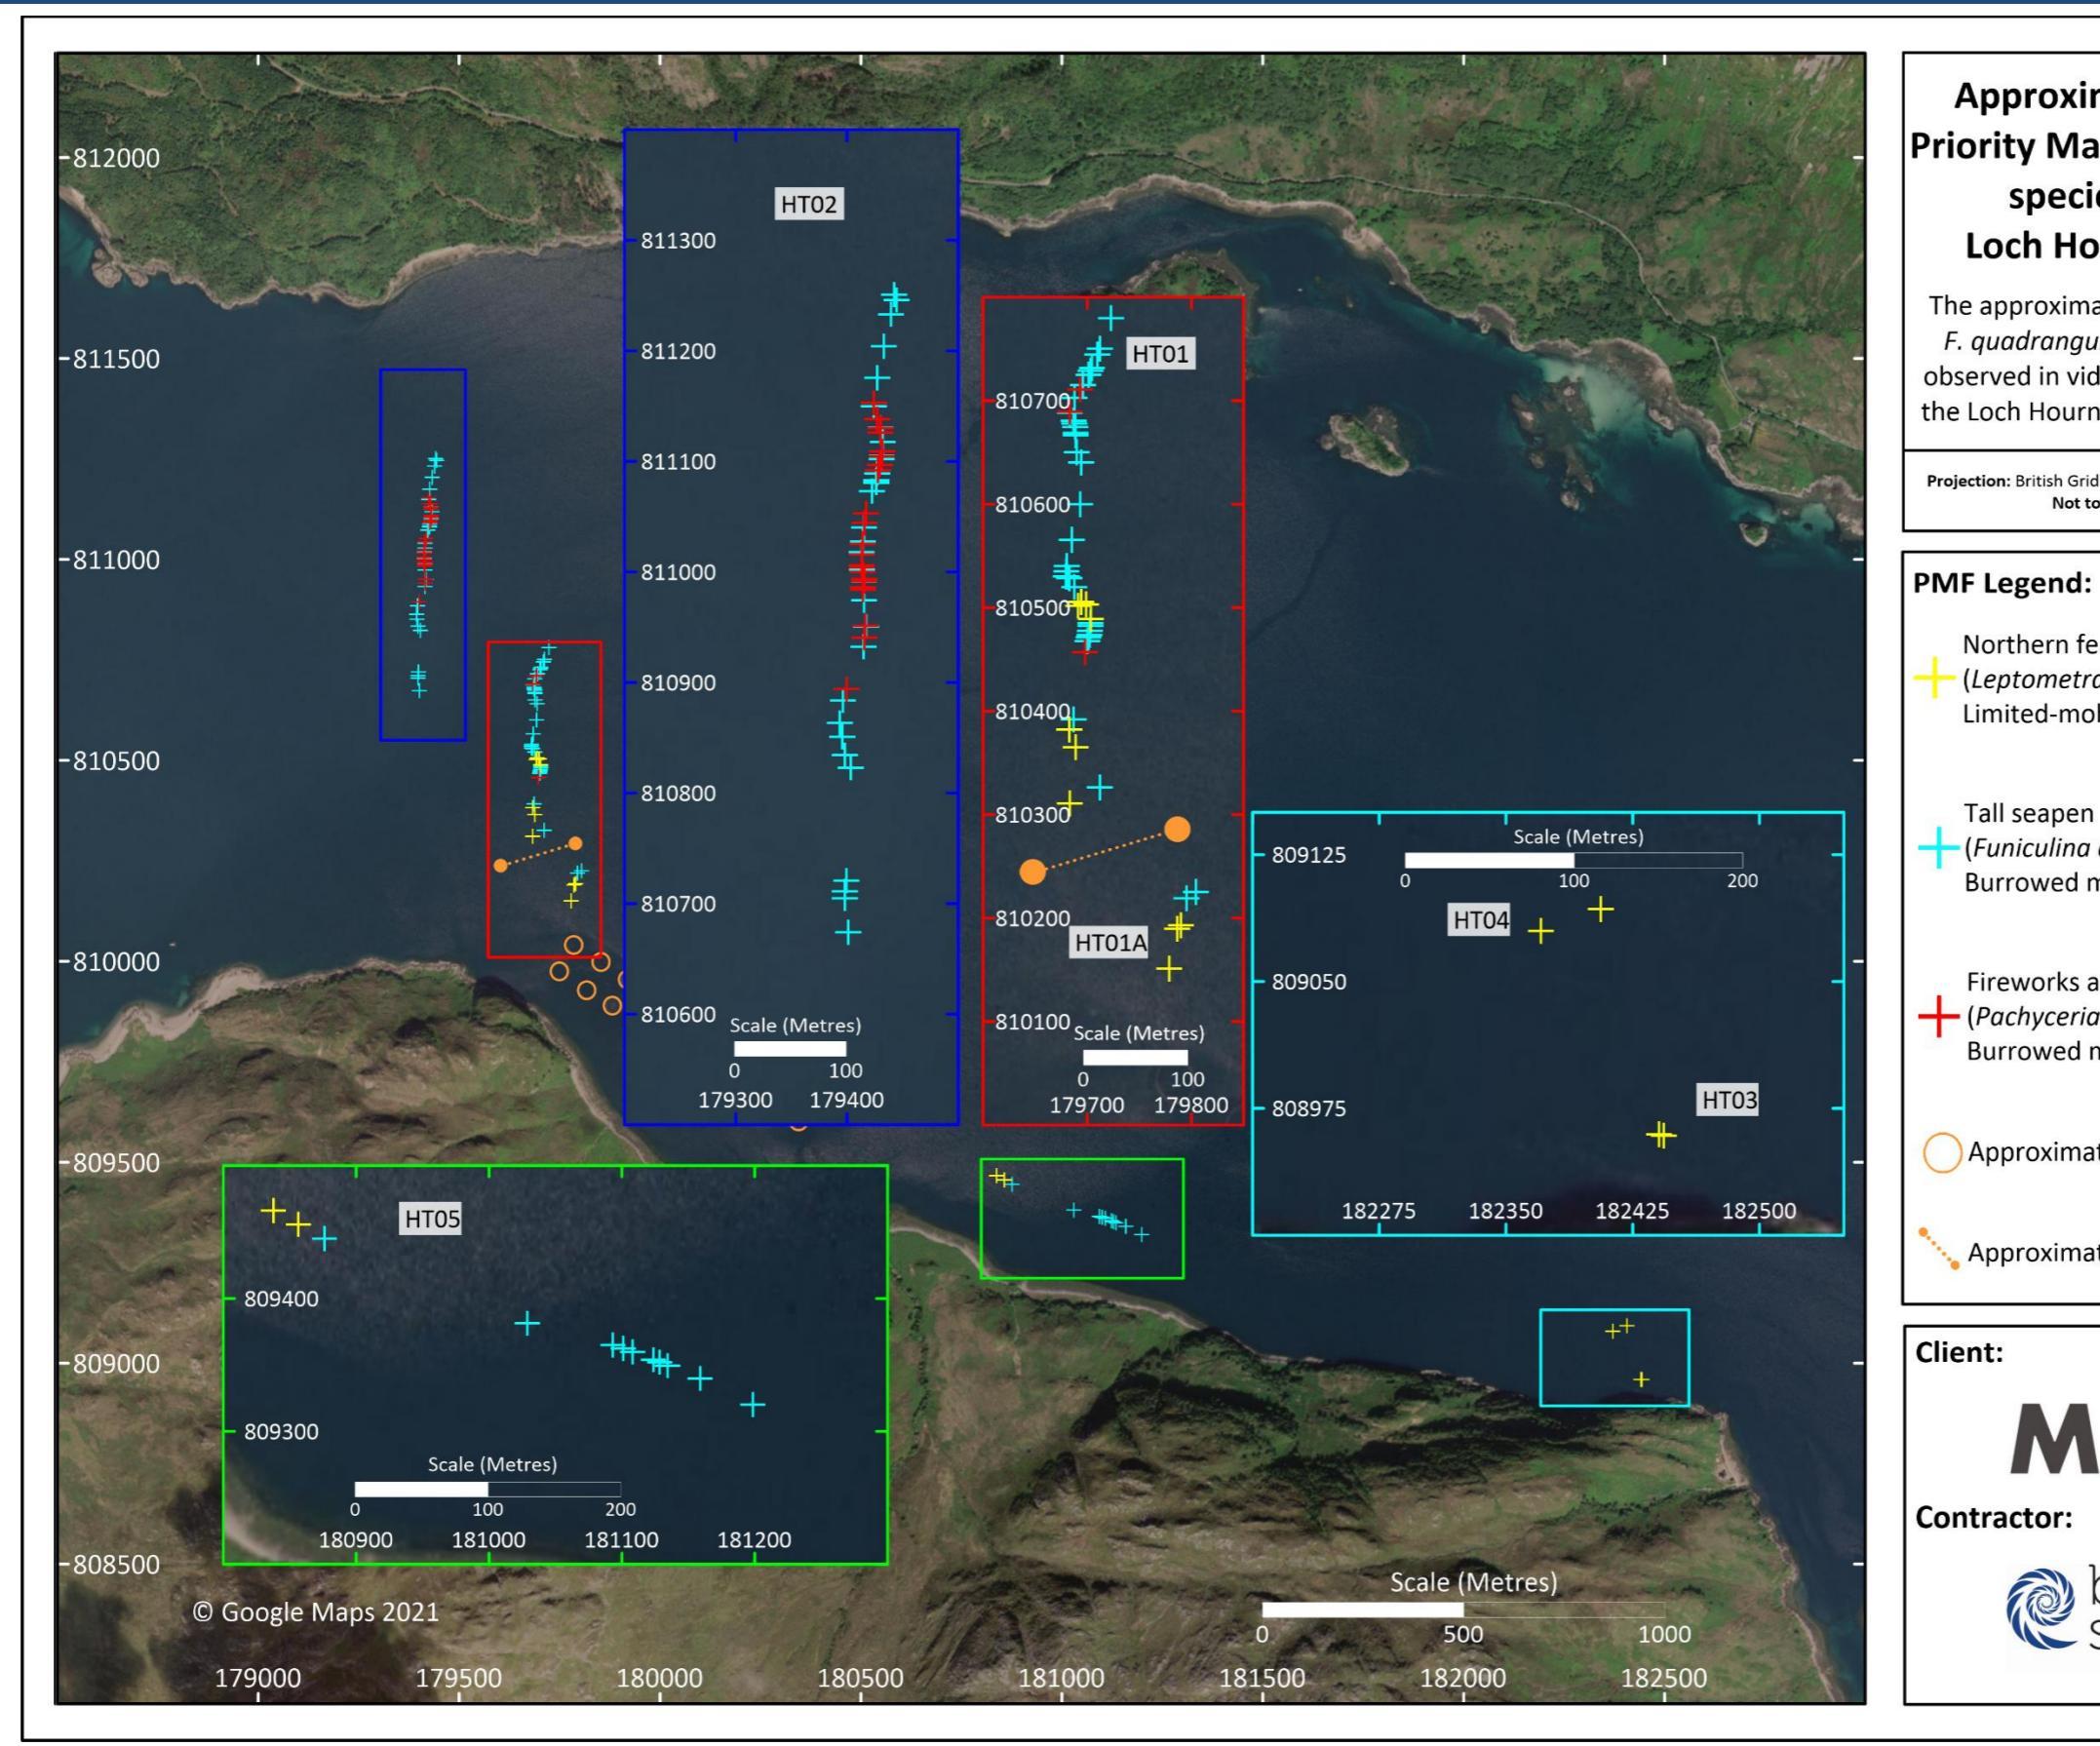
Figure 10.2 Summary of Priority Marine Feature Species Observed Along Each Transect

Approximate locations of Priority Marine Feature (PMF) species around the Loch Hourn Survey Area

The approximate locations of L. celtica, F. quadrangularis and P. multiplicatus observed in video transects conducted at the Loch Hourn fish farm site during 2021

Northern feather stars, listed as a limited mobility species PMF, were widely distributed across the Loch Hourn survey area on areas of exposed bedrock, pebbles and cobbles, with prominent aggregations observed on exposed bedrock along transects HT01 and pebbles/cobbles along transect HT04. Tall seapens and fireworks anemones which are species listed under the burrowed mud PMF were also observed across the Loch Hourn survey area, with greater abundances recorded northwest of the fish farm which correlated with the distribution of the mud/sandy mud sediment type. All three PMF listed species were found in close proximity to the fish farm, between approximately 70m and 380m from the cage edges, which could indicate either no or only minor impact from fish farm activities or some sort of resistance of these species to this influence. However, it is presumed that the distribution and hence close proximity of these PMF species to the Loch Hourn fish farm was more likely to be attributed to the natural variation in substrate across the survey area.
