Marine Aquaculture Site Loch Hourn Appendix 9. Habitat Assessment - Loch Hourn Fish Farm (BSL)

Mowi Scotland Limited November 2021

Habitat Assessment Survey – Loch Hourn Fish Farm

Benthic Solutions Ltd

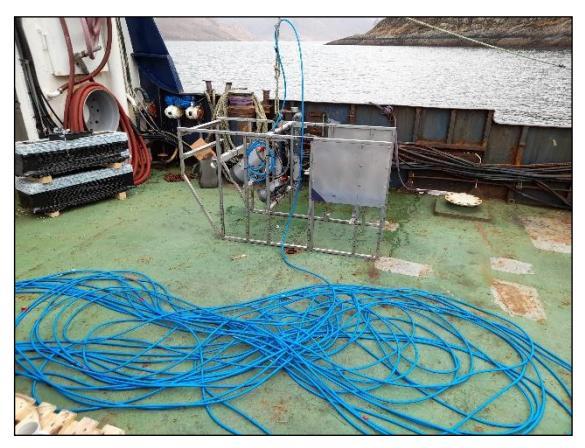
Seabed video footage was acquired at five main transects using a BSL MOD4 underwater camera system mounted within a BSL camera sled equipped with a separate strobe, LED lamp. The camera system itself can acquire images at 24MP resolution (6000 x 4000 pixels).

Once at the seabed, the camera was moved along the length of the transect at as slow a speed as possible (ideally <1 knot). Still photographs were captured remotely using a surface control unit via an

umbilical to the camera system. The stills were uploaded in real-time and saved to the laptop via specialist software. Live video footage, overlaid with date, time, position and site details were viewed in real time. The live video stream was used to assist with the targeting of the stills camera. HD footage was saved internally by the video camera and data was downloaded at the end of each shift of environmental operations and backed-up onto a hard drive.
